Home Inspection Report

1234 Sample Report
Fort Lauderdale, FL 33308

Inspection Date: January 1, 2017 | 9:00 AM

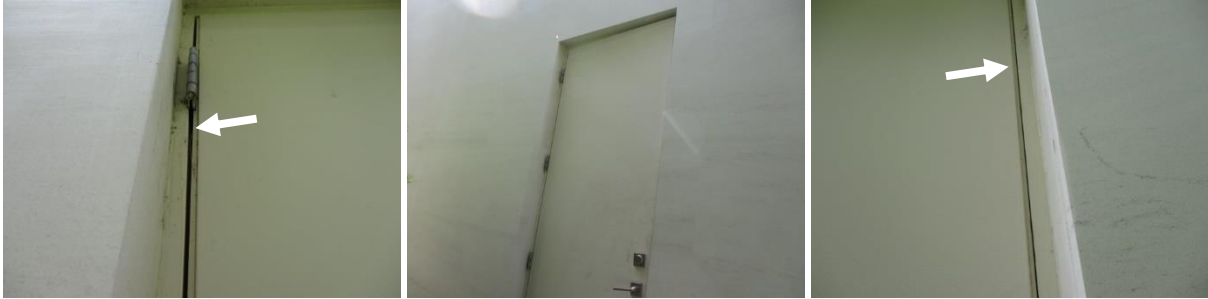
The North Side Exterior Door is tight at the frame. I recommend adjustment for better functioning.

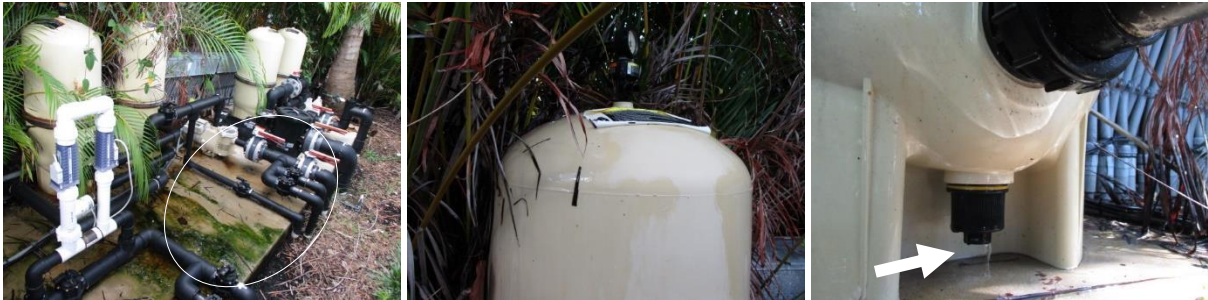
- Leaking was observed at the Pool Filter, second from left, coming from the Gauge area. I recommend further evaluation and repair by a qualified pool technician.

Leaking was observed at the Pool Filter, second from left, coming from the Gauge area. I recommend further evaluation and repair by a qualified pool technician.

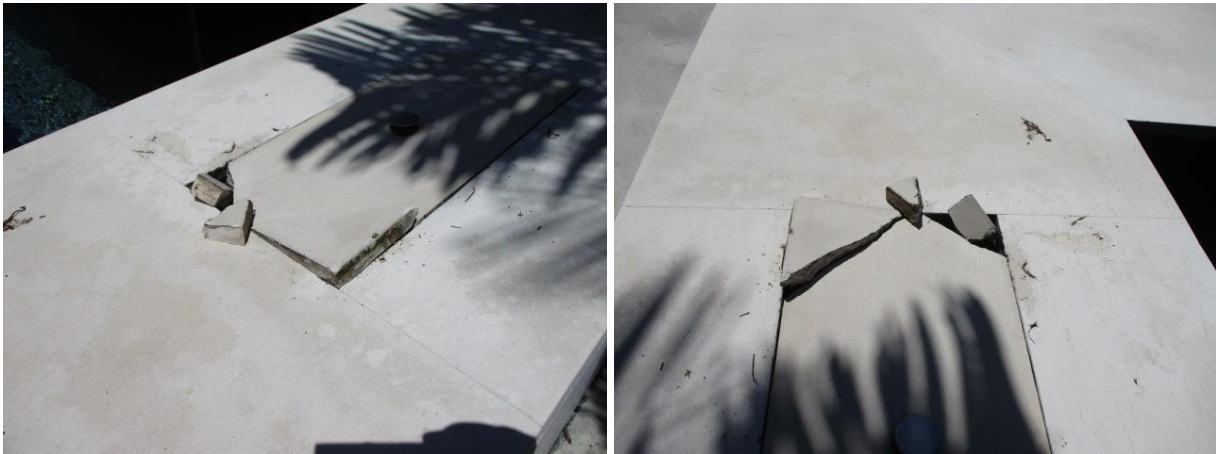
The decorative Limestone over a Cover Plate below the pool is cracked

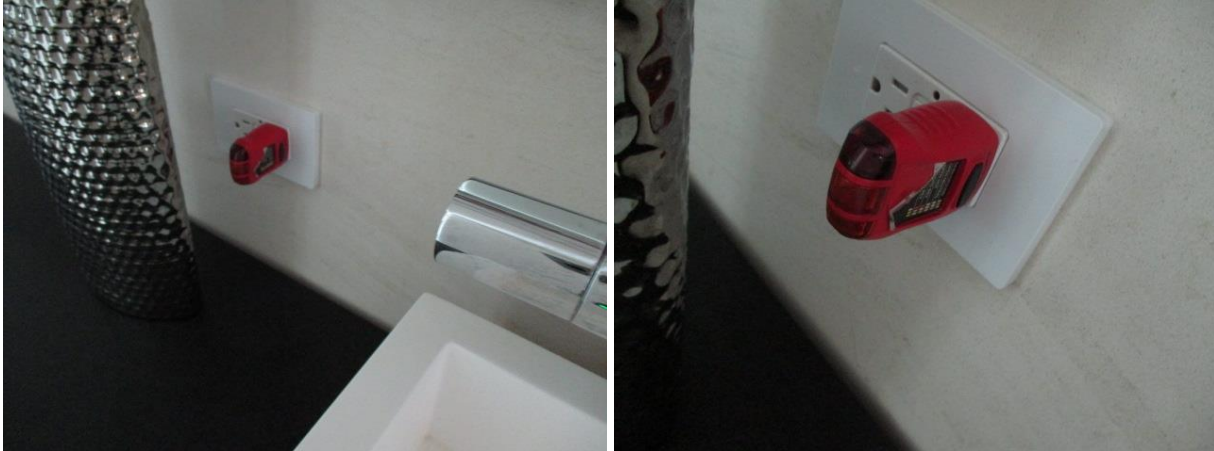
- ❑ The GFCI Outlet next to the left Sink at the Master Bathroom is not functional.

The GFCI Outlet next to the left Sink at the Master Bathroom is not functional.

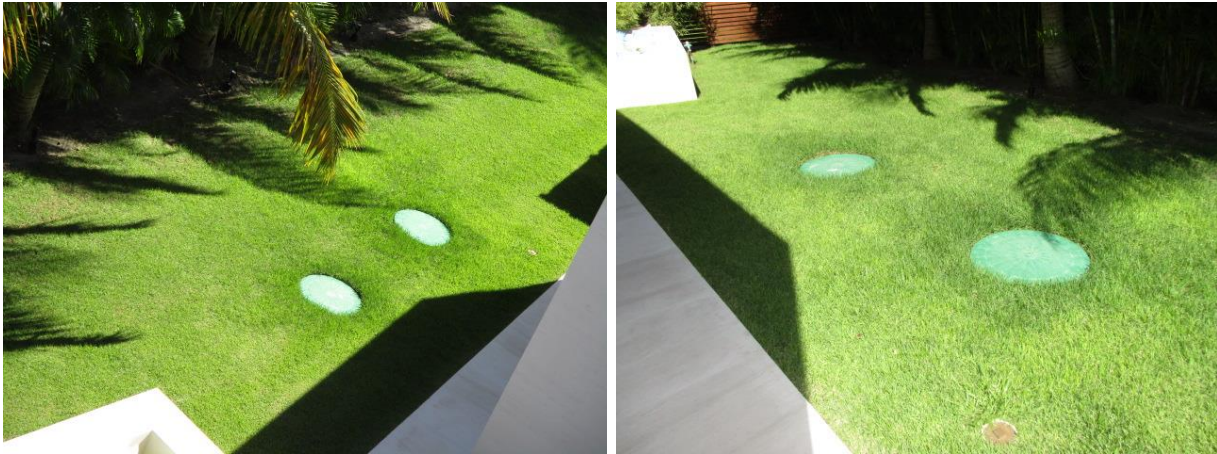
The sewage disposal for this home is done into a **Private Septic Tank**. Septic Inspections are limited to visual aspects of the system. I recommend consulting with a licensed septic contractor to identify the exact location of the system and its components, evaluate it and making any necessary repairs

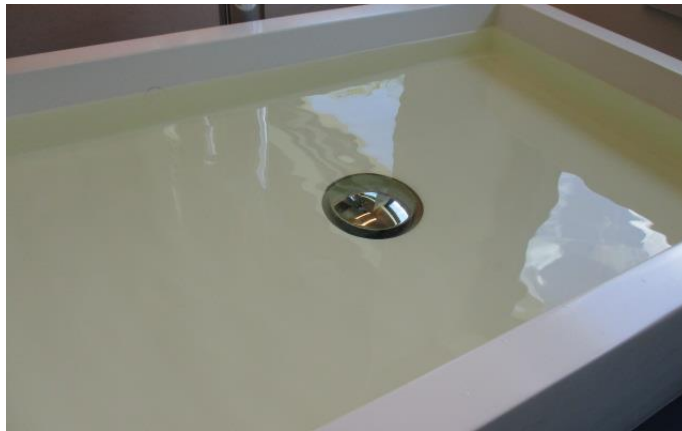
Slow draining was observed at the middle Upstairs Bathroom Sink.

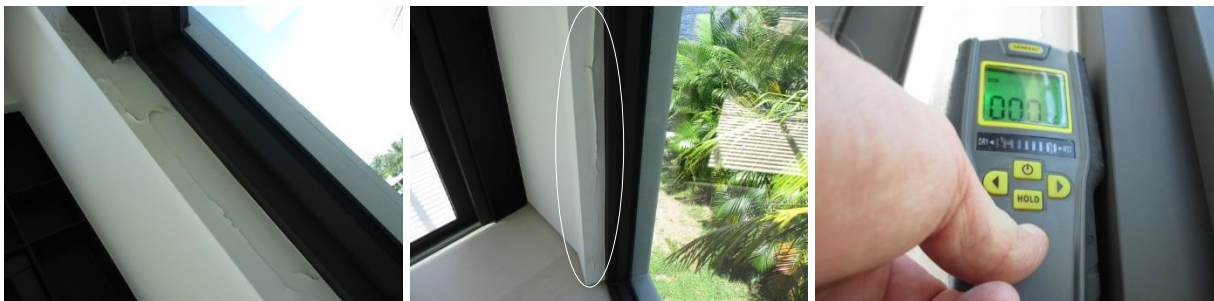
Water staining with some paint peeling was observed at the Master Bathroom NW corner. This area was dry at inspection time. I recommend repair and remediation if necessary.

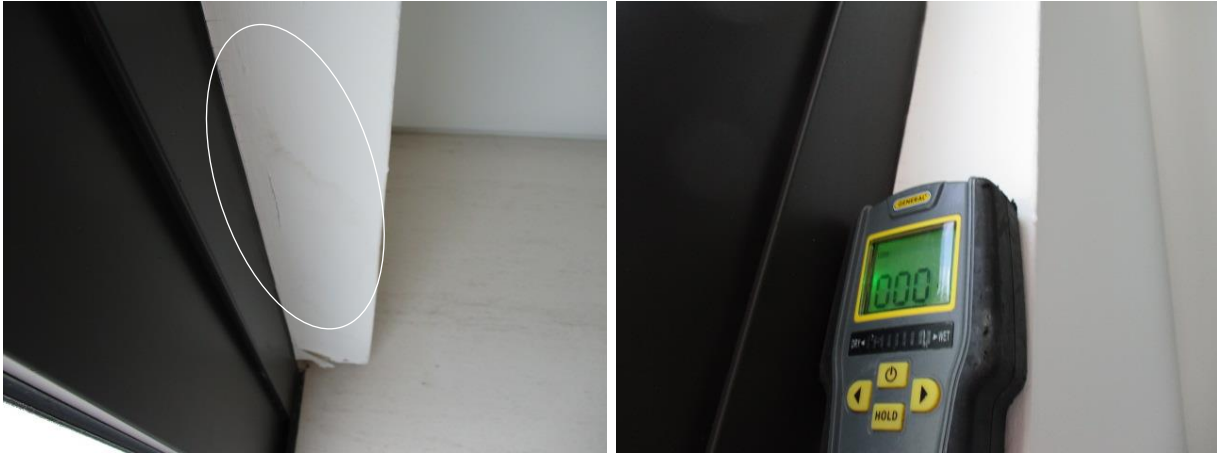
Water staining was observed at the bottom of the inactive sliding door wall frame at the middle Bedroom. This area was dry at inspection time. I recommend repair and remediation if necessary.

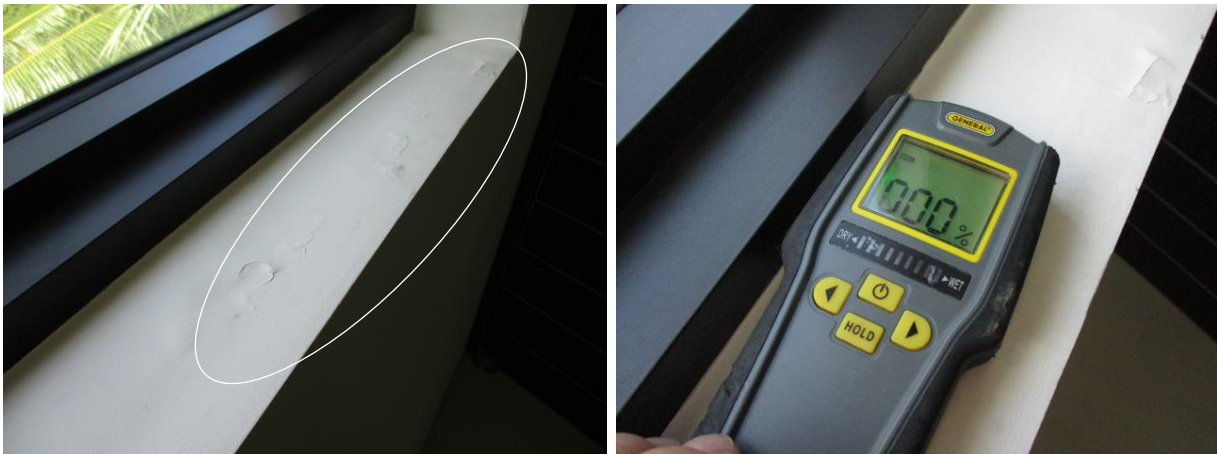
Water staining with some paint peeling was observed at the Window Sill at the "Jack & Jill" East Bathroom. This area was dry at inspection time. I recommend repair and remediation if necessary.

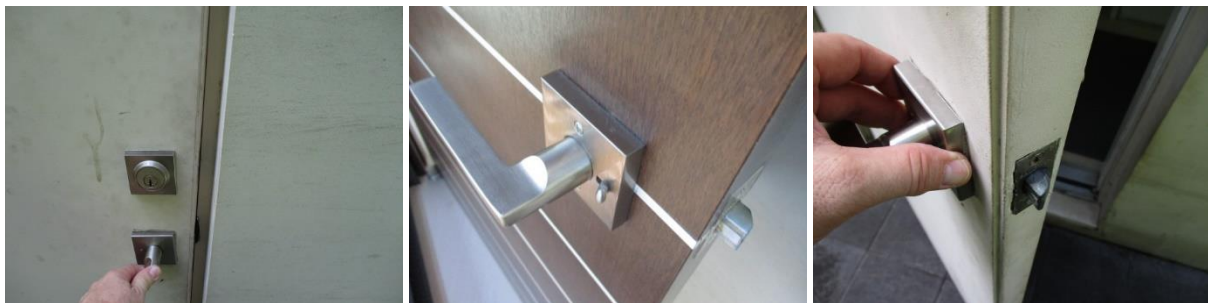
Some Door Handles are loose. They should be tightened up.
