Home Inspections By PJM, Inc.

Confidential - Property Inspection Report - Confidential

Sample Report, FL
Inspection prepared for: Sample Report
Date of Inspection: 11/24/2018
Age of Home: 3 years Size: 7,321 SqFt

Inspector: Luis D. Nigaglioni
Sub Contractor for Home Inspections by PJM Inc. License #HI-2100
11621 Thurston Way, Orlando, FL 32837

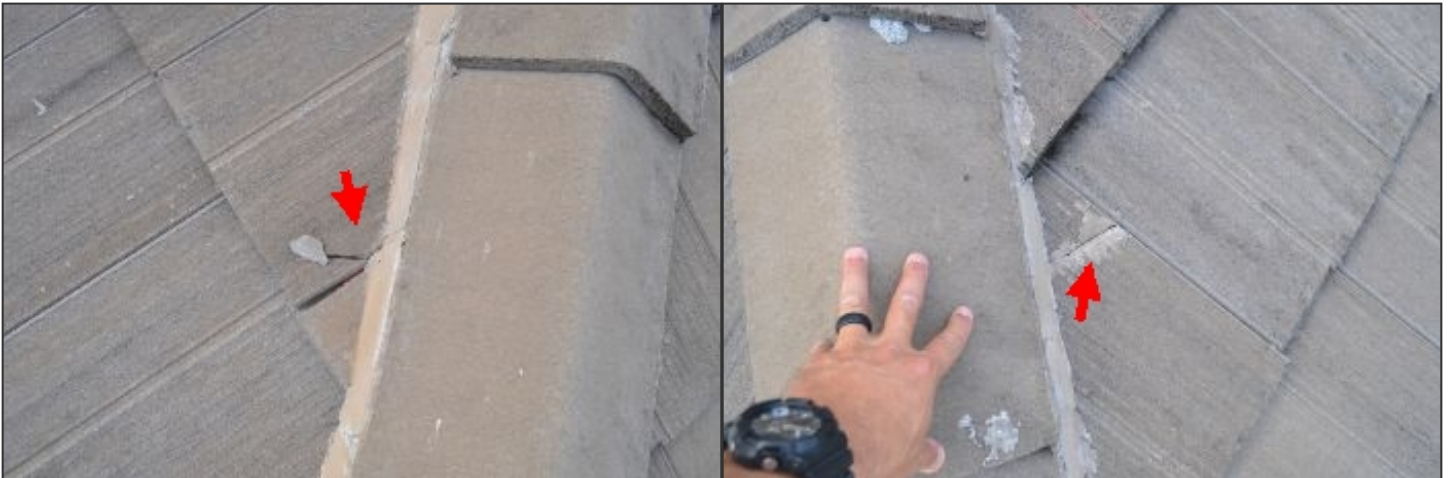
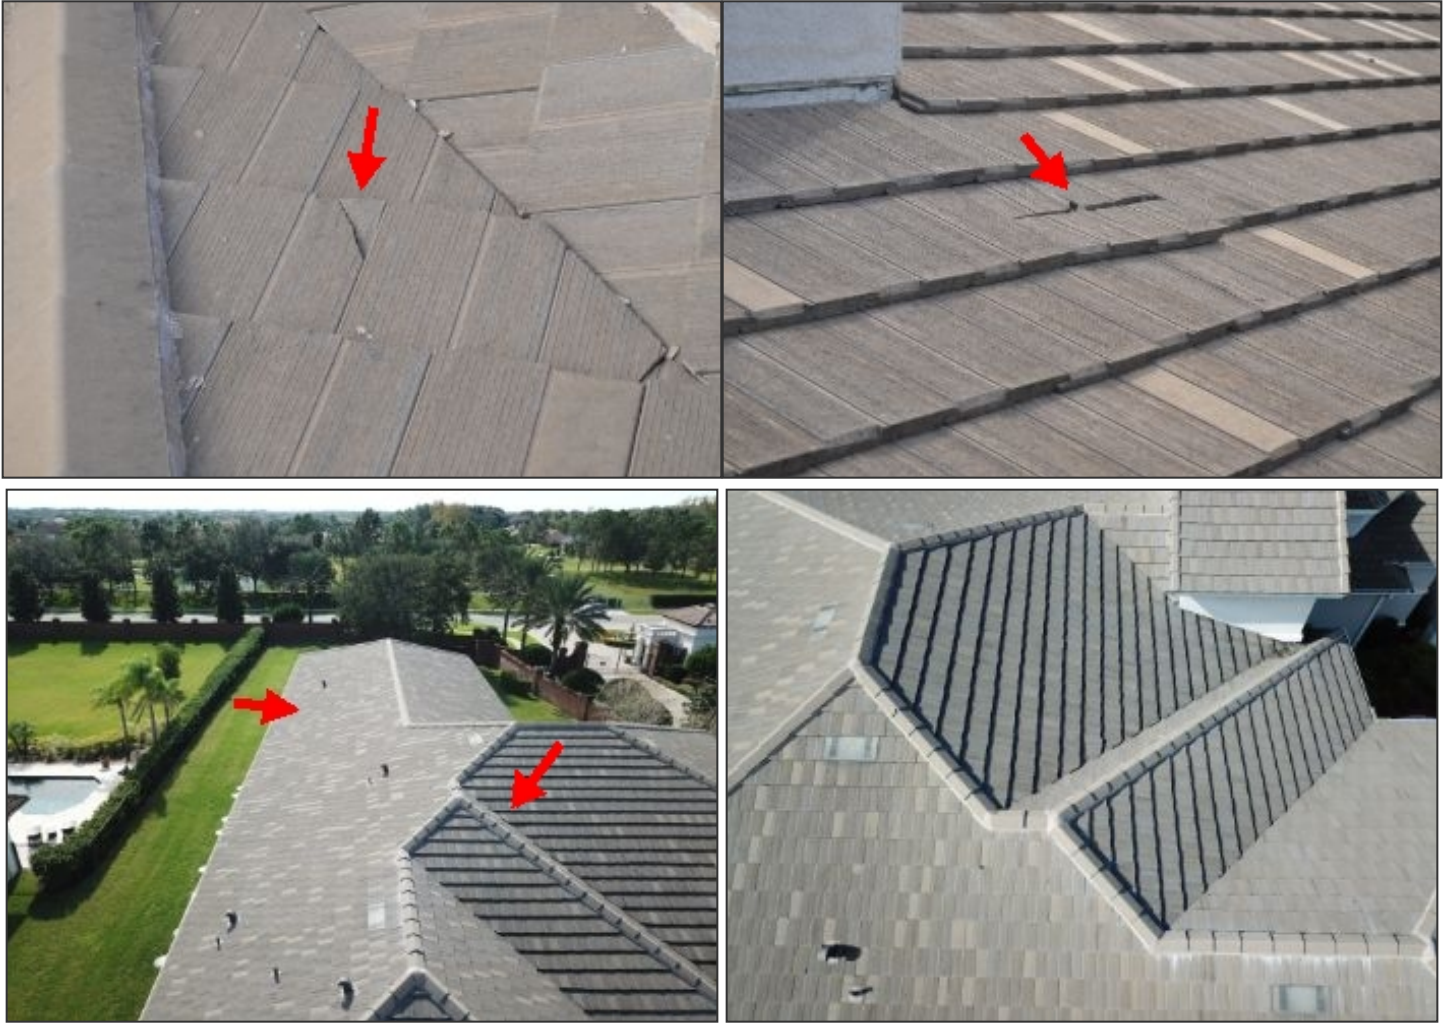
3.1. The roof had cracked or broken concrete roof tiles which should be replaced to prevent damage to the underlying roof structure from moisture intrusion.

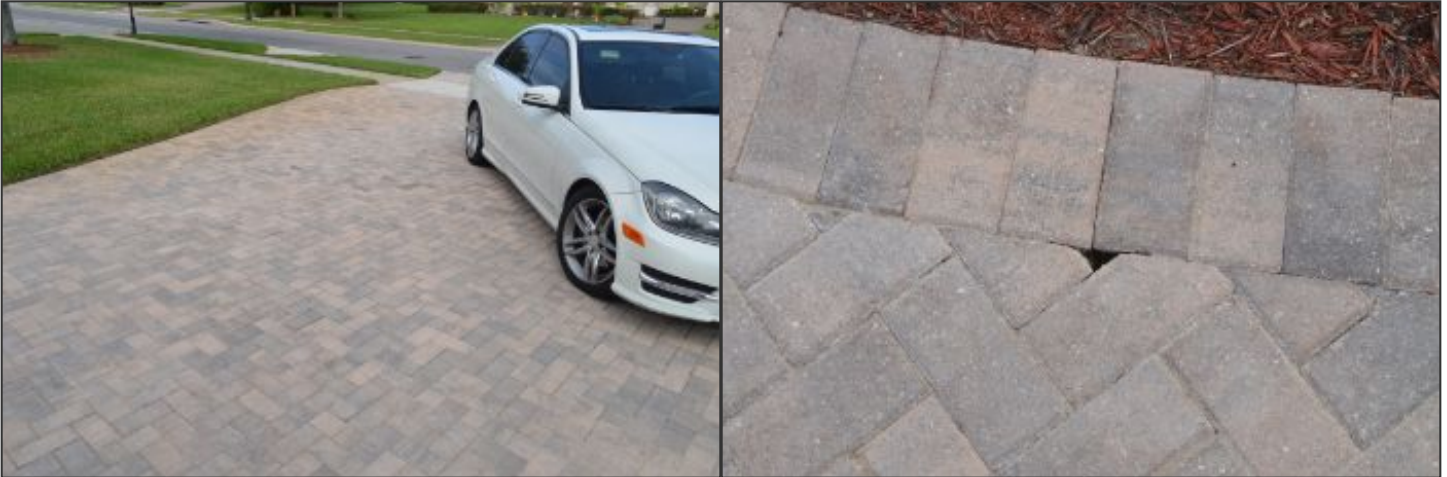
3.1. Minor damage noted on driveway at the time of the inspection.

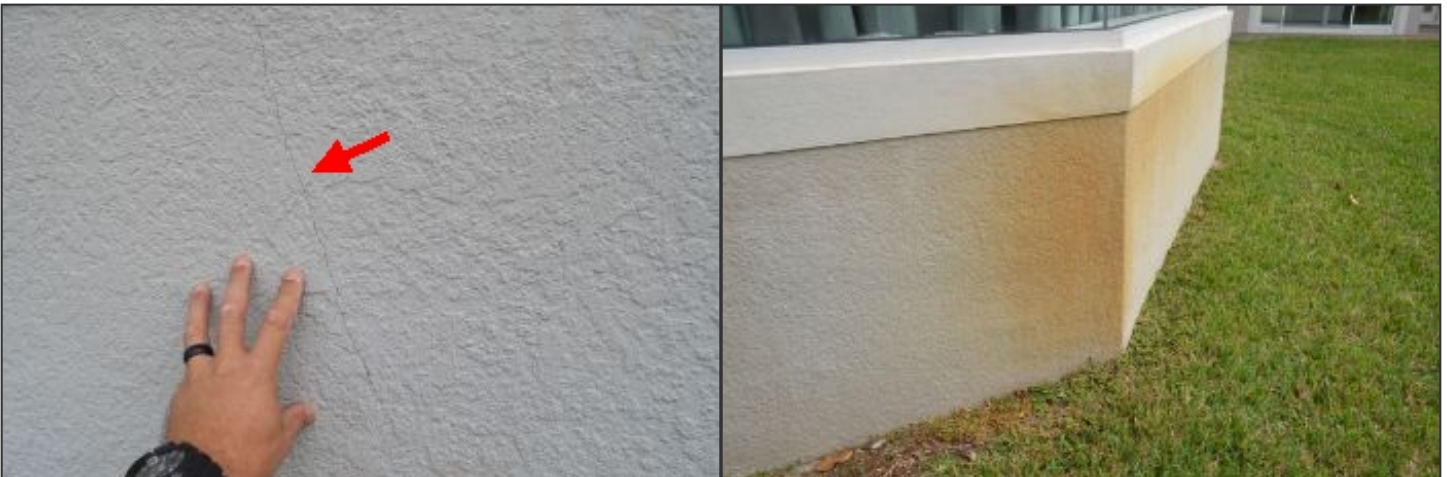
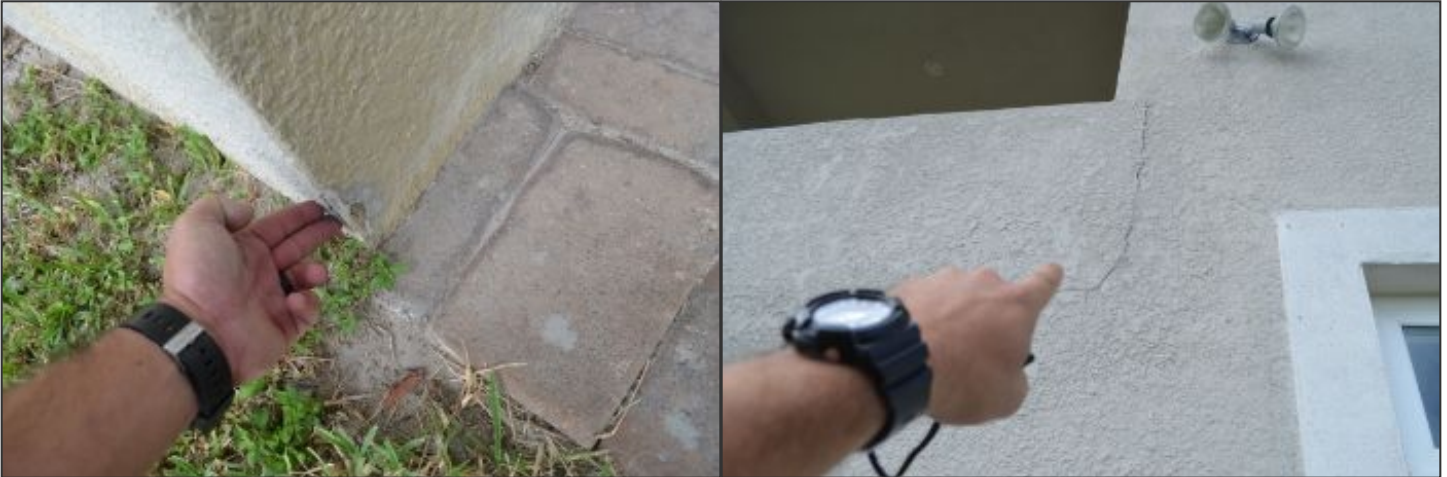
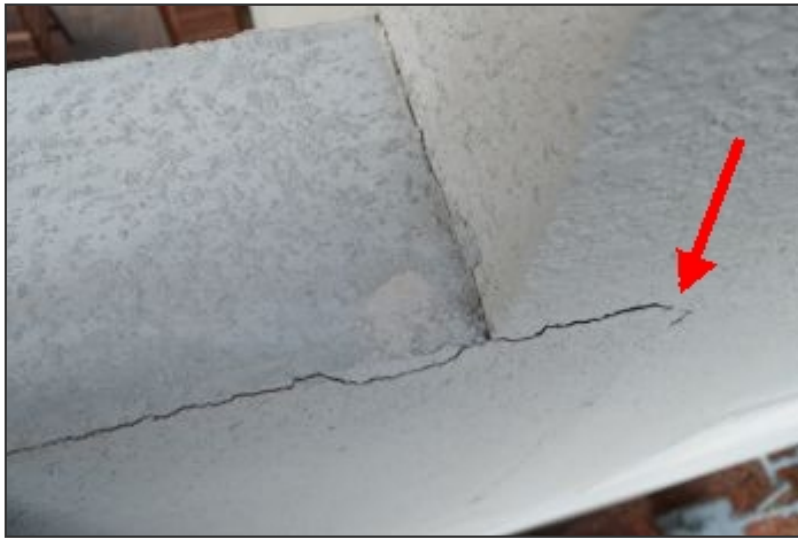
Page 7 Item: 4	WALL COVERING	4.4. Partially detached stucco noted on the left side of the home in area were outdoor kitchen met main wall. Recommend repairs by a qualified person to prevent further damage.
----------------	---------------	--

- 4.1. General cracking, not uncommon in stucco covering exterior walls, was visible at the time of the inspection. This condition is typically the result of long-term thermal expansion, contraction and minor settlement. Cracks should be sealed with an appropriate material to help prevent damage from moisture intrusion of the wall assembly.
- 4.2. Damaged corners noted at the bottom of walls at the time of the inspection. Areas will need to be repaired.
- 4.3. Exterior walls exhibited staining at the time of the inspection. Some areas will need to be repainted.
- 4.4. Partially detached stucco noted on the left side of the home in area where outdoor kitchen met main wall. Recommend repairs by a qualified person to prevent further damage.

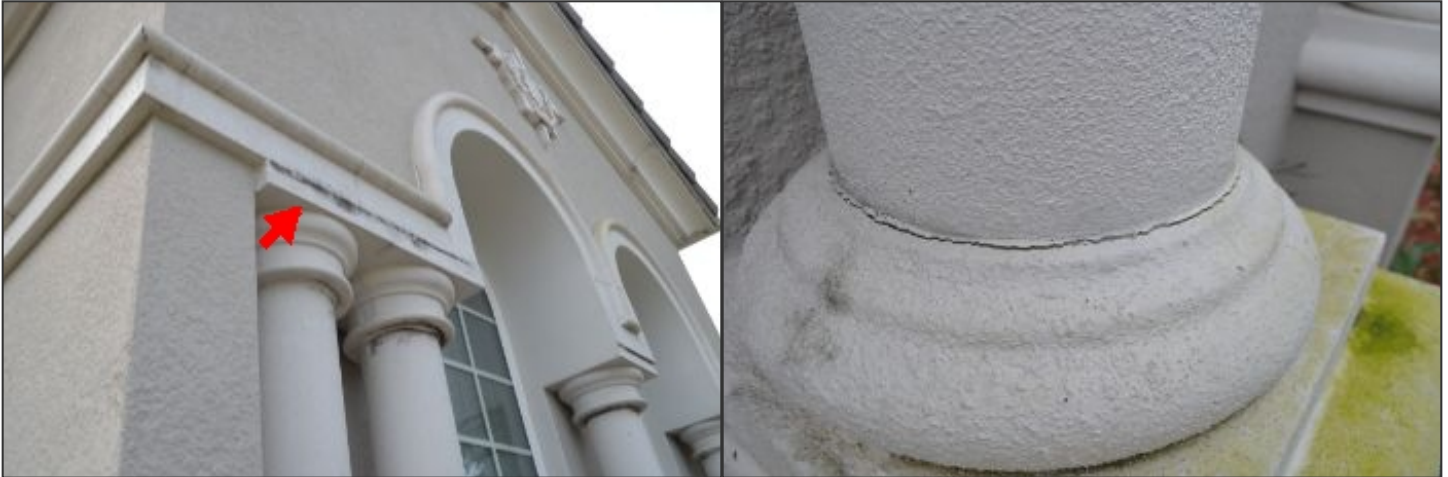
6.1. Organic growth noted on trim areas on the front side of the home (master bedroom). Recommend cleaning and resealing areas to prevent further damage.

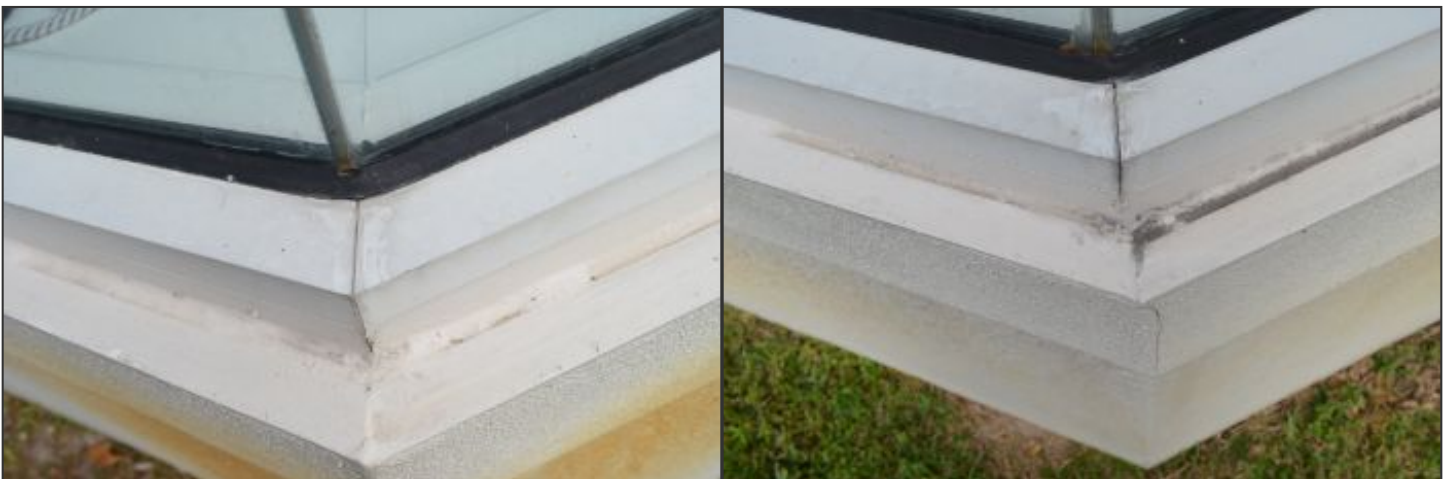
8.1. Gaps noted on the master bedroom windows need to be sealed to prevent moisture intrusion.

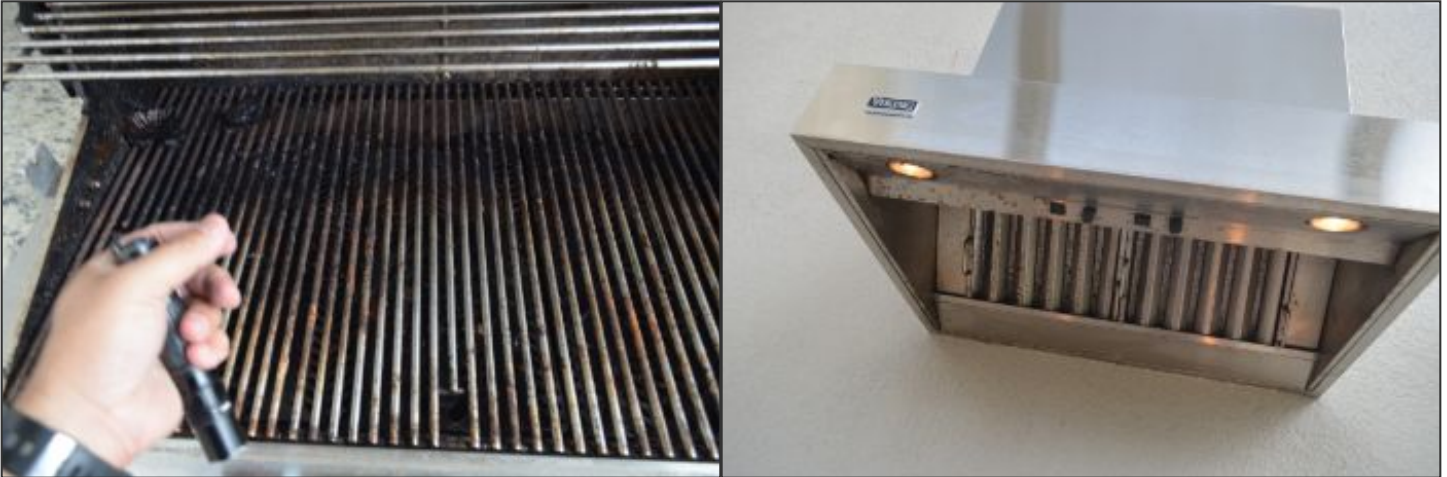
- 9.1. Outdoor grill had excess build up and needs to be serviced before using.
- 9.2. Exterior range hood was in serviceable condition at the time of the inspection.

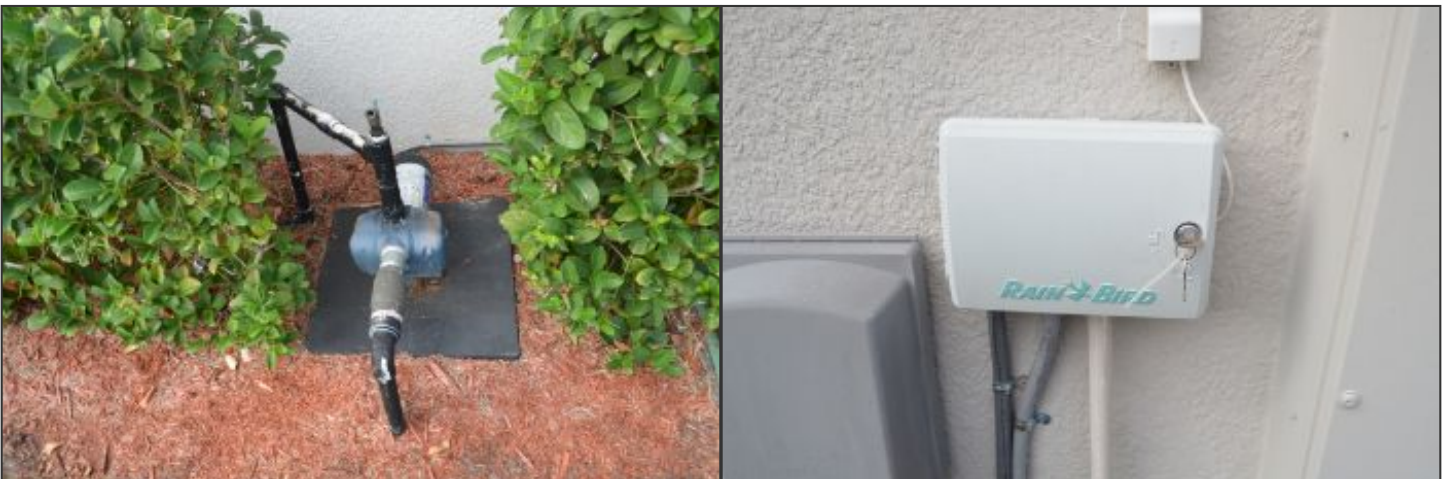
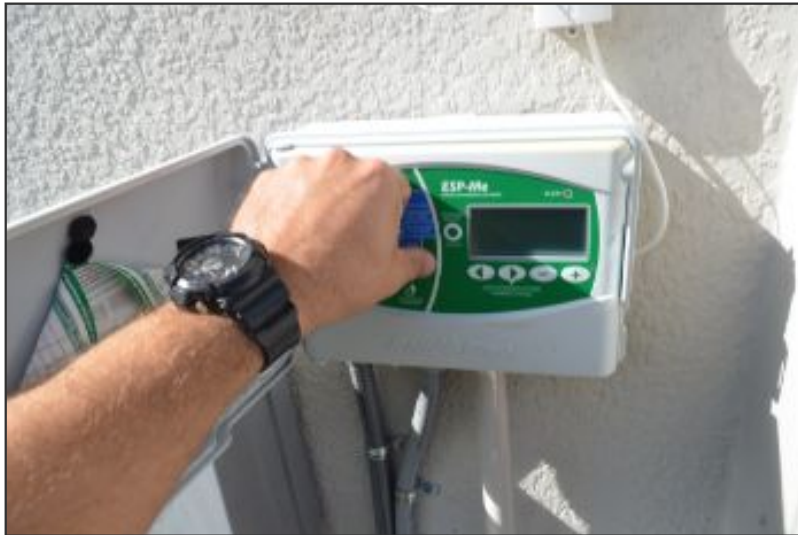
12.2. The lawn & garden sprinkler system did not respond to the control. Unable to operate or fully evaluate system.

Recommend landscaping specialist be consulted for further evaluation/repairs, and to check for other repairs that may be needed at that time.

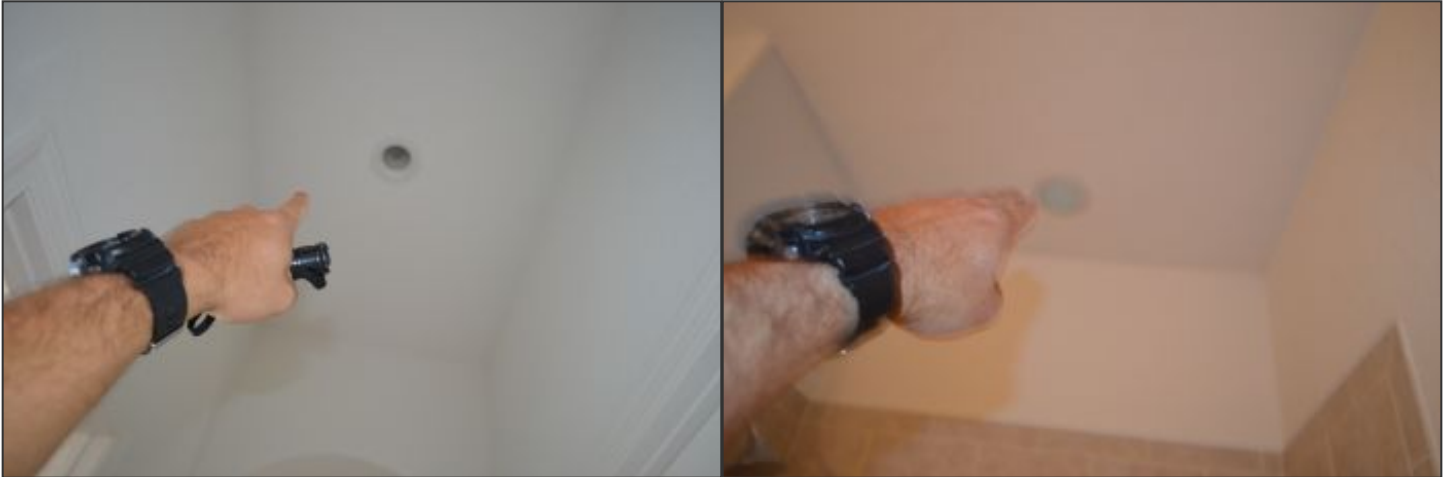
10.1. Some interior and exterior light fixtures in the home appeared to be inoperable. The bulbs may be burnt out, or a problem may exist with the fixtures, wiring or switches. See photos for location.

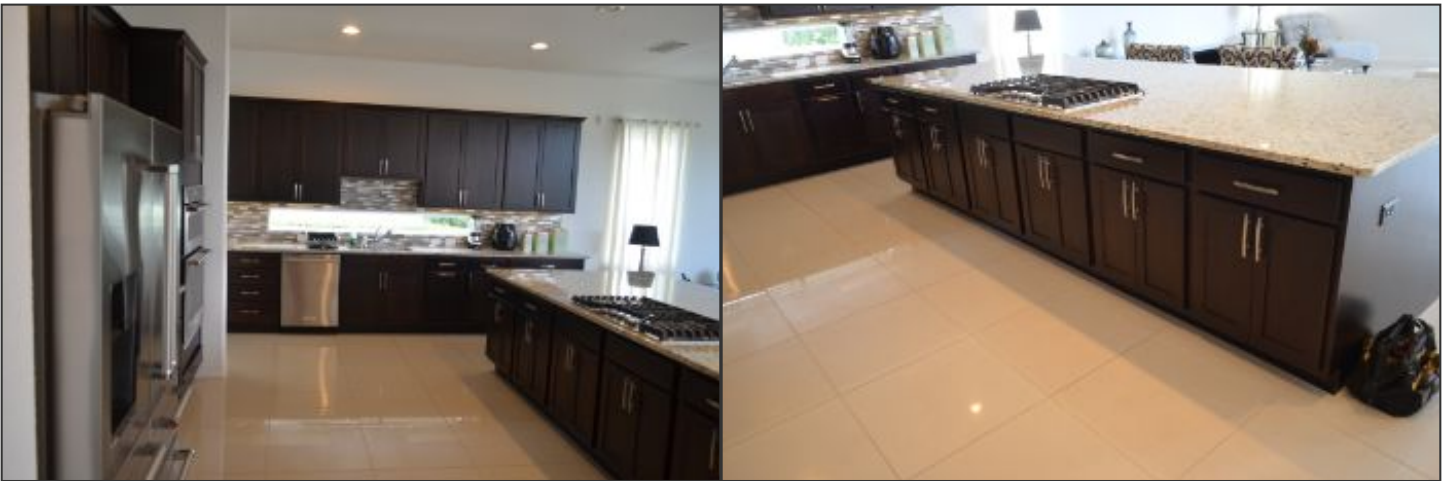
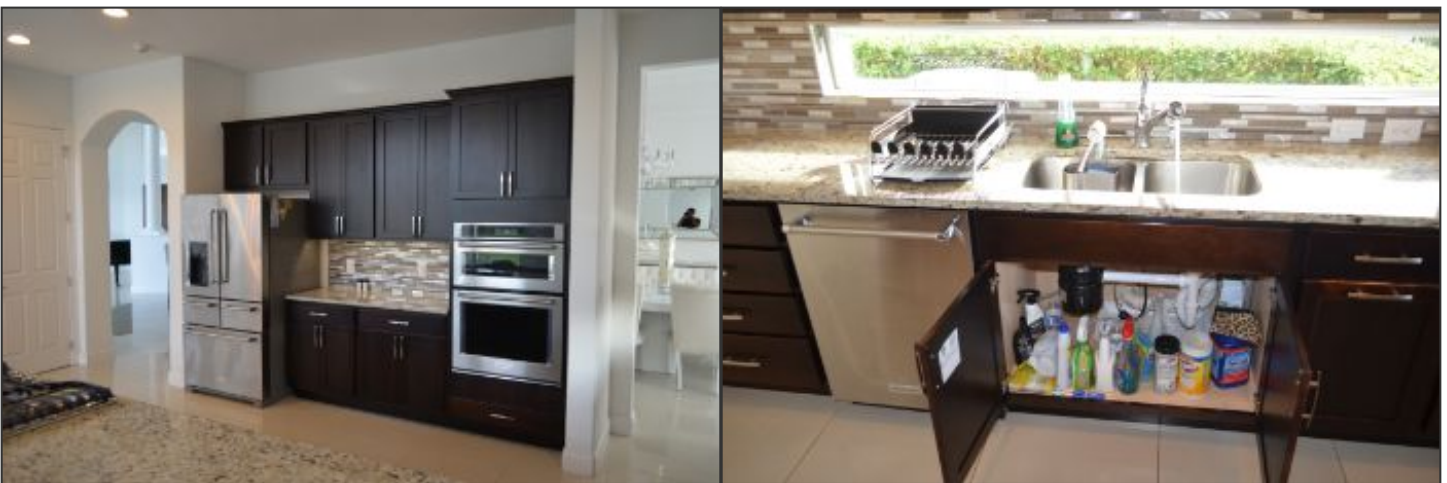
2.1. The kitchen cabinets appeared to be in satisfactory condition at the time of the inspection.
2.2. Evidence of past moisture intrusion was noted at the time of the inspection. The areas were dry at the time of the inspection.

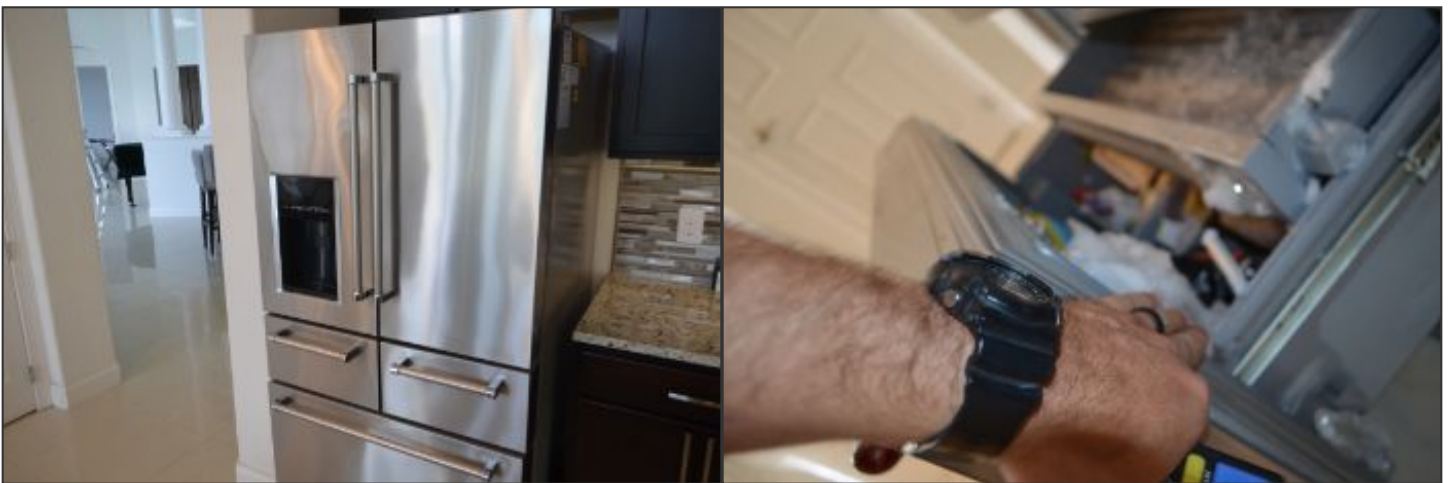
11.1. The refrigerator was working but excess ice build up was noted on freezer around gasket. Recommend service by a qualified technician.

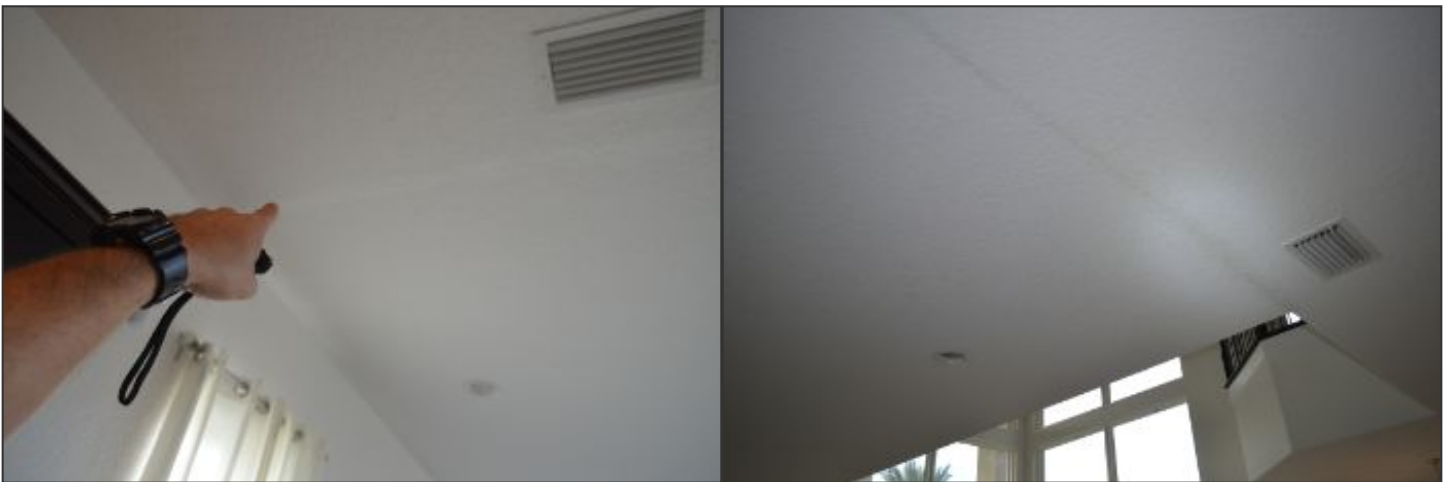
2.1. Minor general damage to the ceilings was visible at the time of the inspection. Seam crack noted on the kitchen ceiling.

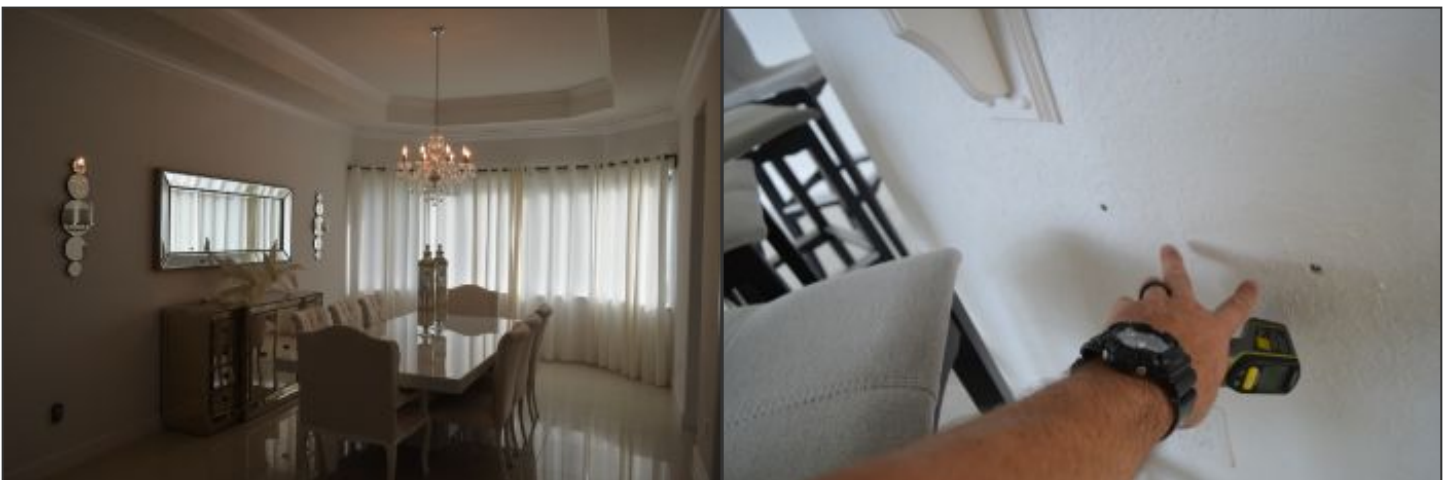
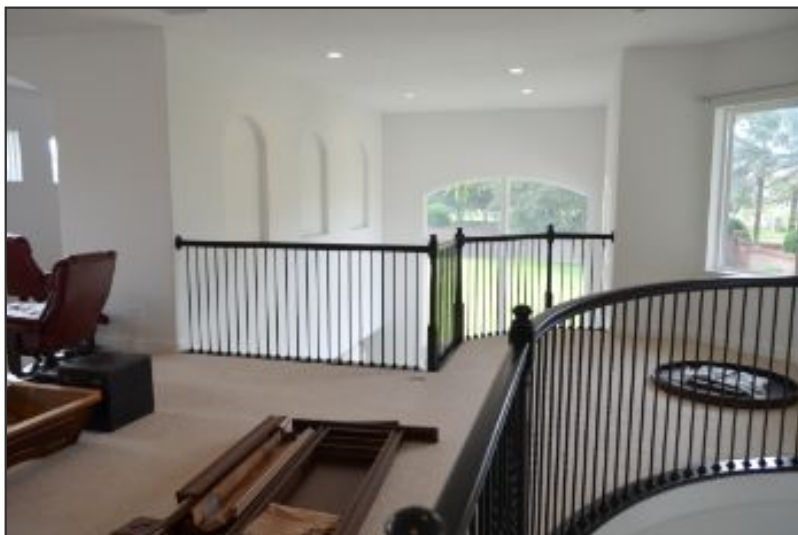
3.1. Some cosmetic, common small cracks and typical flaws in drywall finish noted. This is normal wear for age of home.

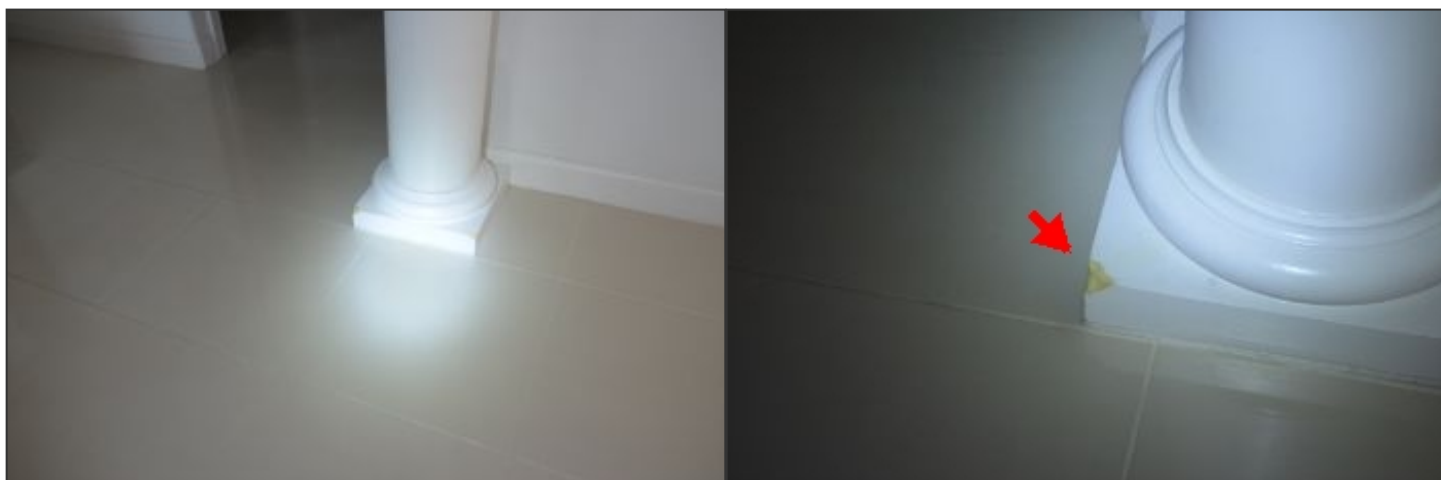
4.1. Dining room column trim exhibited damage on corners at the time of the inspection.

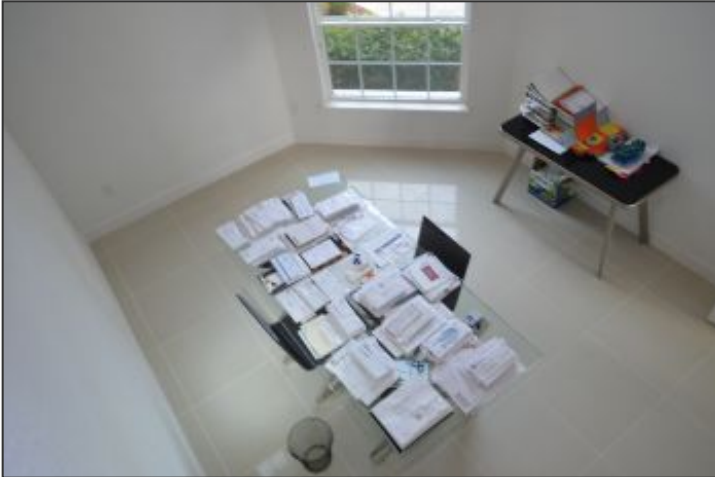
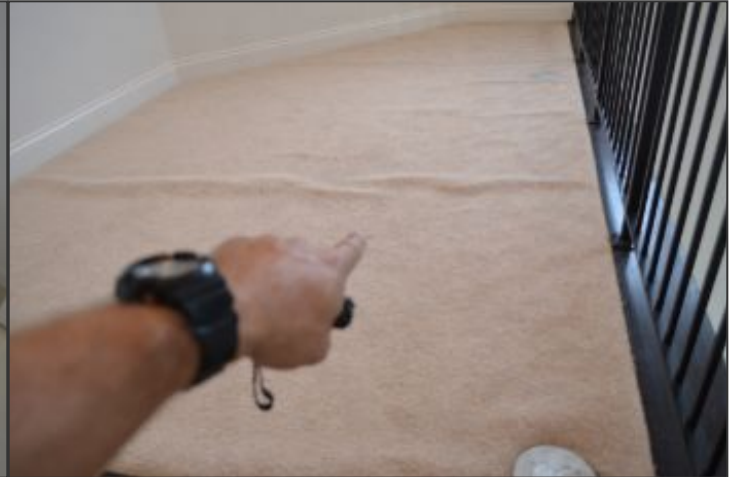
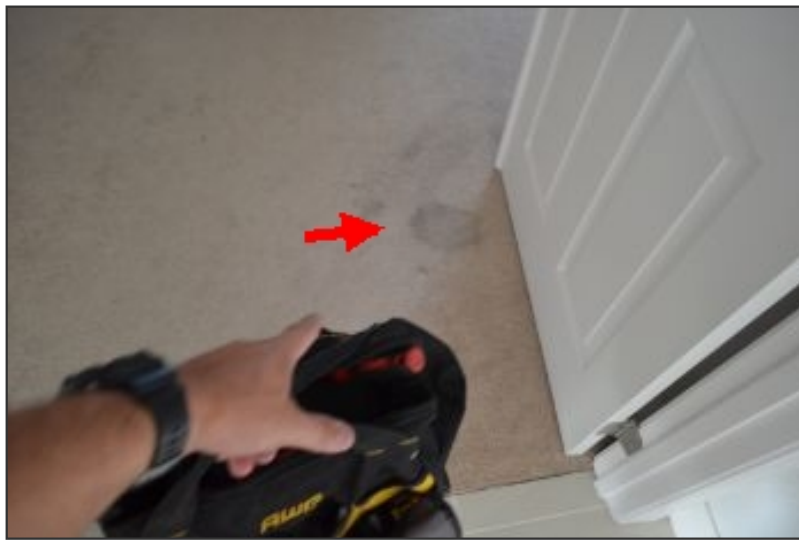
- 5.1. The floors showed general minor damage or wear in various areas.
- 5.2. Carpet on loft above office needs to be stretched.
- 5.3. Master bedroom carpet exhibited staining at the time of the inspection.

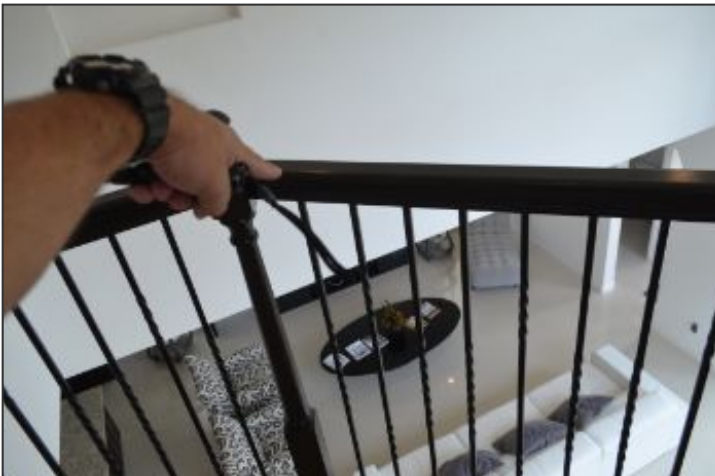
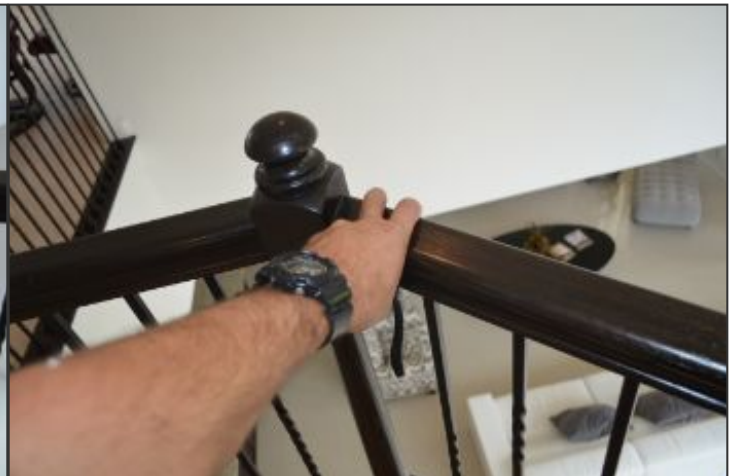
6.1. A section of handrail on loft upstairs was not properly secured at the time of the inspection. See photo for location.

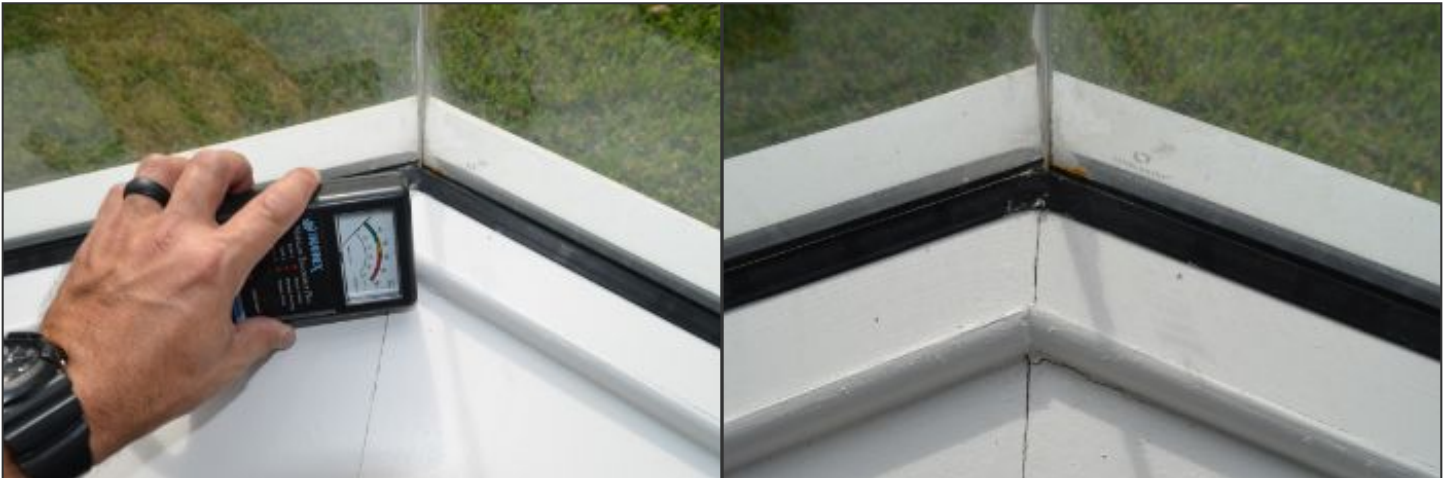
8.1. Master bedroom window exhibited evidence of apparent moisture intrusion. The areas were dry at the time of the inspection.

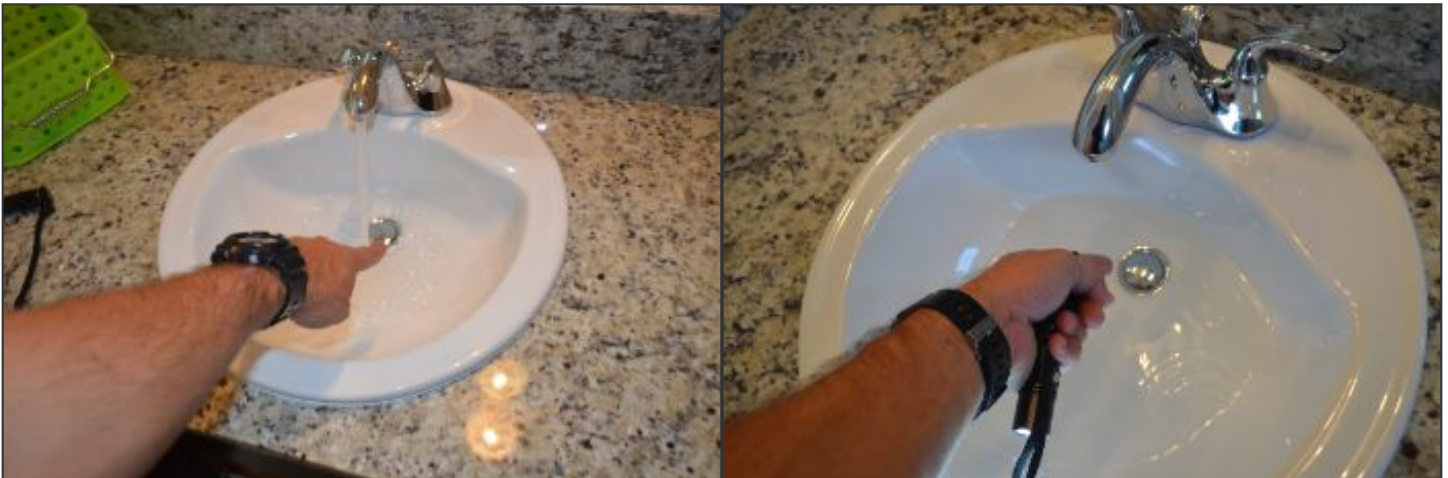
3.1. The drain pop up assembly in the guest bathroom downstairs and guest bathroom upstairs were inoperable at the time of inspection.
