Home Inspections by PJM, Inc.

Confidential - Property Inspection Report - Confidential

1234 Sample Rd, Kissimmee, FL 34746
Inspection prepared for: Sample Sample
Date of Inspection: 5/9/2017 Time: 2:00 PM
Age of Home: 5 years Size: 3,650 SqFt
Weather: Scattered Clouds/Warm
The utilities were on at the time of the inspection.

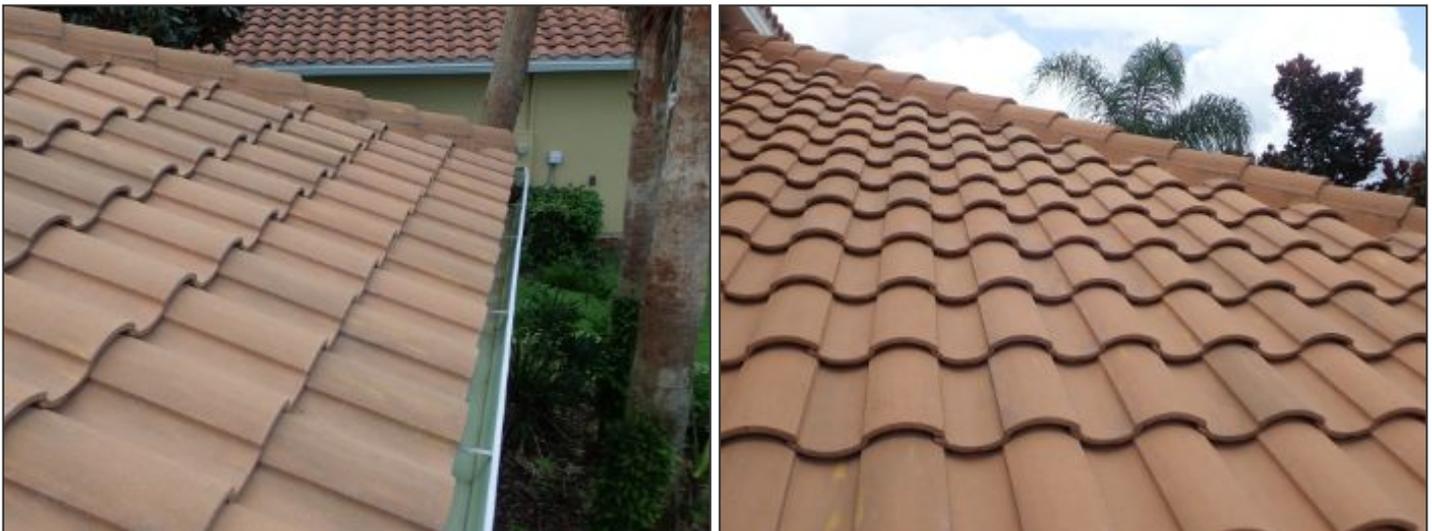
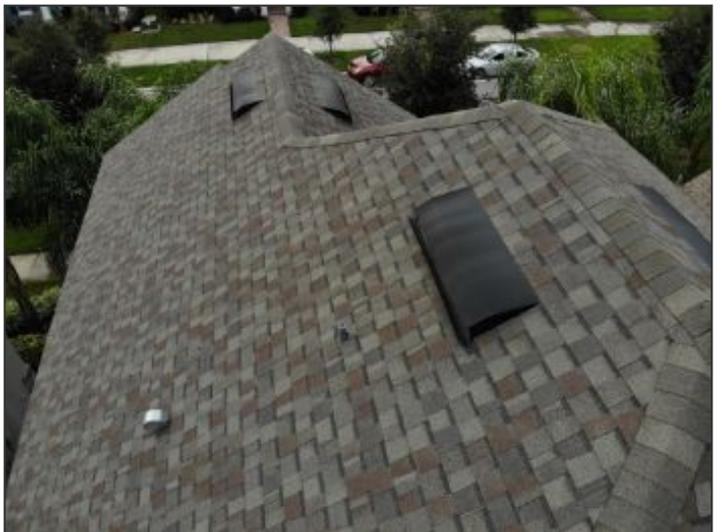
3.2. The inspector noted minor chips and hairline fractures at the roof tiles. This is a common condition for normal wear and age of the roof covering. Consider having someone service as required. Mortar joints at the tiles had minor cracks observed as well, proper maintenance includes sealing as required.

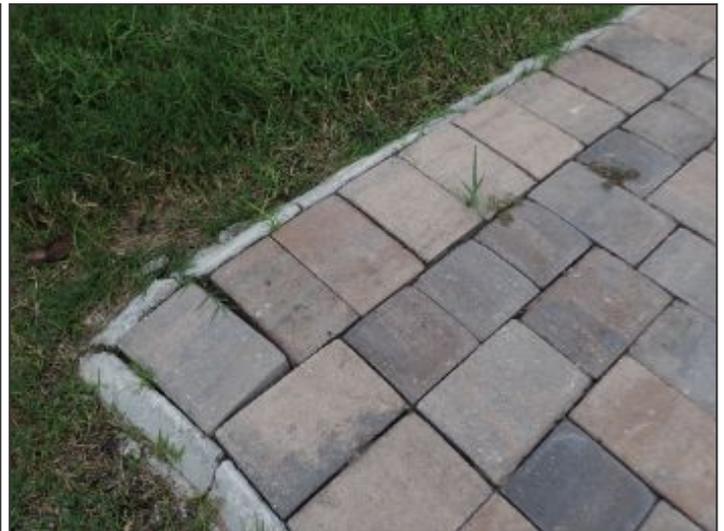
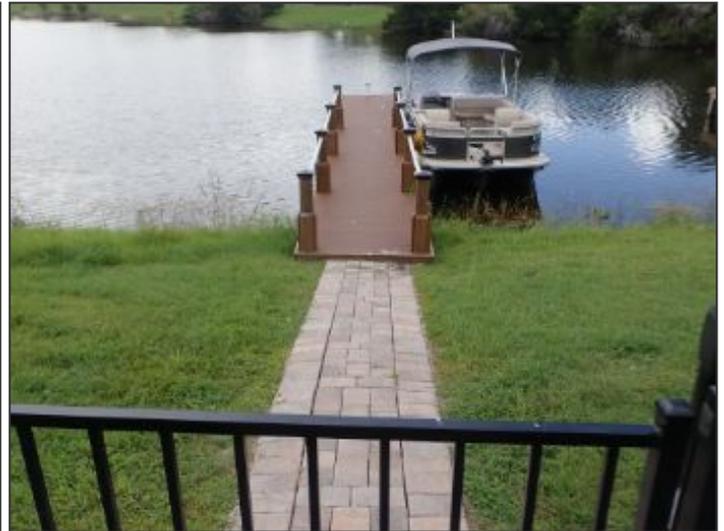
2.1. The inspector noted the pavers leading to the boat dock were loose and appear to require service. Ensure to fasten and seal to avoid pavers becoming a trip hazard or detached.

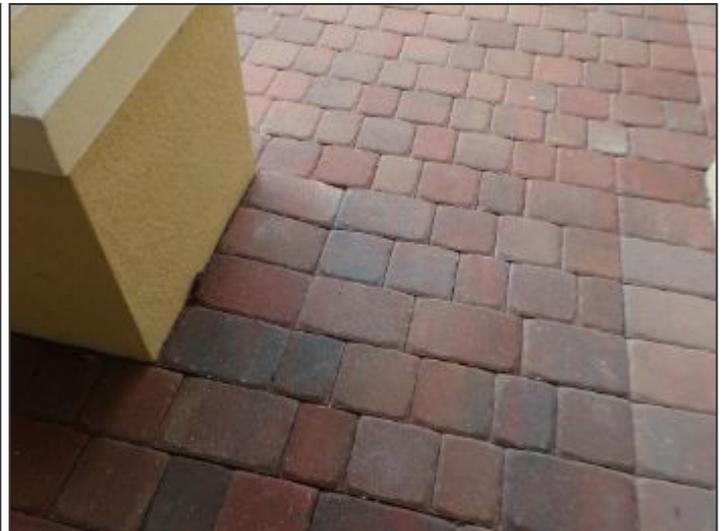
3.1. Driveway in good shape for age and wear. Some of the pavers were loose and should be refastened and serviced.

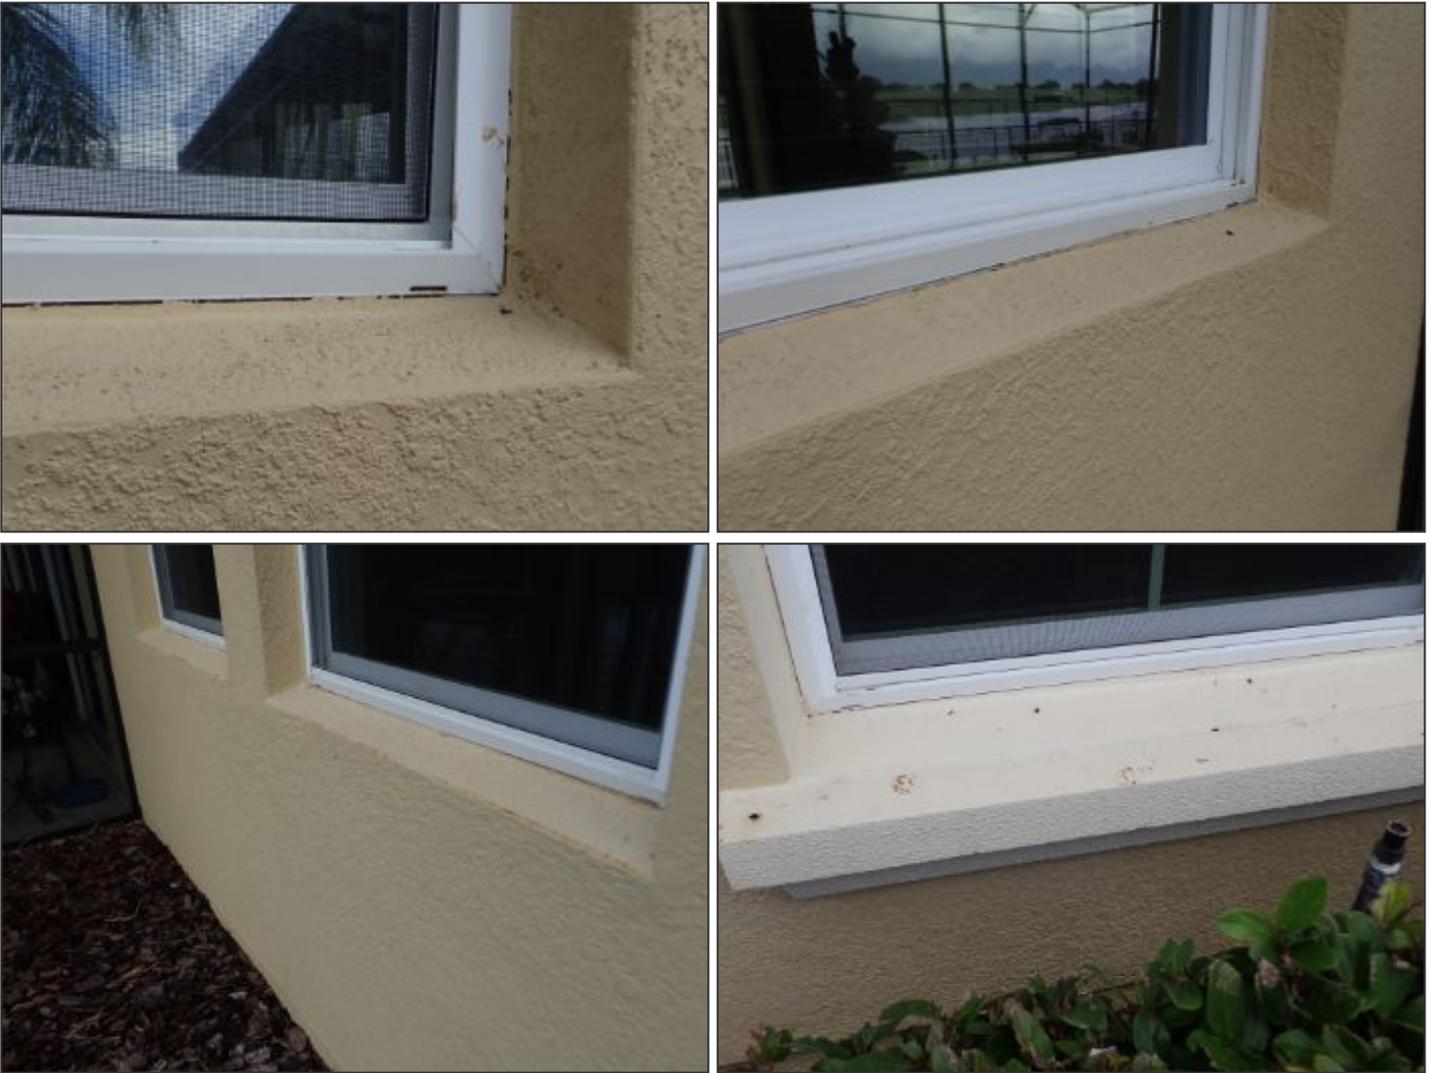
8.1. At the time of the inspection, windows in the home had gaps around the perimeter which should be sealed with an appropriate sealant to help prevent moisture intrusion of the exterior wall assemblies.

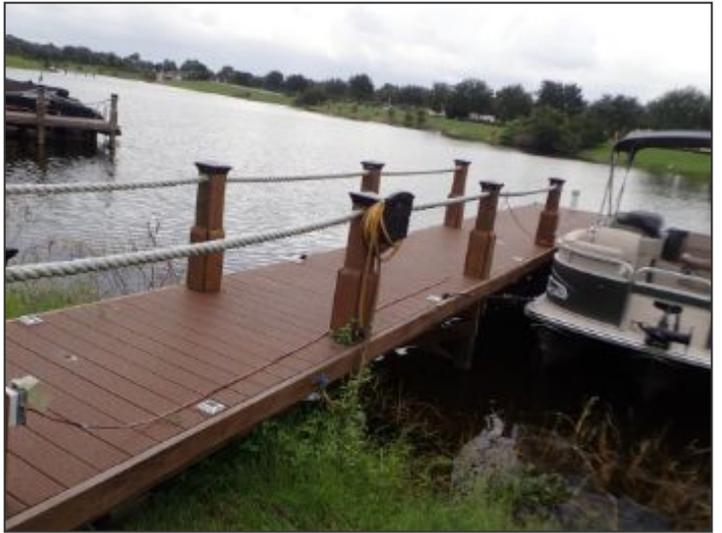
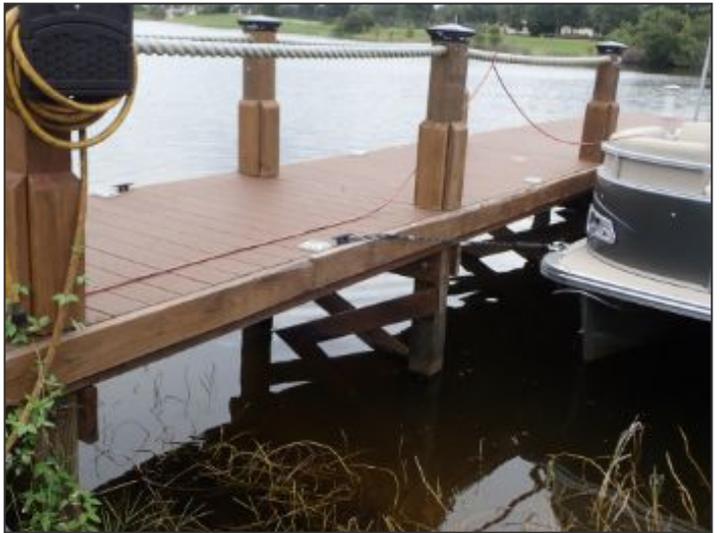
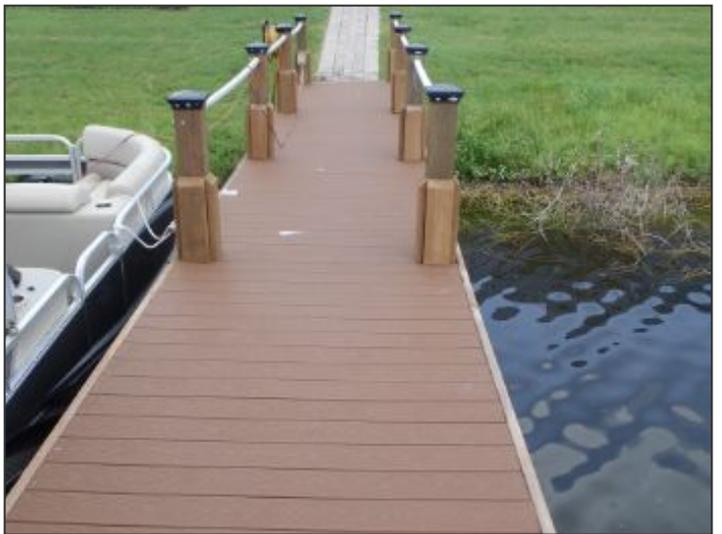
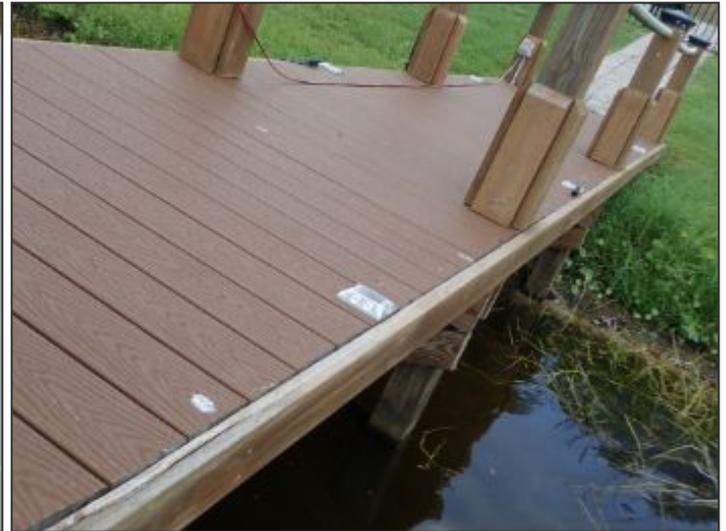
10.1. The inspector observed a boat dock at the rear of the home. There was permit found online for this dock from 2017, which was finalized and closed. The inspector noted the conditions of the dock were in satisfactory condition. The structure was stable and appeared to be in good condition. This inspection was completed under the scope of the general home inspection and evaluated visually.

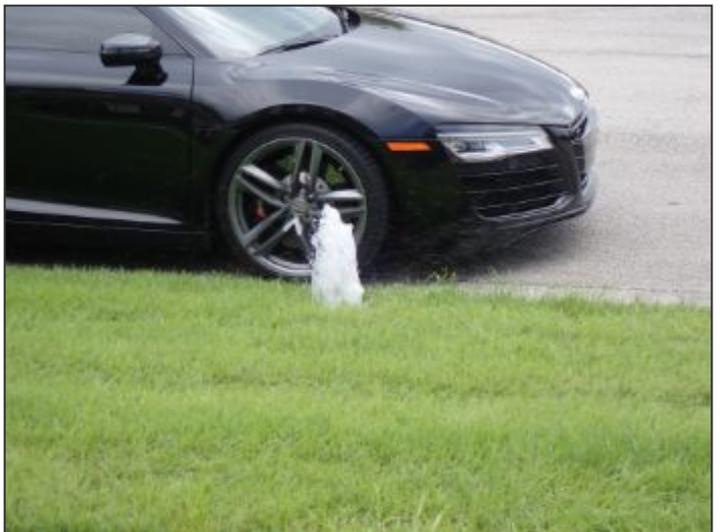
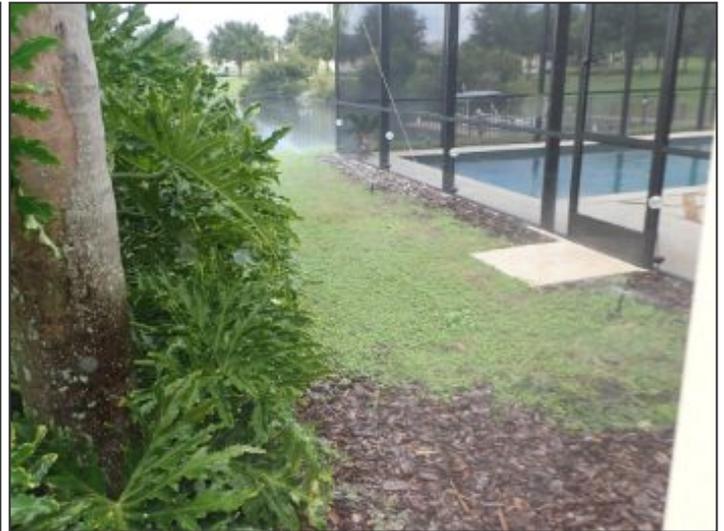
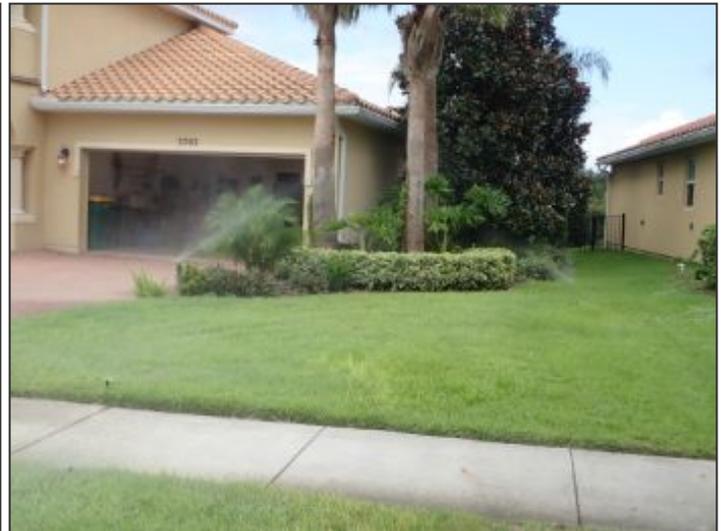
14.1. The inspector noted there was an additional sprinkler control panel located near air condenser unit 1, but it did not operate. The inspector could not determine if this unit is no longer in use or its damaged. The inspector also noted a damaged/leaking sprinkler head at the front of the home. Further evaluation and repairs will be required by a qualified person.

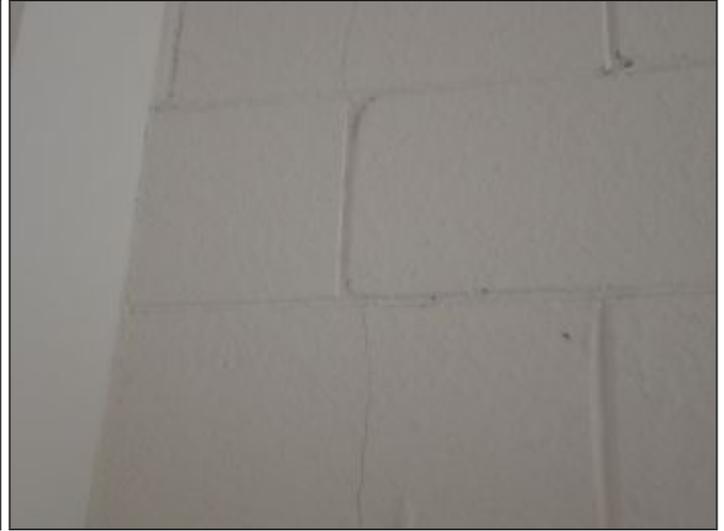
5.1. Minor stepped cracking was noted at the garage walls at various locations. Ensure to service and seal to avoid these areas becoming points of moisture intrusion.

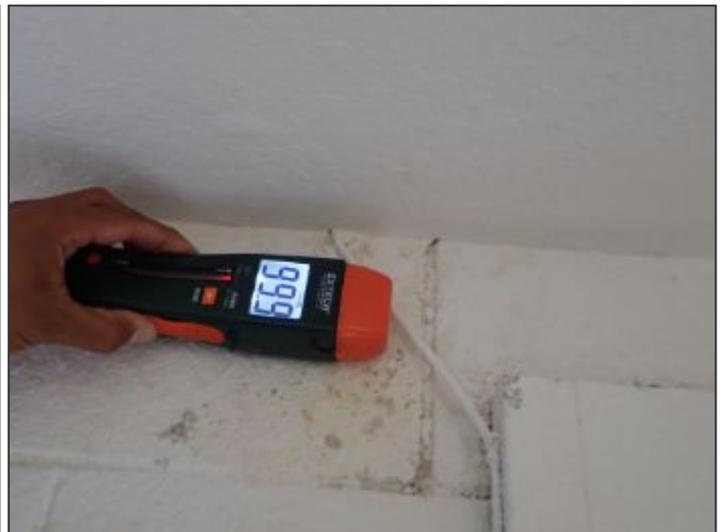
6.1. Moisture intrusion and damage was noted at the single car garage ceiling. The area had staining and organic growth (mold like appearance). The inspector noted the area registered with active moisture when tested with a moisture meter. The inspector could not determine the extent of the damage due to lack of attic access at this area. Further evaluation and repairs will be required.

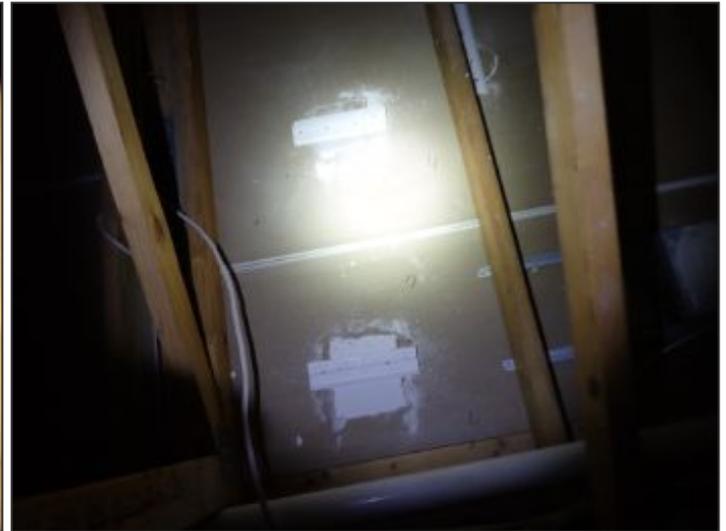
4.1. The inspector noted a repair at the attic space ceiling panel in the second floor. The inspector recommends having this repair reviewed by a qualified person, substandard repair was observed. Consider servicing this area as required.

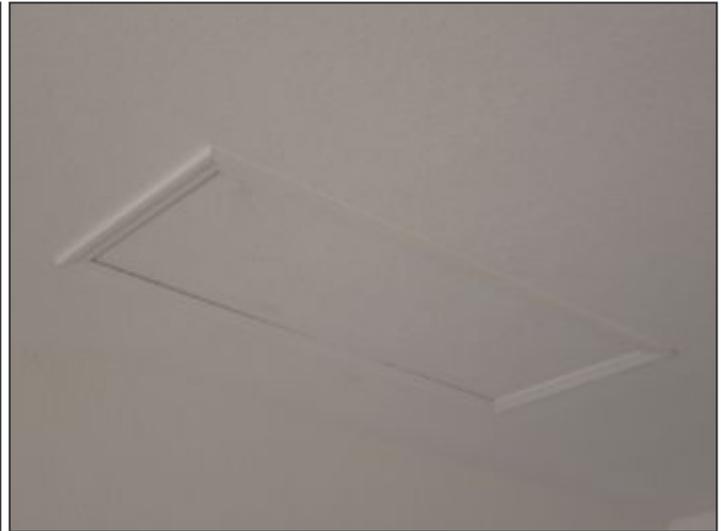
1.2. Consider installing an additional attic hatch(s) which can help view more of the roof structure to ensure physical access if issues arise.

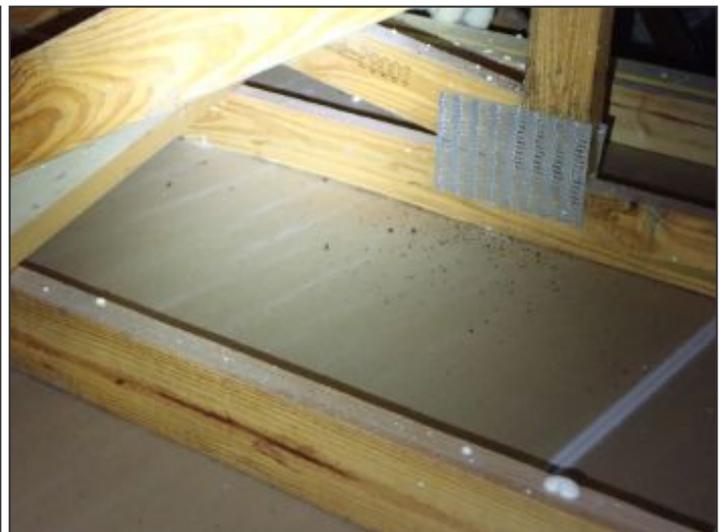
2.2. The attic had minor amounts of rodent feces visible. You should consider setting traps for mice and closing off avenues of entry. The inspector cannot determine the recency of the feces.

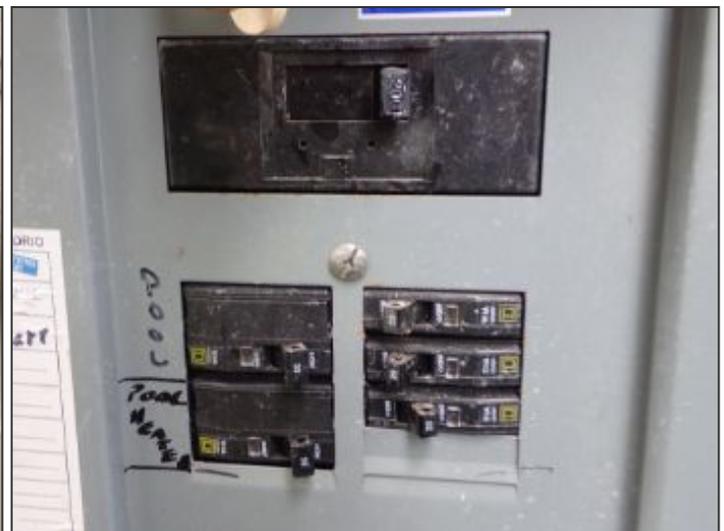
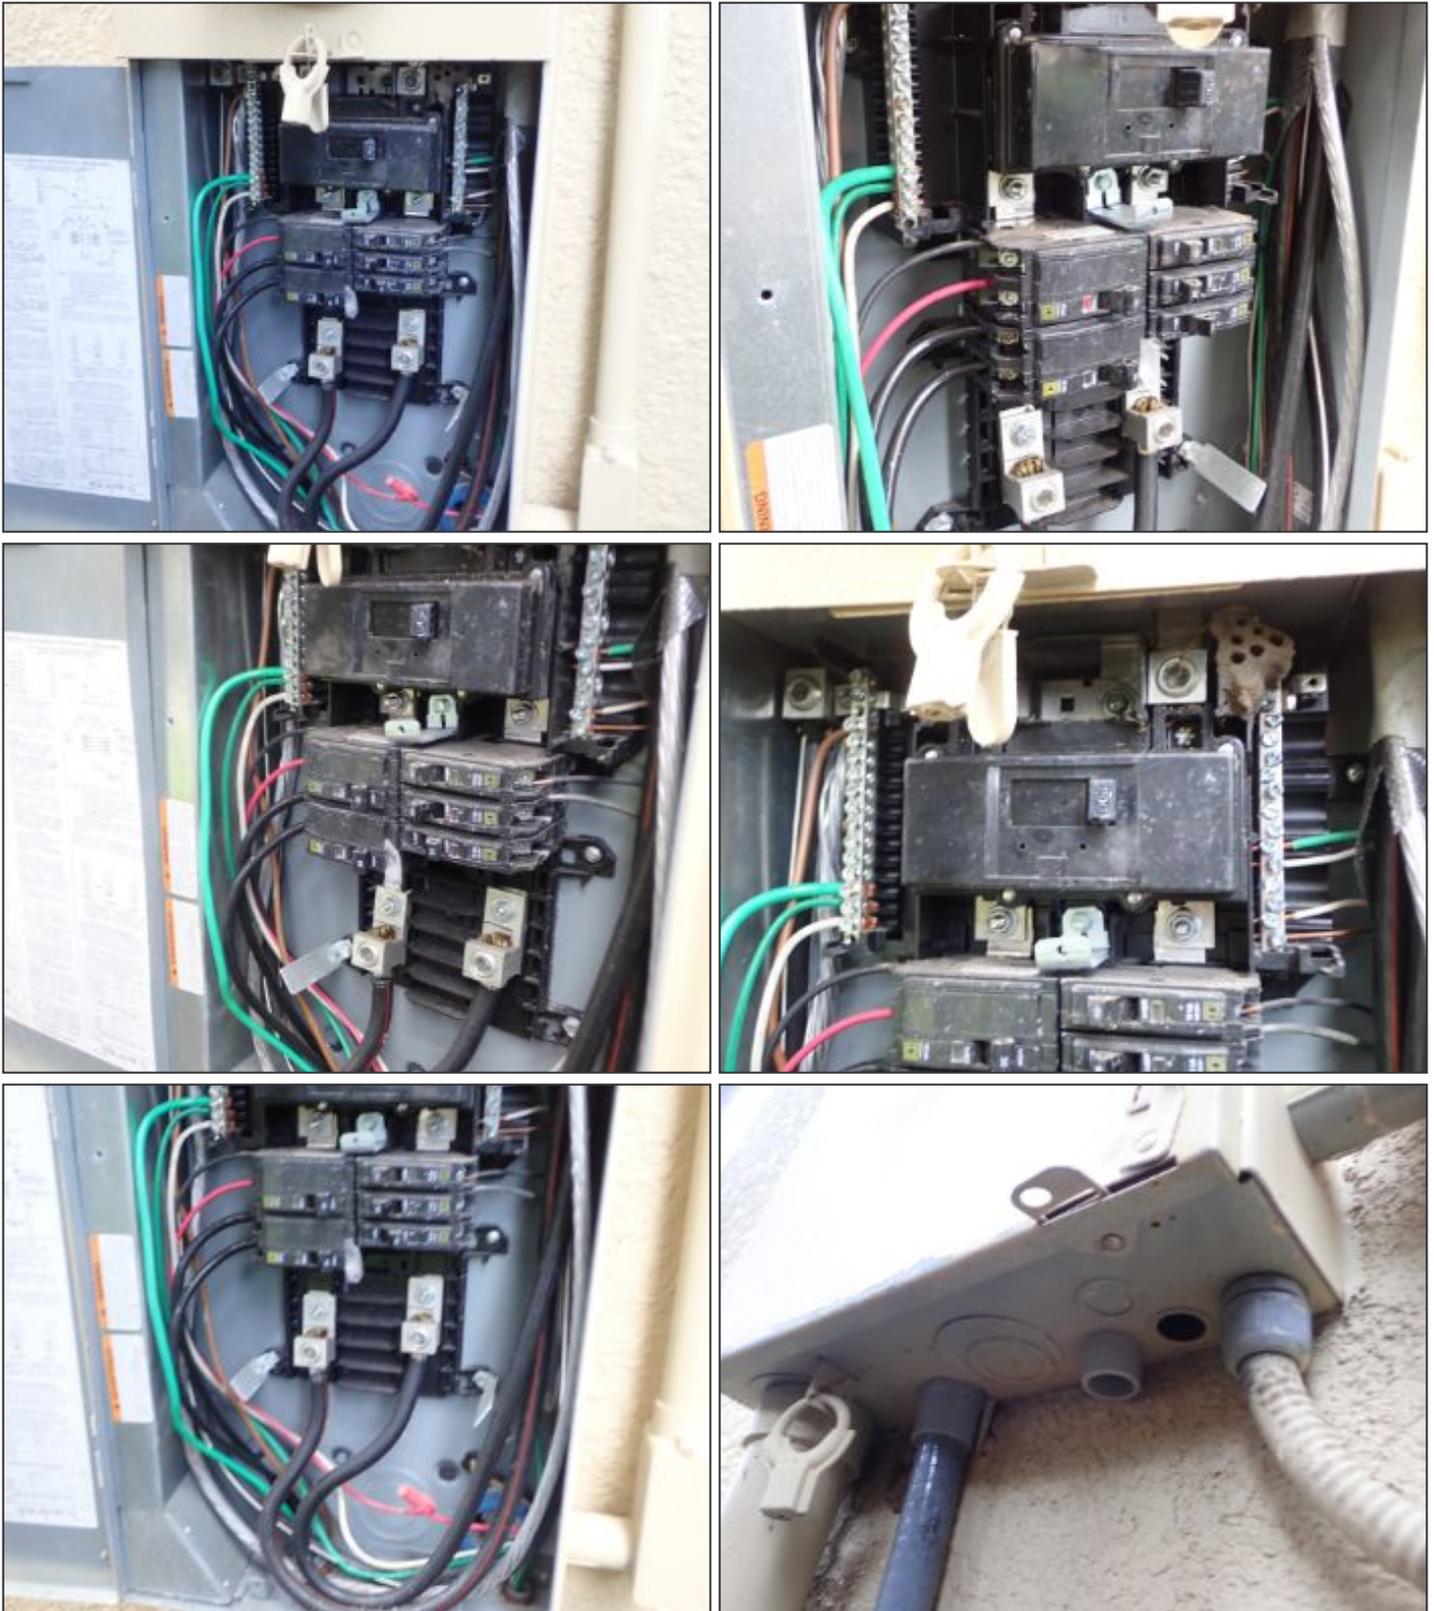
- 4.4. The main panel had visible corrosion near the bottom panel. The inspector recommends ensuring panel is properly secured and covered to avoid moisture damage. There was a nearby sprinkler head which sprayed water towards the panel. The panel had a knockout/void at the bottom which should be filled in to avoid pest/moisture intrusion. (frogs were noted inside panel)

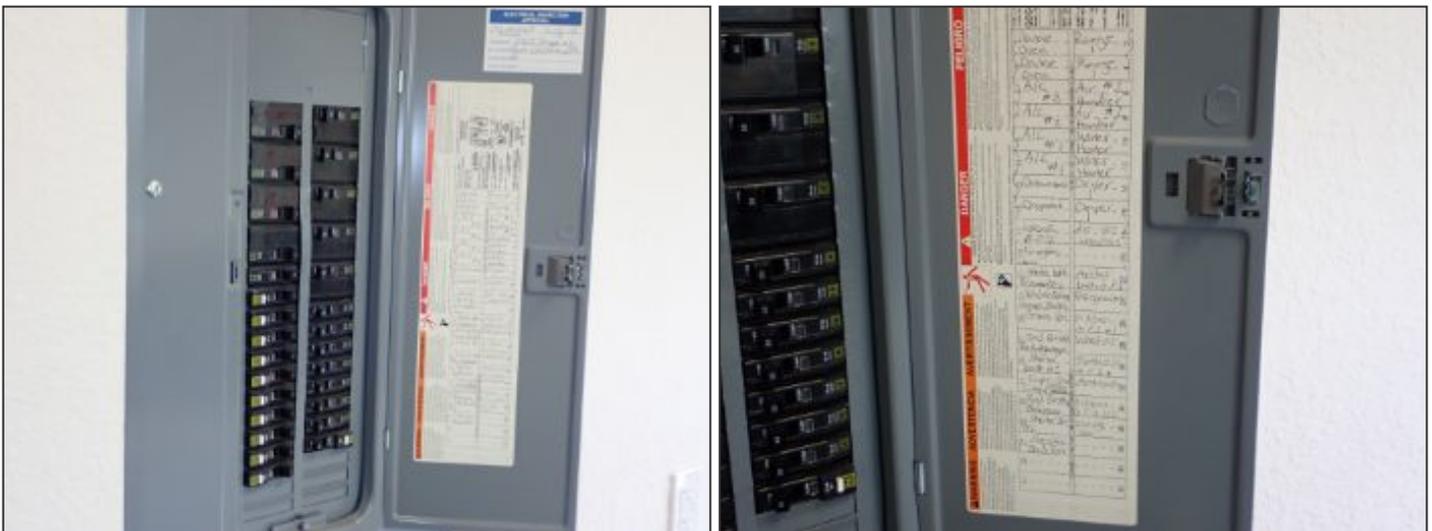
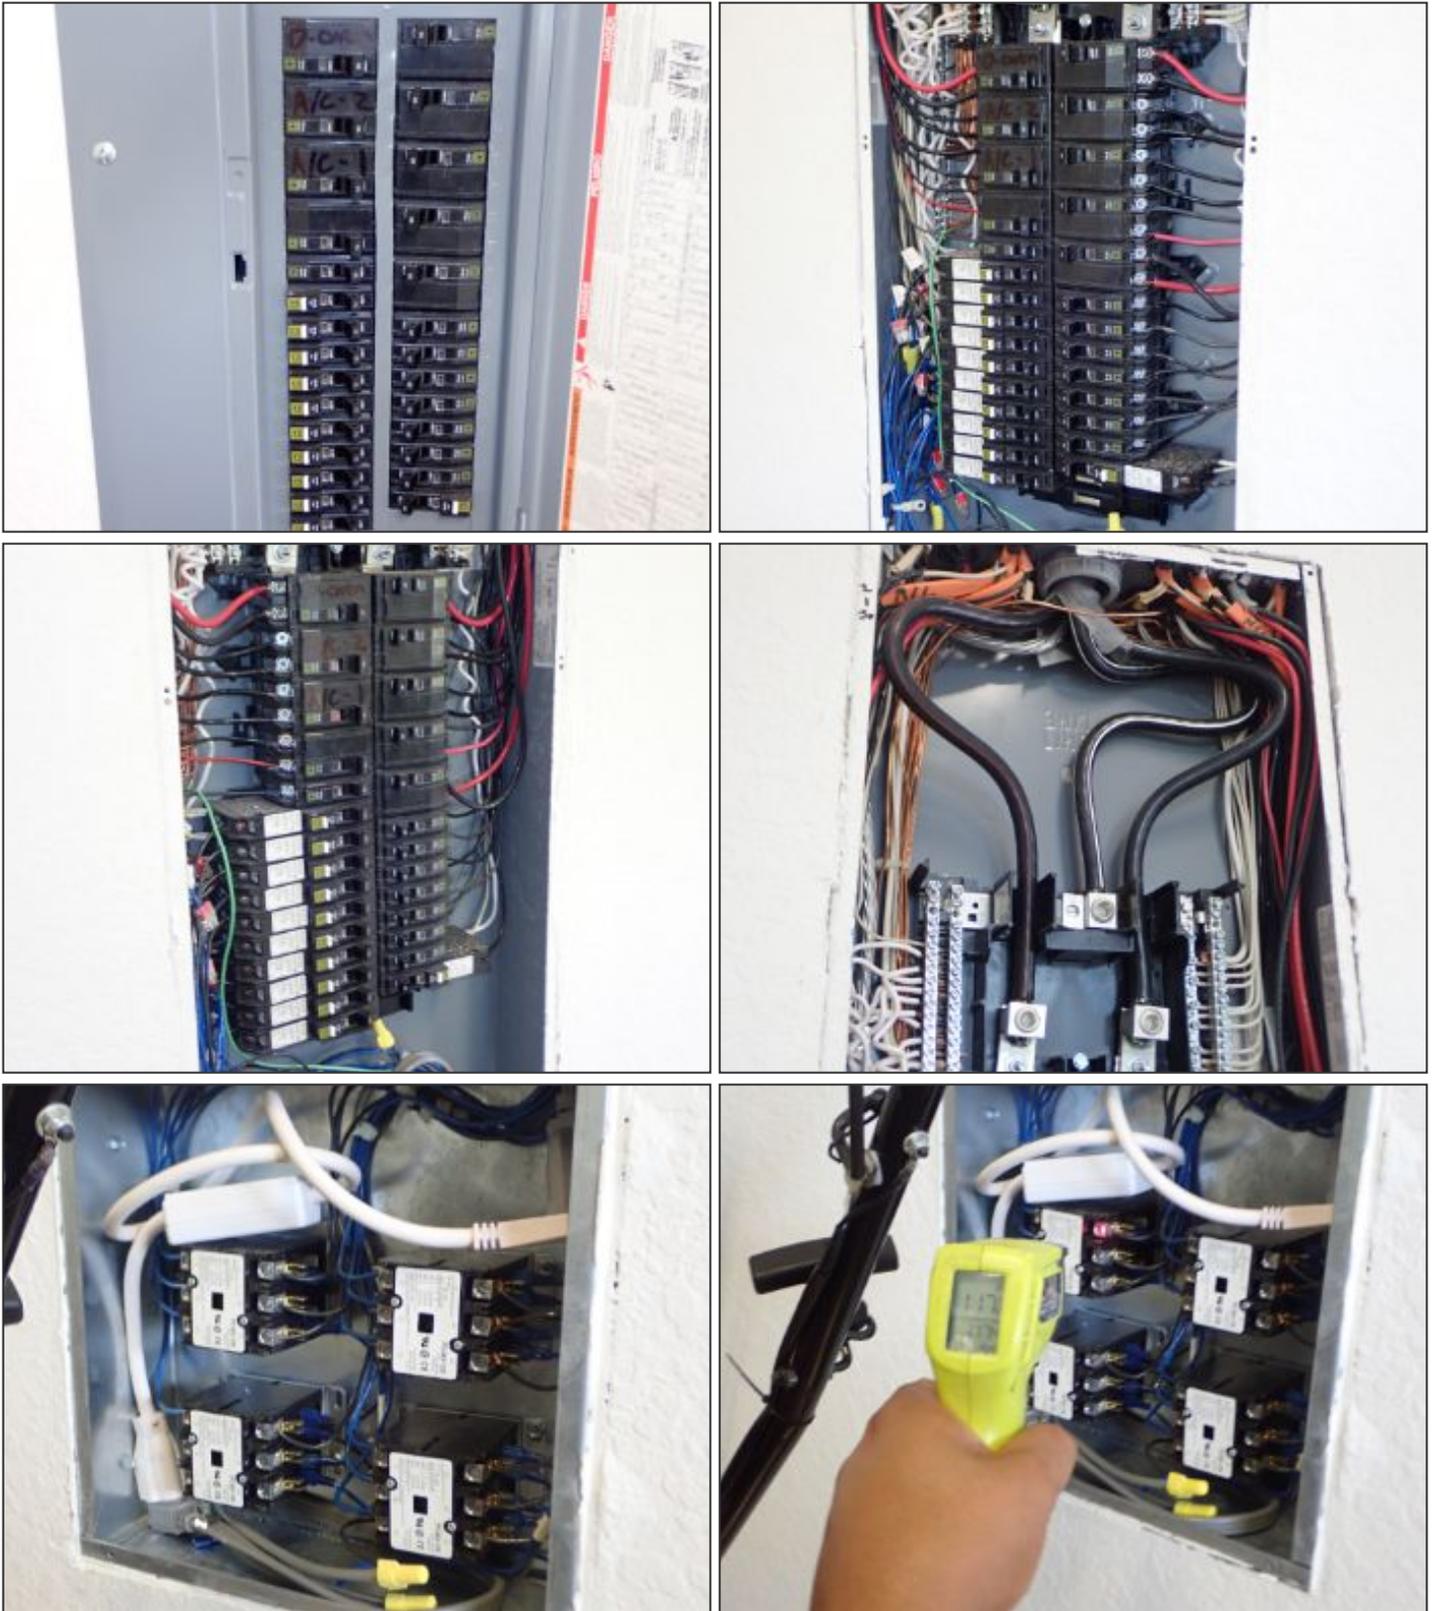
8.3. Additional panel was located below. This is not common practice, but appears to be in acceptable conditions. The inspector suspects these units are surge arrestors, but could not confirm. Consider having a qualified electrician verify the install and work performed. The inspector noted the cover plate was difficult to access components. Consider having another panel cover plate installed to ensure easier access.

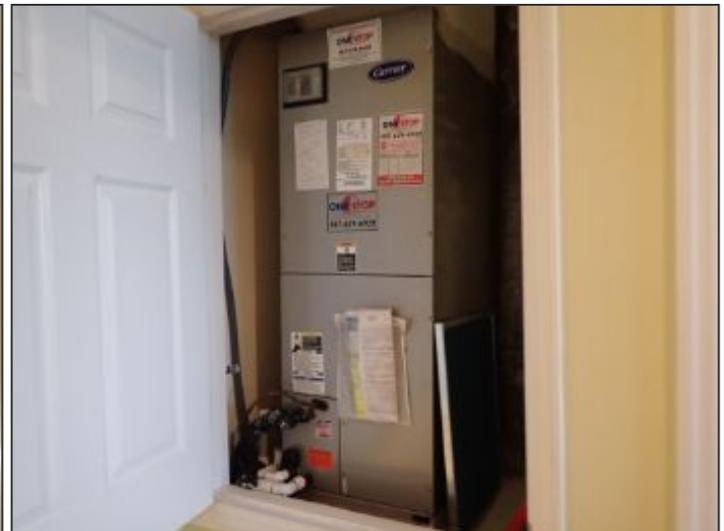
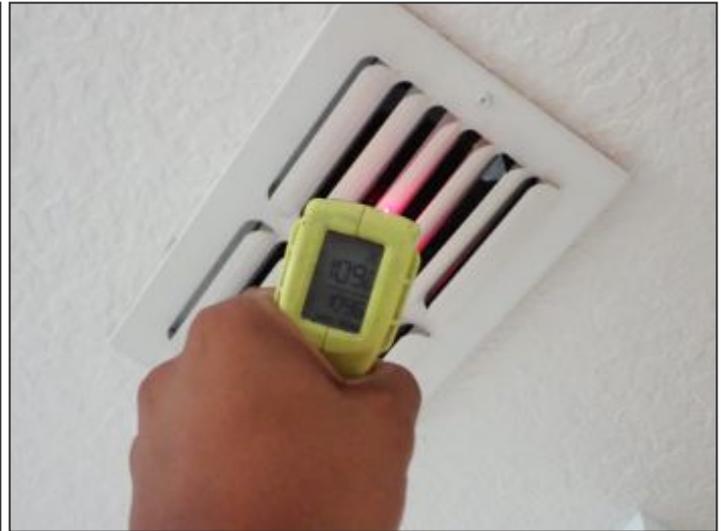
- 1.4. The inspector recommends further evaluation and repairs of the air handlers located at the upstairs closets. The inspector noted unit 2 had leaked condensation previously which caused damage to the second floor baseboard and floor boards. The extent of the damage is unknown and requires further evaluation. Air handler unit 1 was actively leaking condensation at the time of the inspection. The unit had visible corrosion along the coils at the time of the inspection. The unit's fins were dirty and clogged which also appears to be causing issues with proper discharge of condensation, the condensation was falling straight down instead of slant. Moisture damage was noted at both of the air handler's plenum ductwork below the filter. Visible organic growth was noted. The inspector recommends further evaluation by a qualified HVAC Tech. Unit 1's condition may warrant replacement to avoid future issues from arising (based on condition observed), but further evaluation is required by a technician.

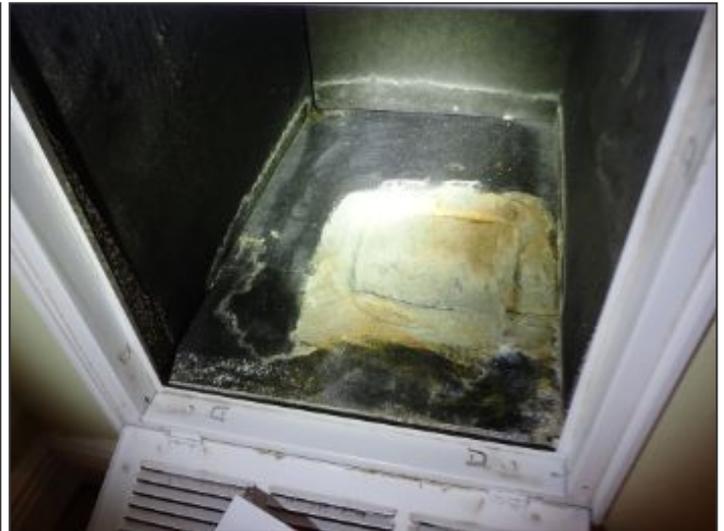
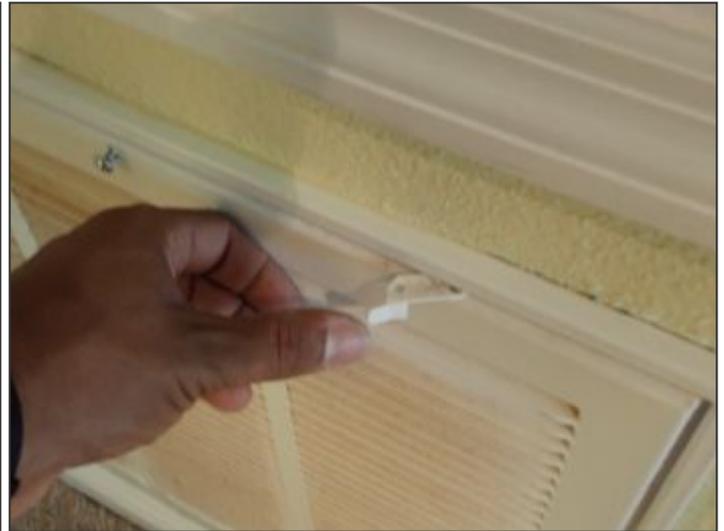
2.3. The filter cover plate at air handler unit 2 was damaged, the latch would not hold closed.

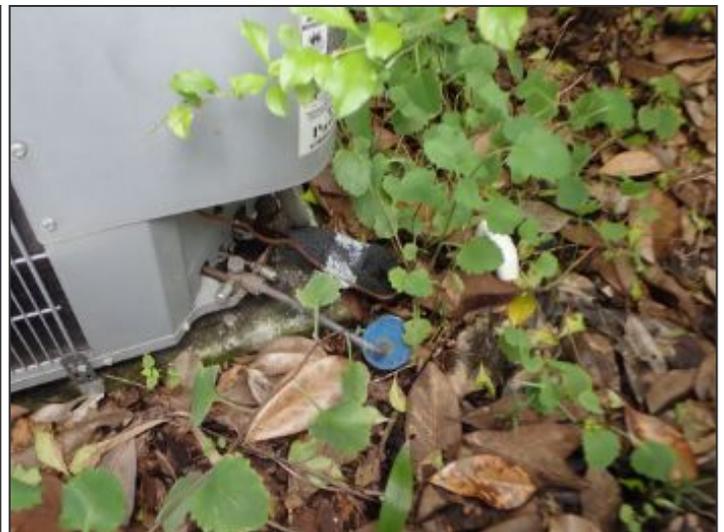
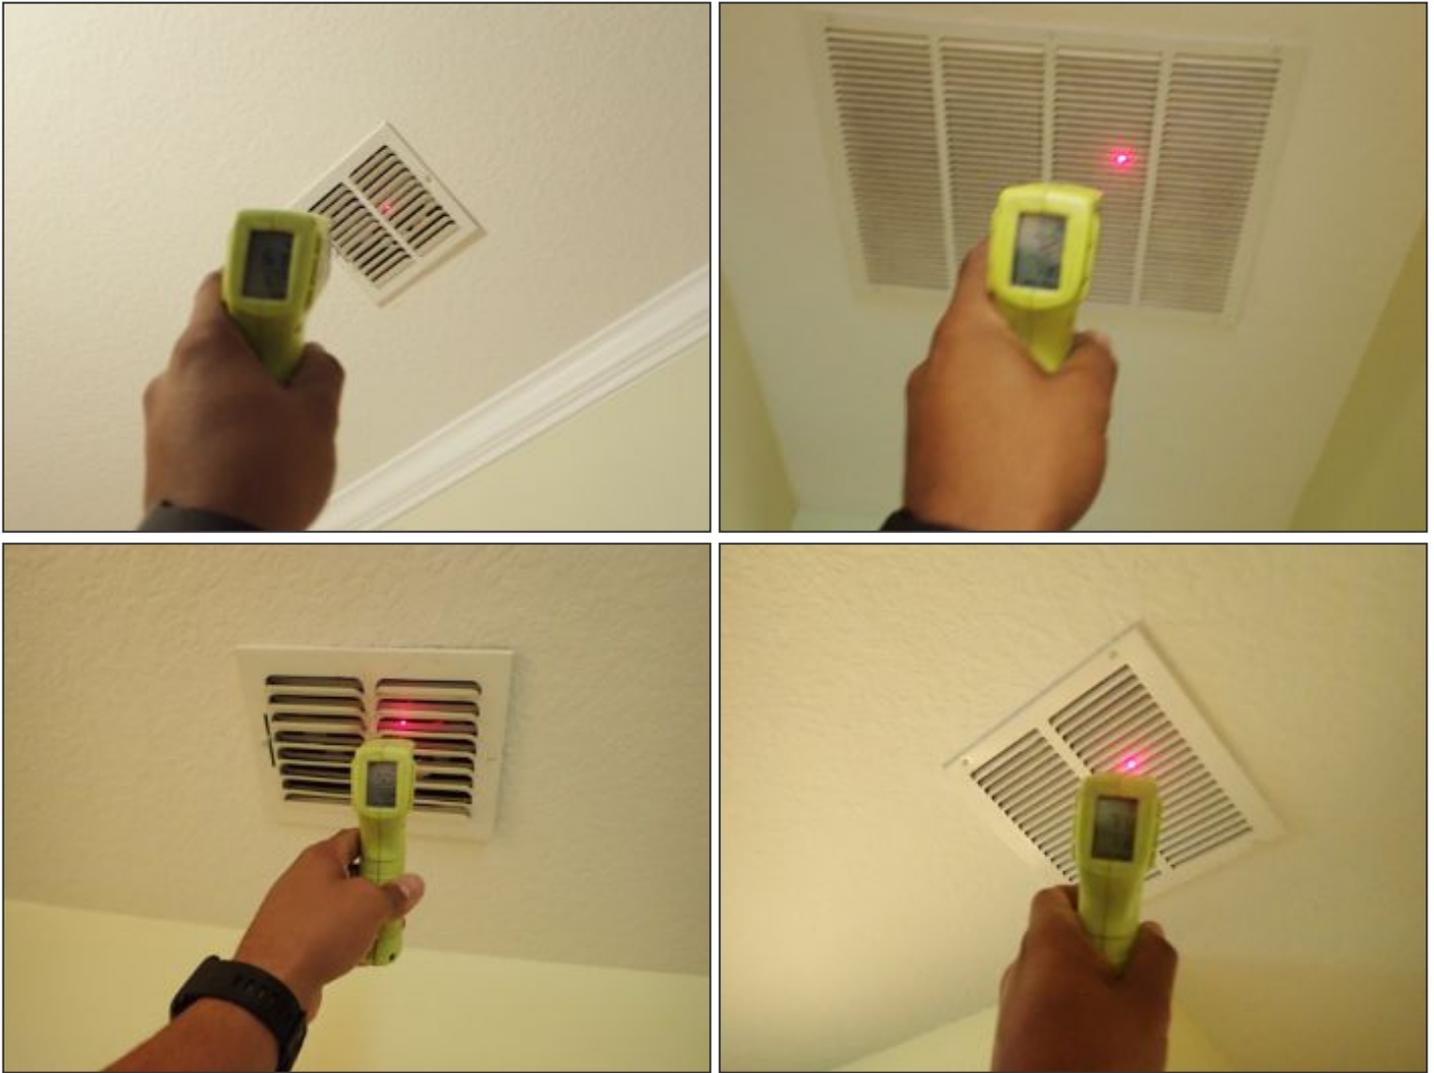
- 4.3. The remaining life expectancy of the unit is approx. 10 years. Average life of an outside **A/C** compressor/condenser is approx. 10-15 years.
- 4.4. Insulation on the air-conditioning suction (large, insulated) line was damaged at unit 1 near the exterior wall, service is required to avoid loss of efficiency.

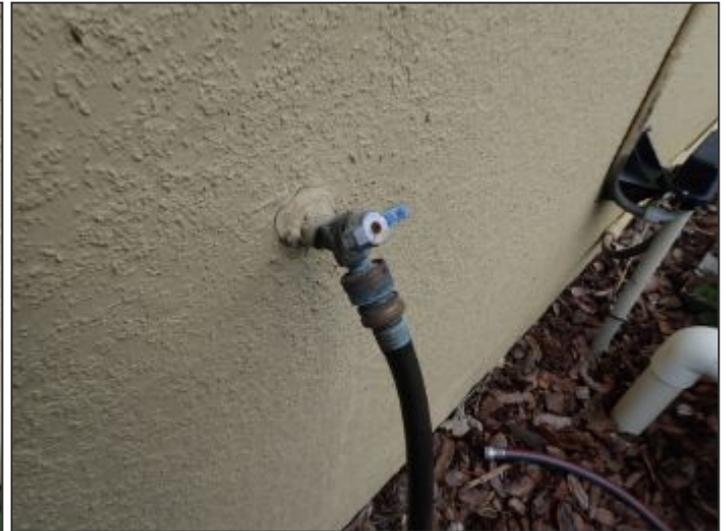
- 5.1. All exterior hose bibs were tested and in good working at the time of the inspection.
- 5.2. Additional piping appeared to run to the rear boat dock.
- 5.3. Hose bibs were loose at the exterior walls, ensure to refasten to avoid damage.

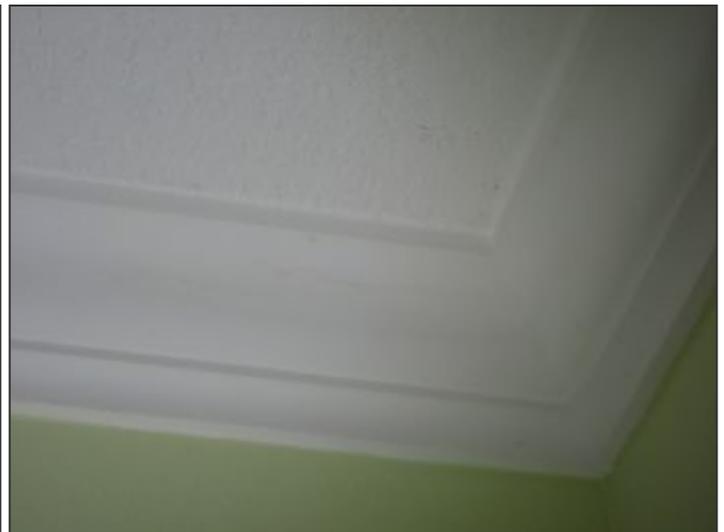
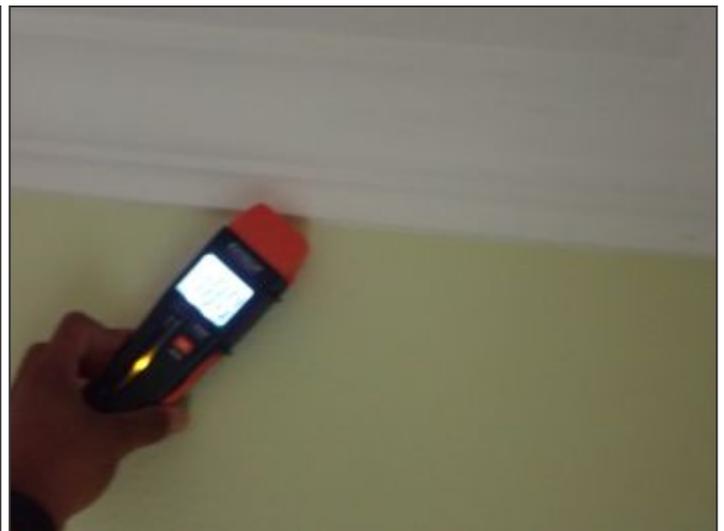
2.2. The inspector noted moisture stains along the ceiling register of unit 1 (first floor hallway), this appears to be an active leak from the air handler coils. Further evaluation and repairs are recommended by a qualified HVAC Tech to avoid further damage. The inspector also noted moisture stains along the crown molding at the front family room near the corner of the garage ceiling (2 car section). The area and adjacent did register with levels of moisture which should be serviced and repaired as mentioned. There was minor cosmetic damage observed at the master bathroom ceiling was a nail pop, fasten and seal.

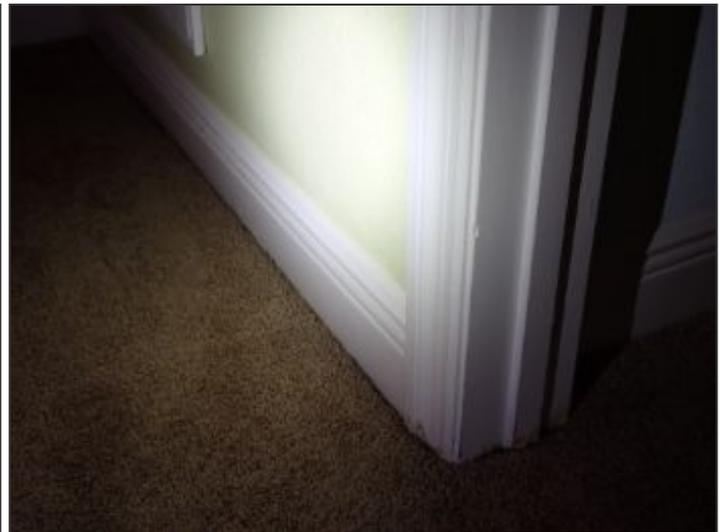
5.1. The inspector observed floor boards/baseboards at the second floor near the air handler at unit 2 had moisture damage. The damage was noted at the baseboards near the air handler and the second floor master bedroom room door trim. The extent of the damaged caused by this leak is unknown. The inspector recommends the seller for disclosures, if none is available, consider intrusive inspection for review.

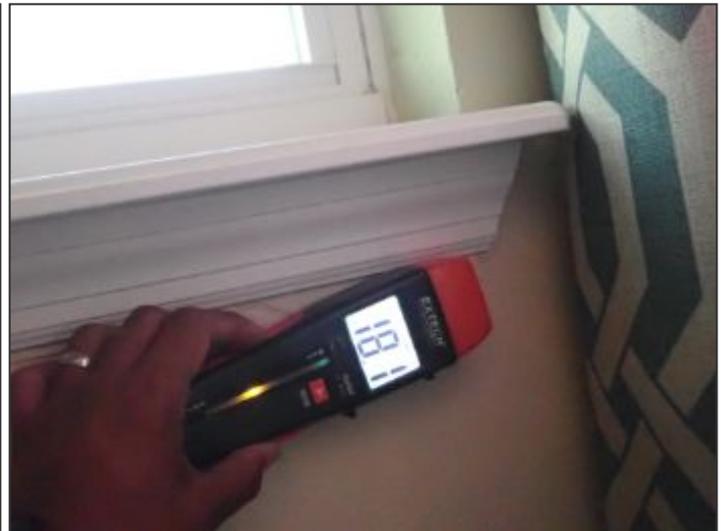
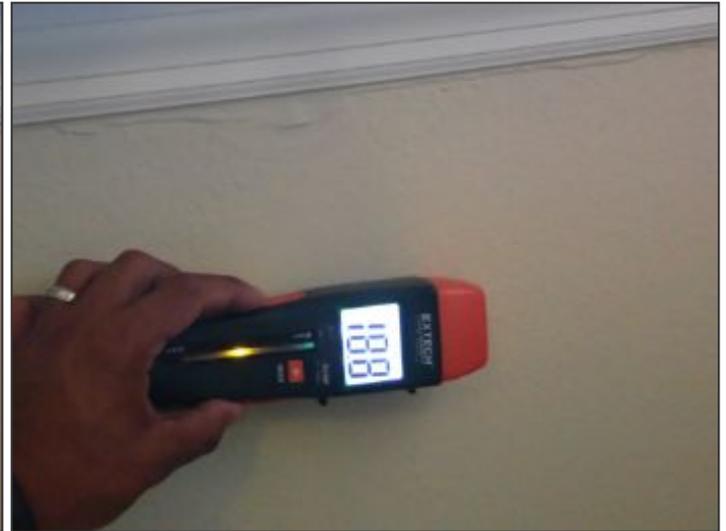
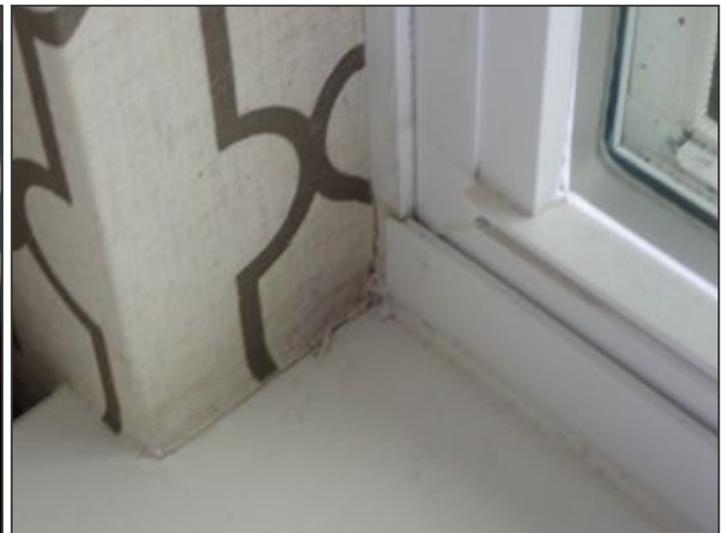
8.1. Ensure to reseal and service all caulking throughout all windows in the home, as mentioned gaps were visible at the interior and exterior. The inspector noted minor levels of moisture was observed below the window sills of windows. The wall paper was noted with moisture stains. Ensure to service as required.

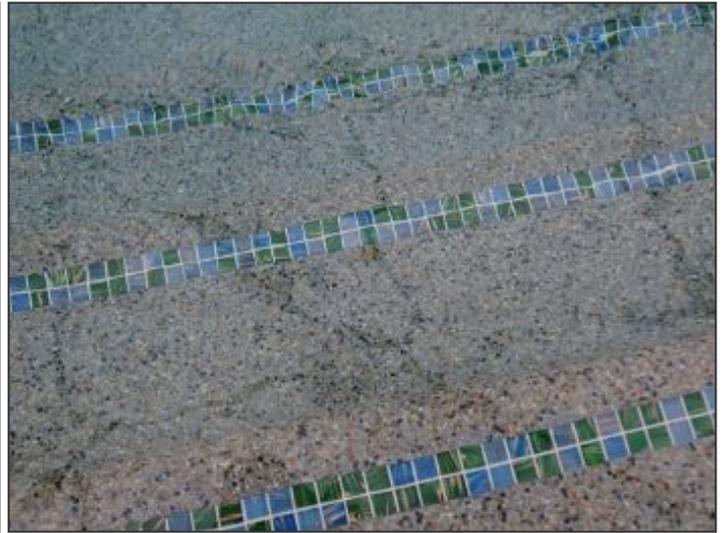
2.1. The pool vessel appeared to be in satisfactory condition at the time of inspection. There were areas of minor discoloration and rusting/corrosion. The inspector does not suspect any major issues, appears to be normal wear for age. Ensure to service pool as required to avoid premature wear and replacement of the vessel.
