Home Inspections by P.J.M. Inc.

Confidential - Property Inspection Report - Confidential

51 Third Moon Landing, Luna, Florida 32732
Inspection prepared for: Luke Skywalker
Date of Inspection: 12/11/2018 Time: 1pm
Age of Home: Built in 2004 Size: Total - 2345 sqft
Weather: Sunny

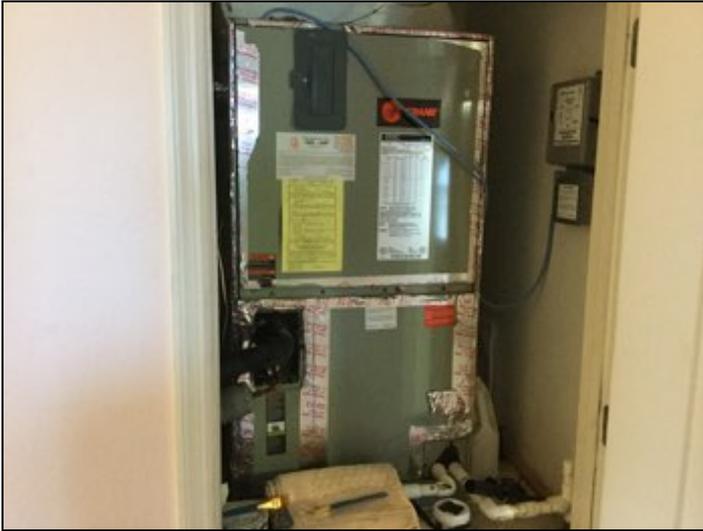
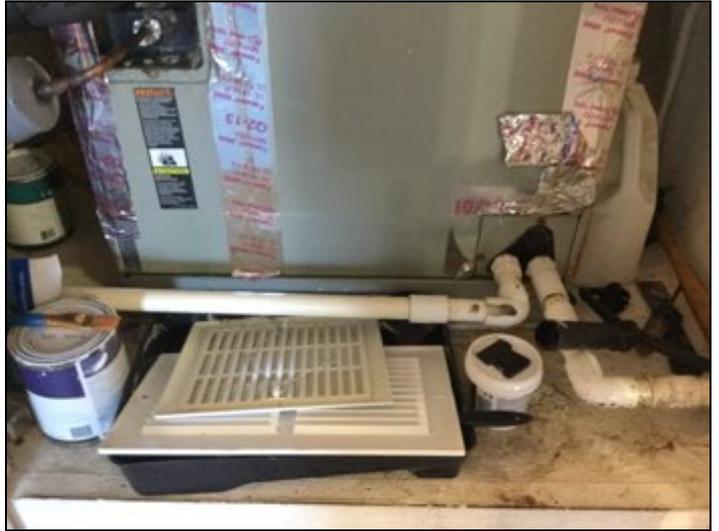
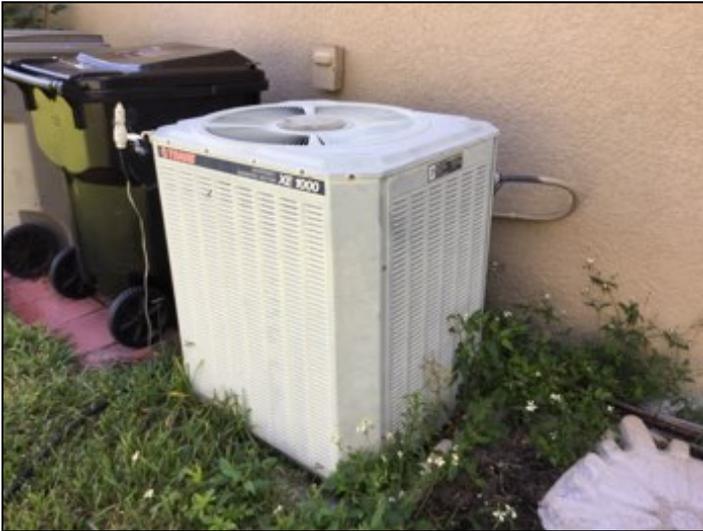
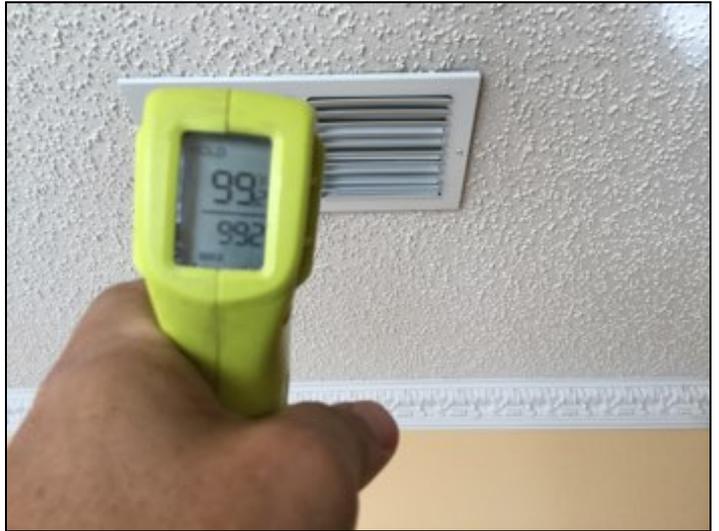
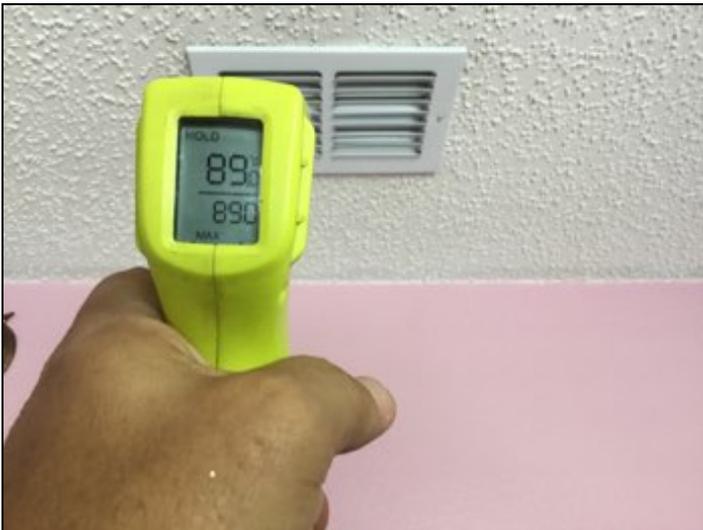
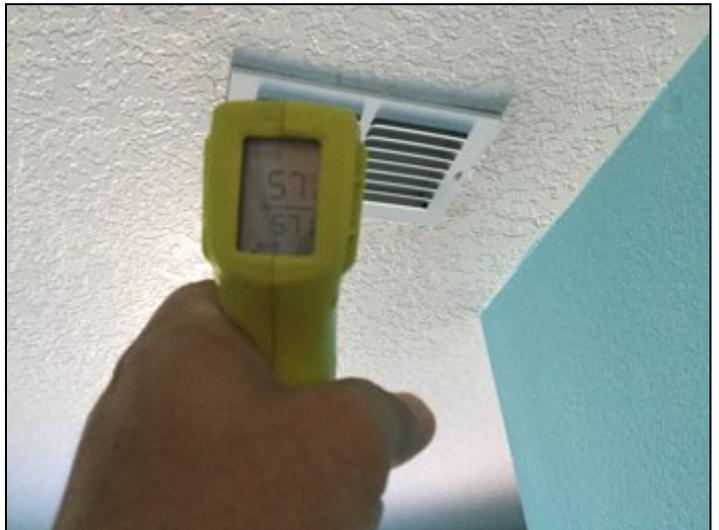
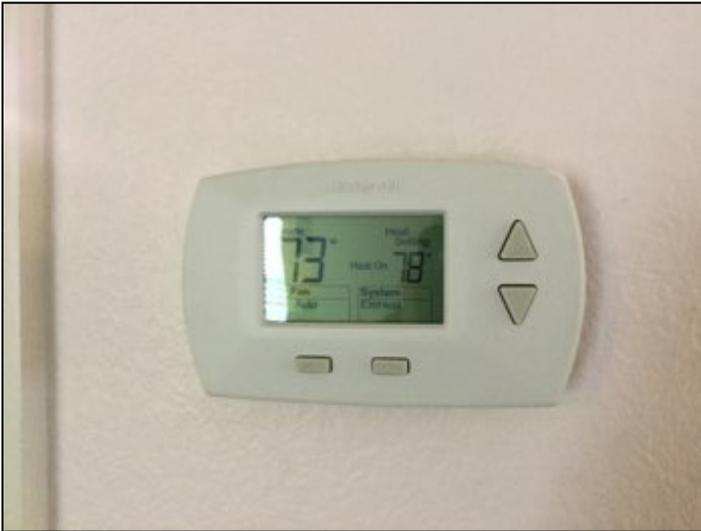
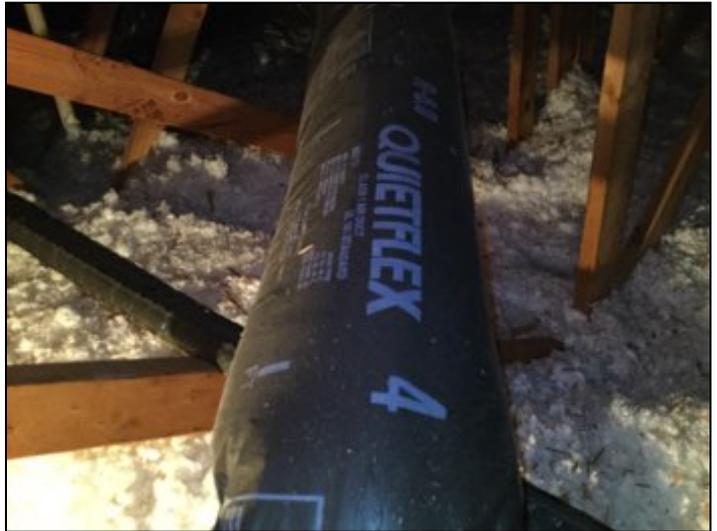
- **The HVAC System is 14 years old and it appears to be approaching the end of its useful life and we recommend you consult with a licensed HVAC contractor to discuss options and costs for replacement or a Home Warranty before the expiration of your Inspection Deadline.**

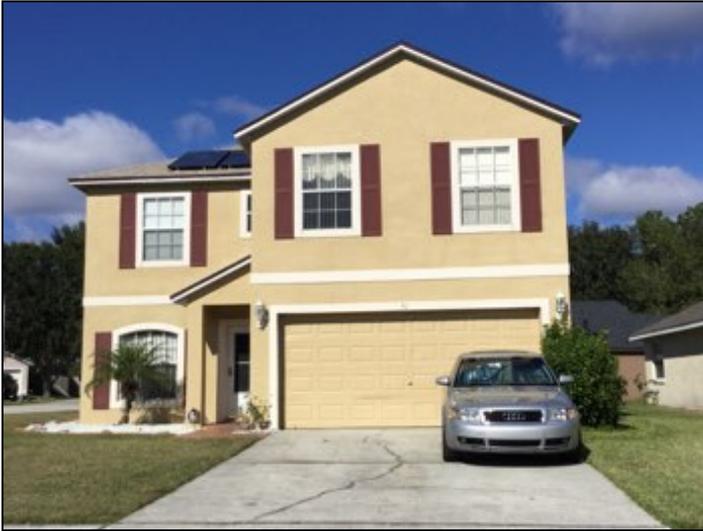
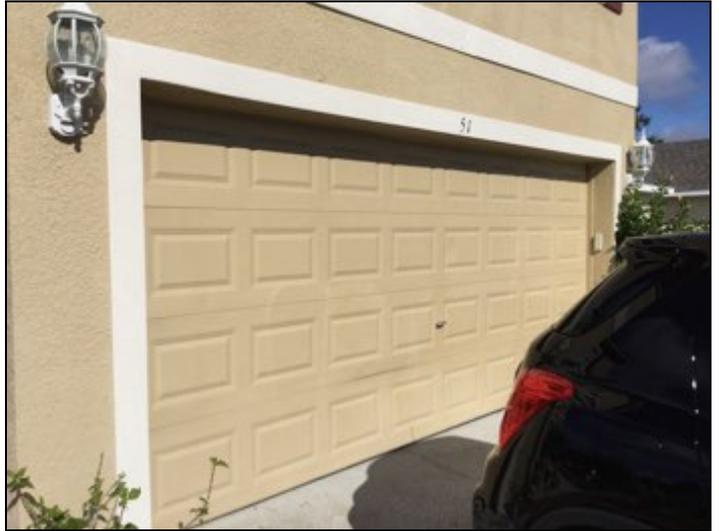
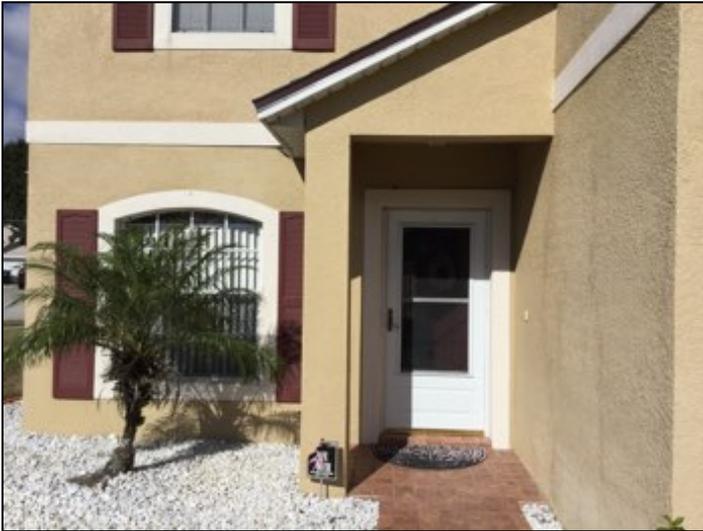
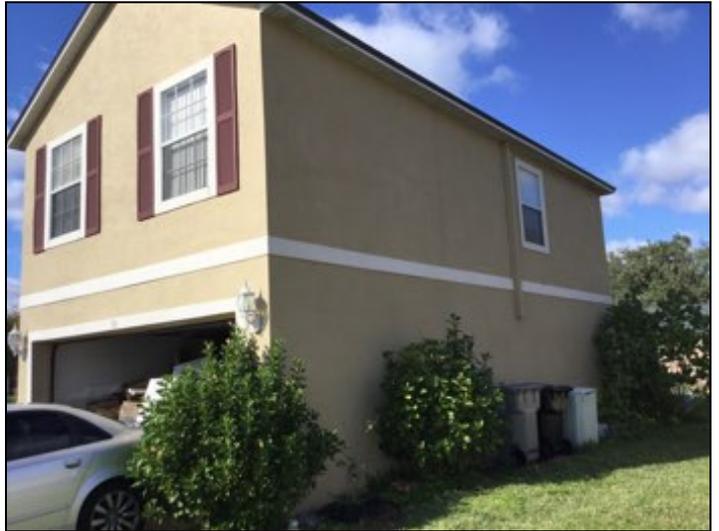
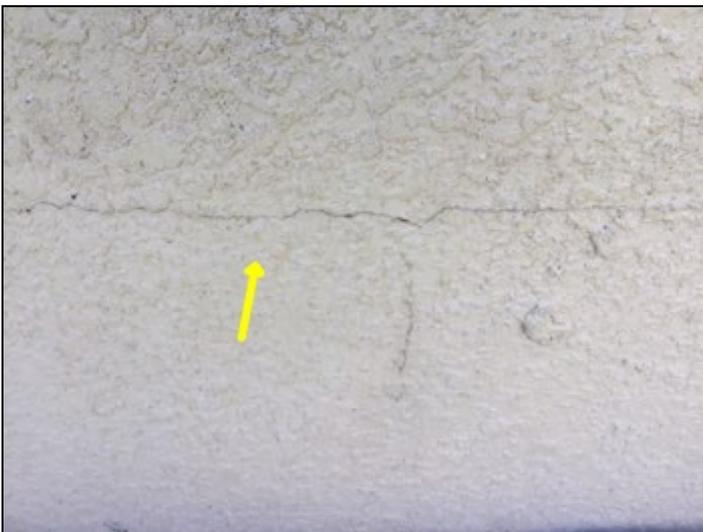
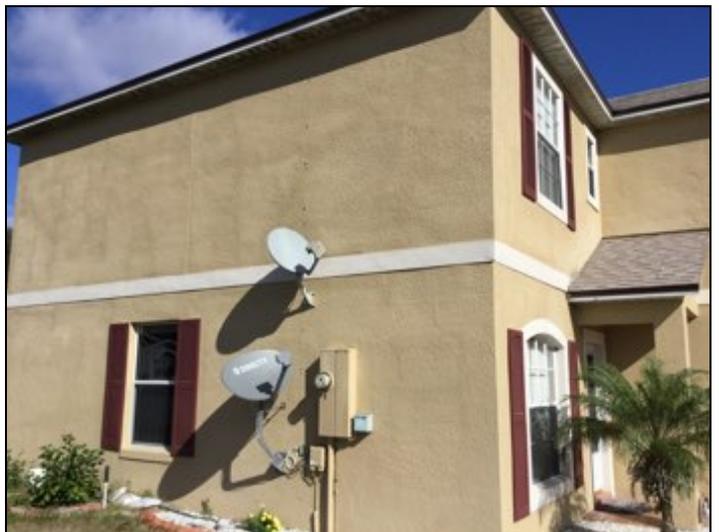
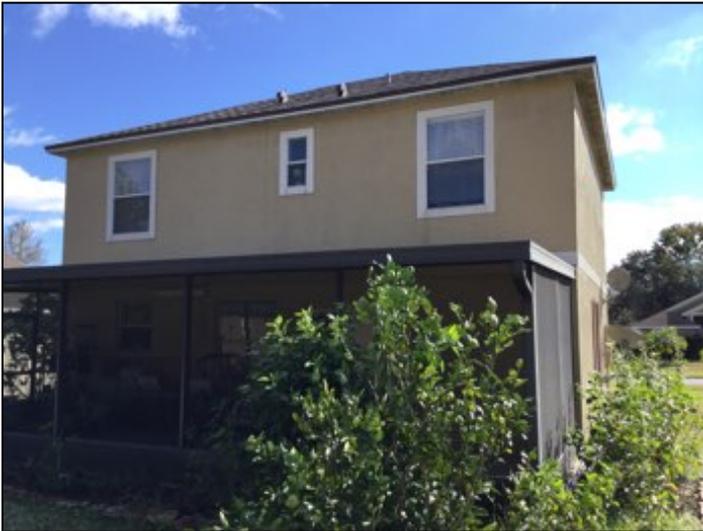
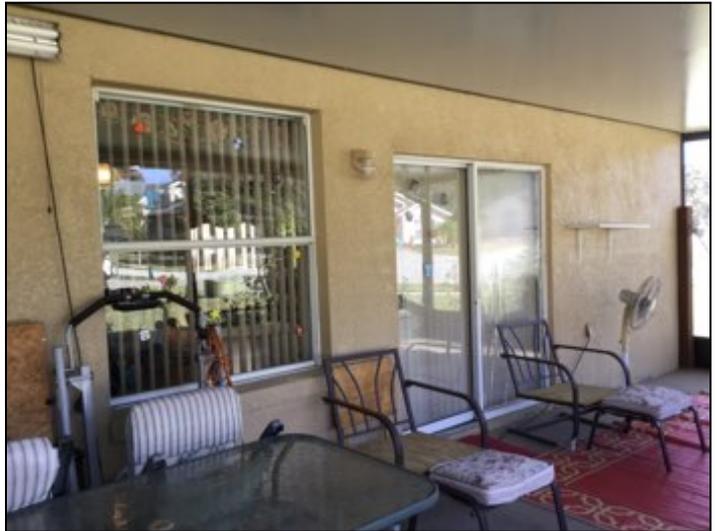
- There are several stucco and vertical cracks on the exterior wall covering around the building that should be sealed to prevent water intrusion into the house.

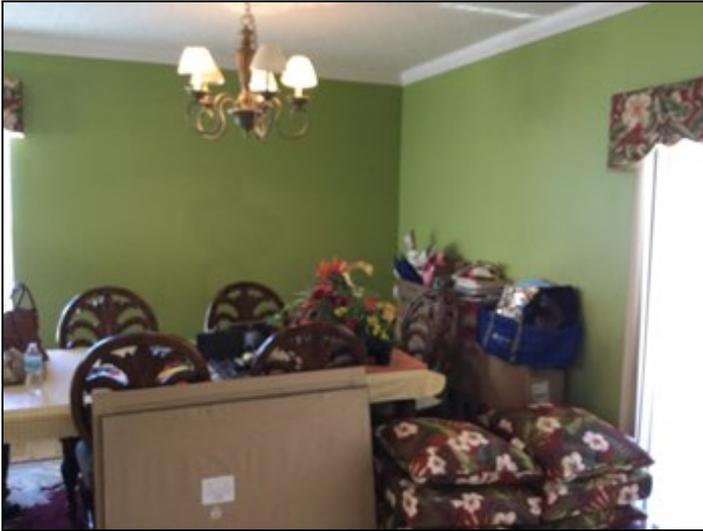
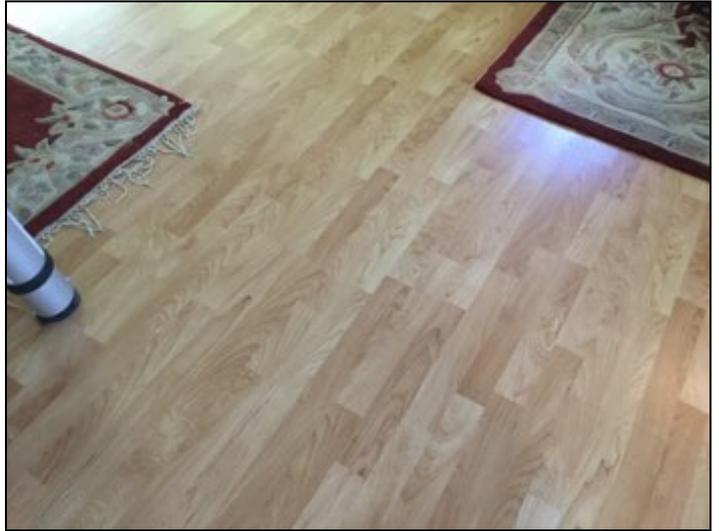
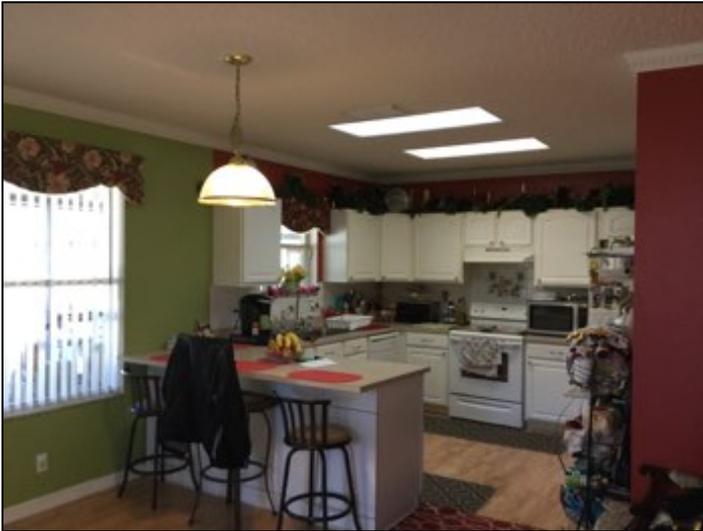
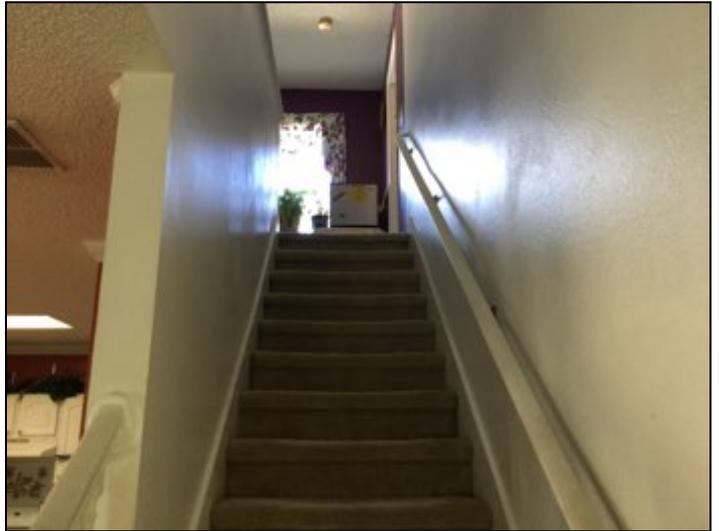
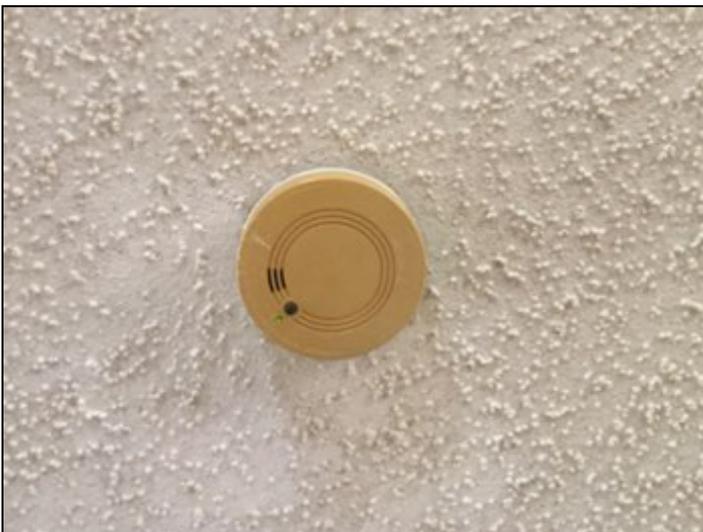
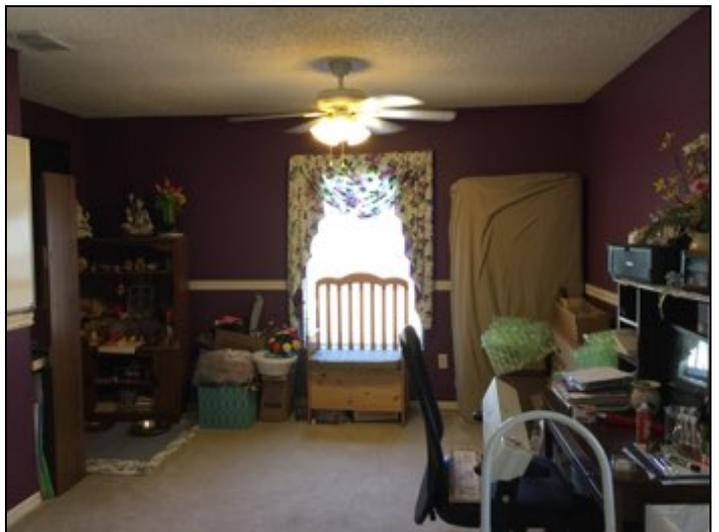
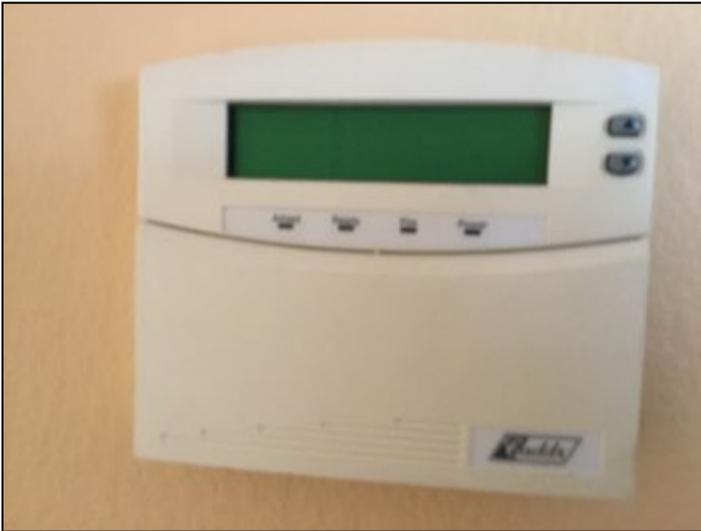
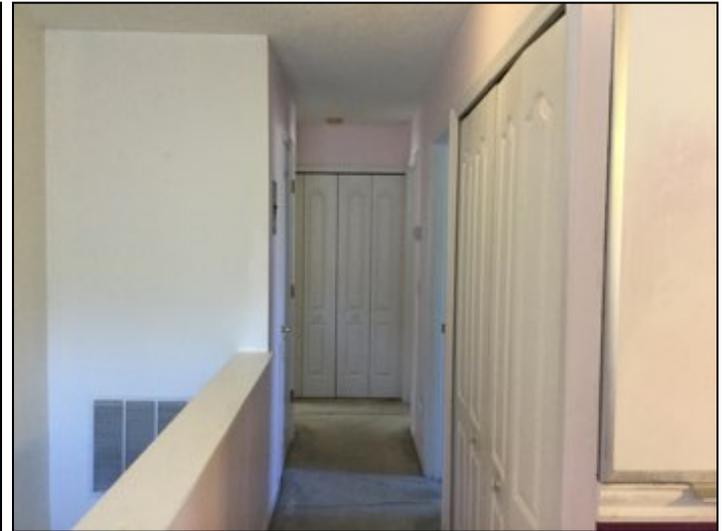
- The sliding glass door lock was not operational and the lock should be replaced.

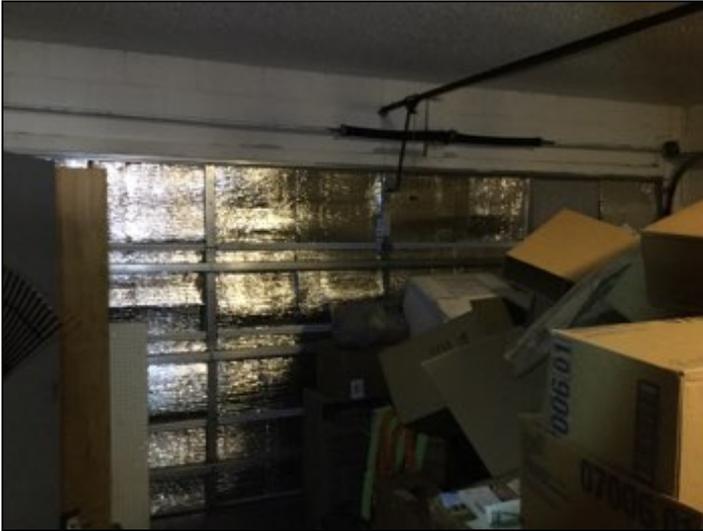
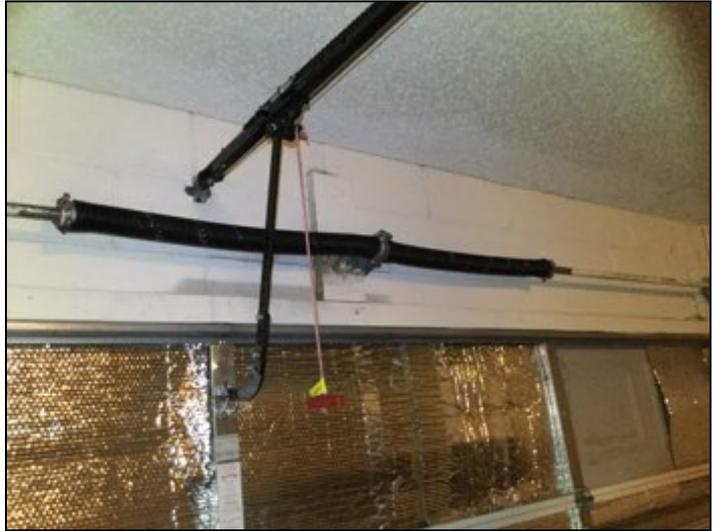
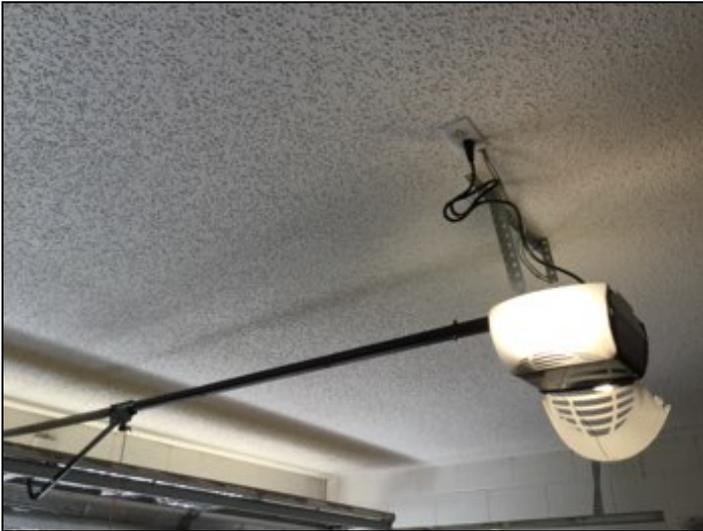
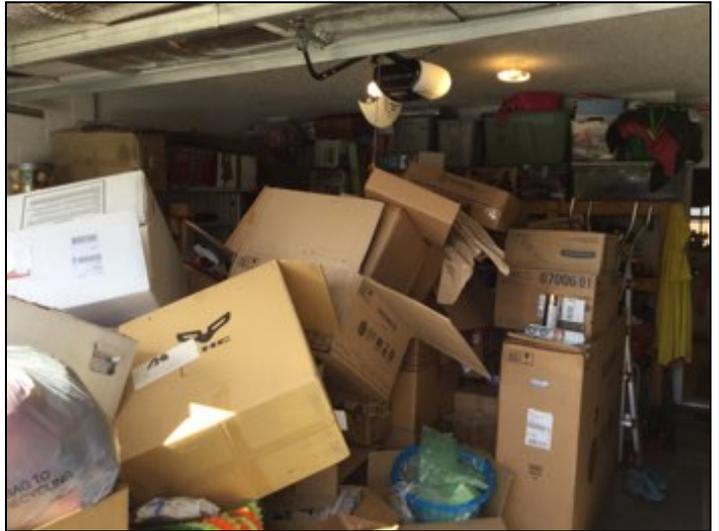
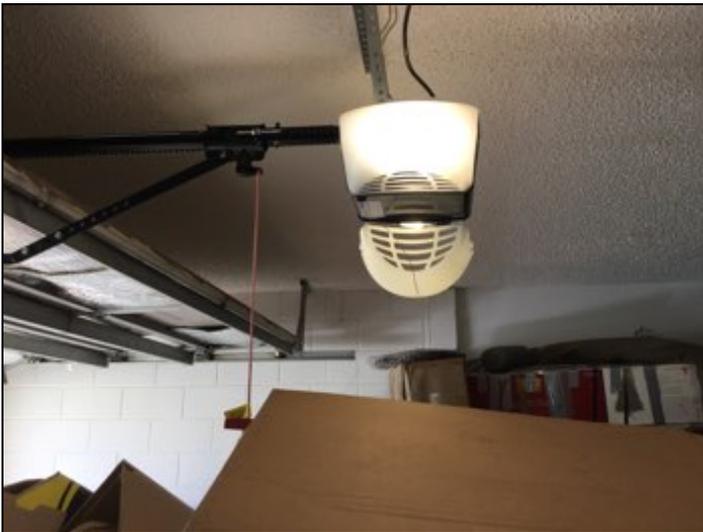
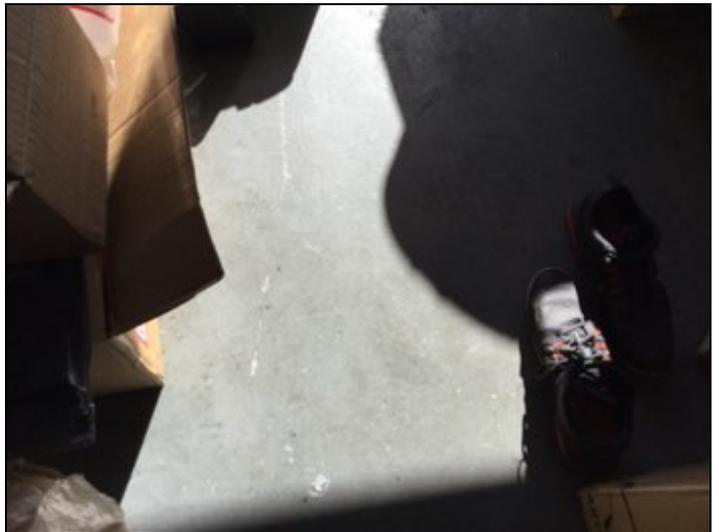
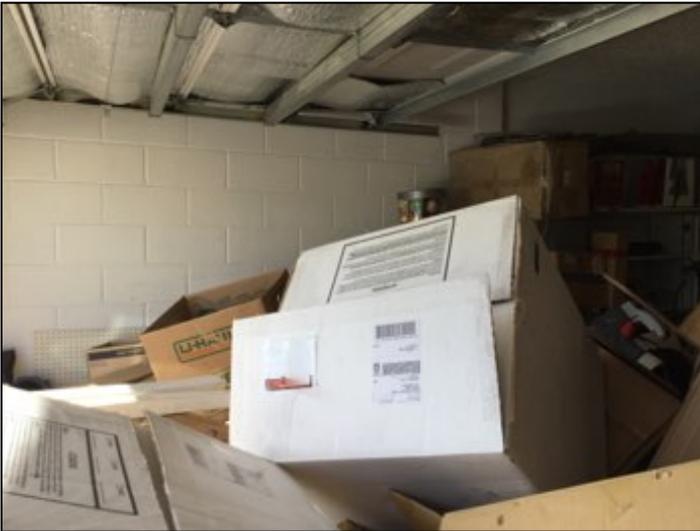
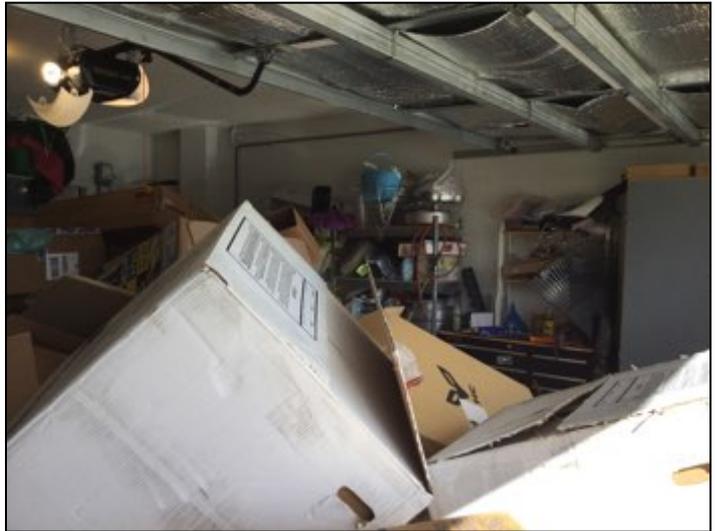
- The photo-electric eyes for the garage door opener are not operational and it should be repaired by a licensed contractor.

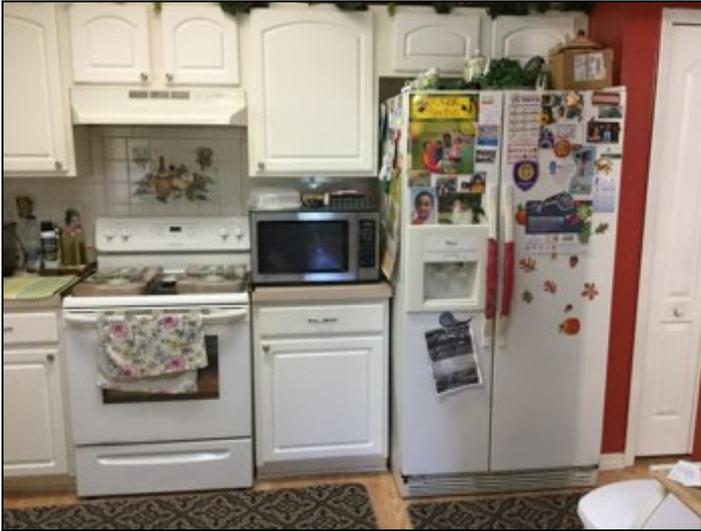
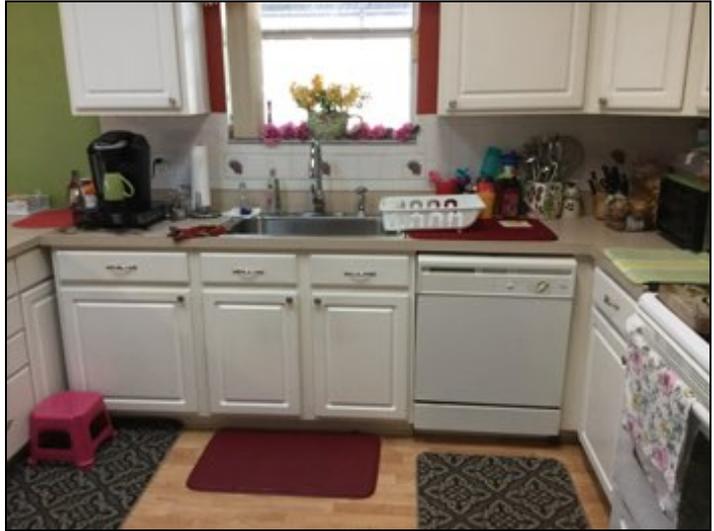
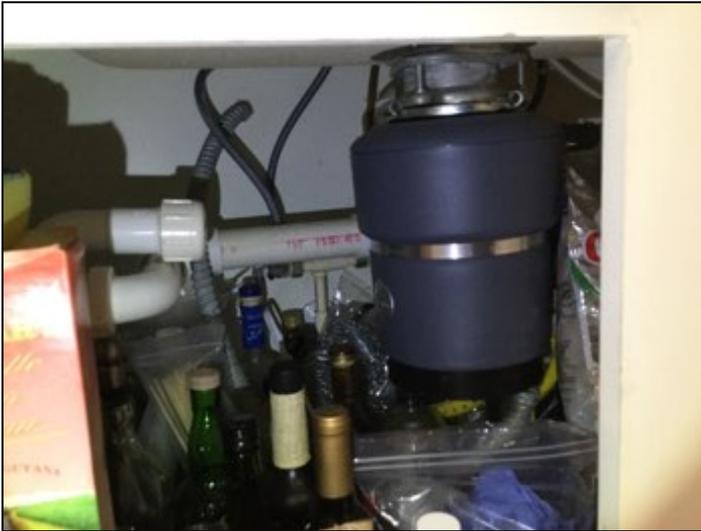
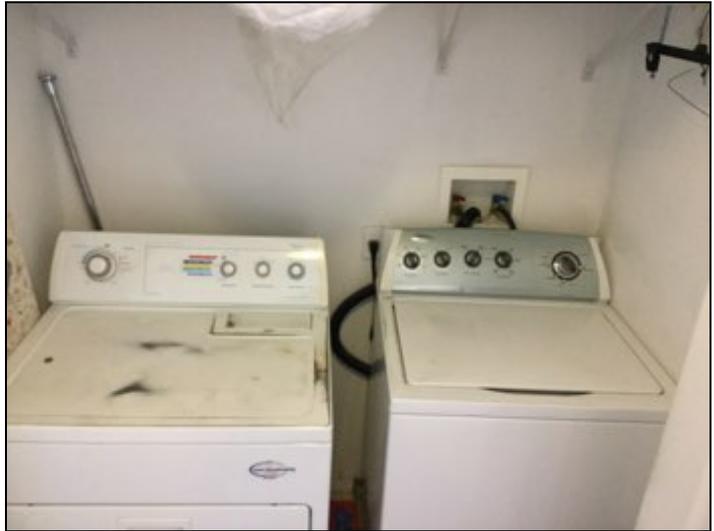
- The hand sprayer at the kitchen sink was not operational and it may need to be replaced.
- There is no water catch pan under the washing machine and the building can be damaged if water leaks from the machine.

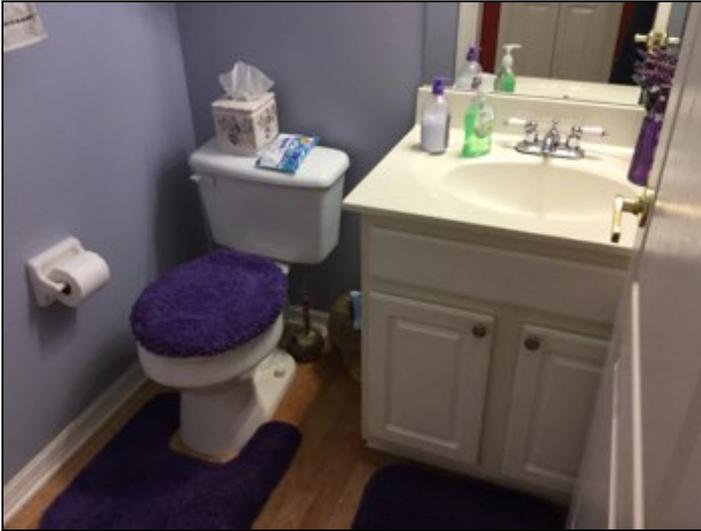
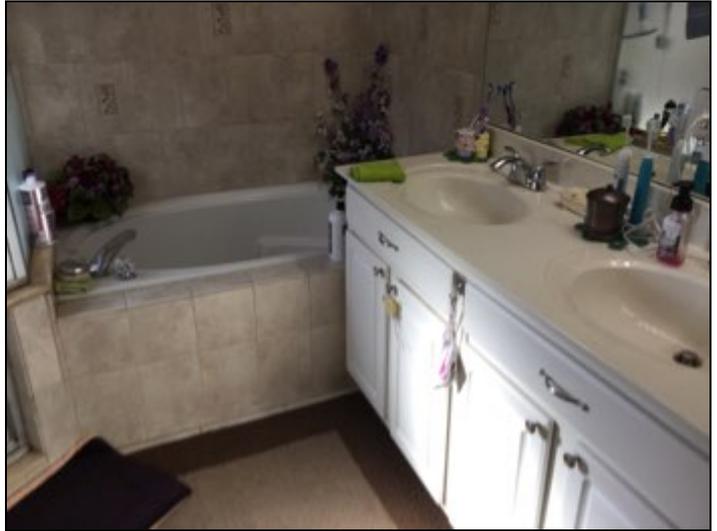
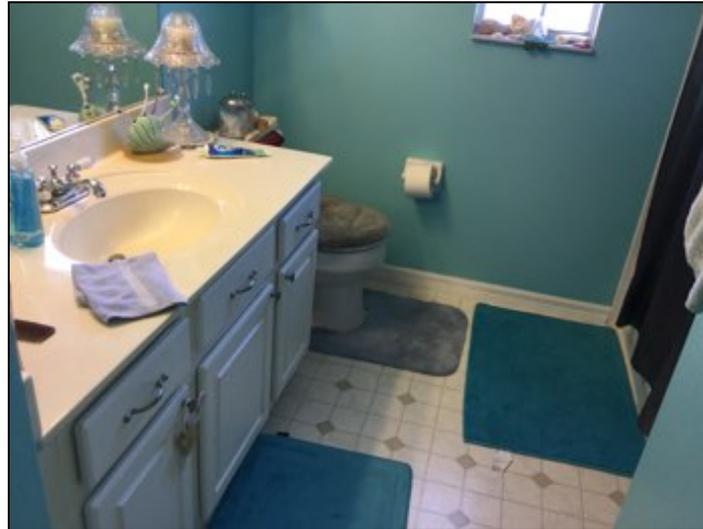
- The hallway bathroom tub drain stopper is missing and it should be replaced.
- The left-side master bathroom drain stopper was not operational and should be repaired.
- The master bathroom toilet is not properly secured to the floor and we recommend it be secured to the floor to prevent waste water from leaking from the wax ring.

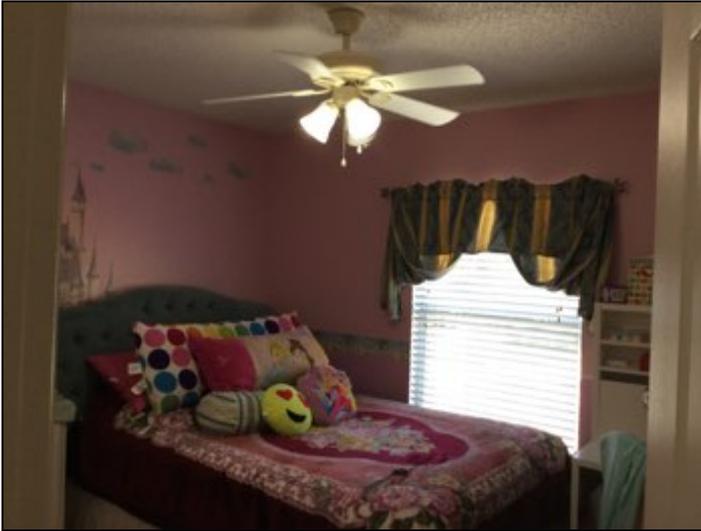
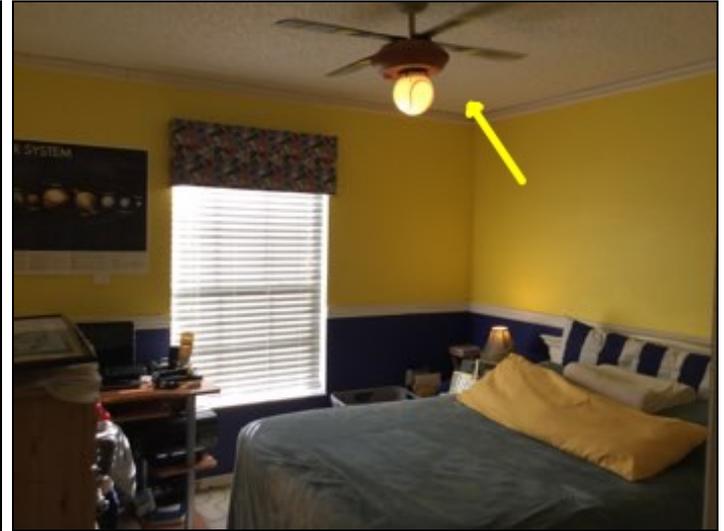
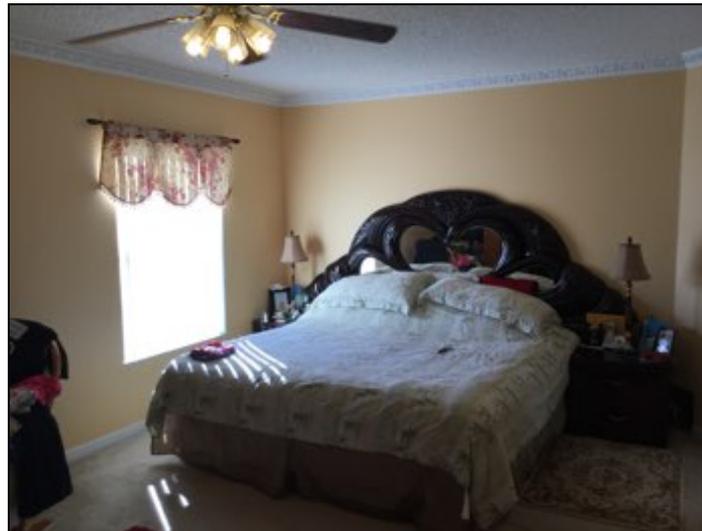
- The south east bedroom ceiling fan was unstable and it may need to be replaced.
