***Home Inspections By
Paul J. Magrone Inc.
321-228-3848 cell
407-816-8209 office***

Inspection Conditions/ Invoice

Year Built: 2003
Building Type/ Stories: Two Story Single Family Home
Front Exposure: East
Building Construction Level #1: Concrete Block Masonry
Building Construction level #2: Wood Frame
Exterior Wall Covering: Stucco & Stone Veneer
Building Foundation Type: Slab
Living Area Square Feet: 5747
Power & Water Utility Services: Public
Sewage Disposal: Private Septic System

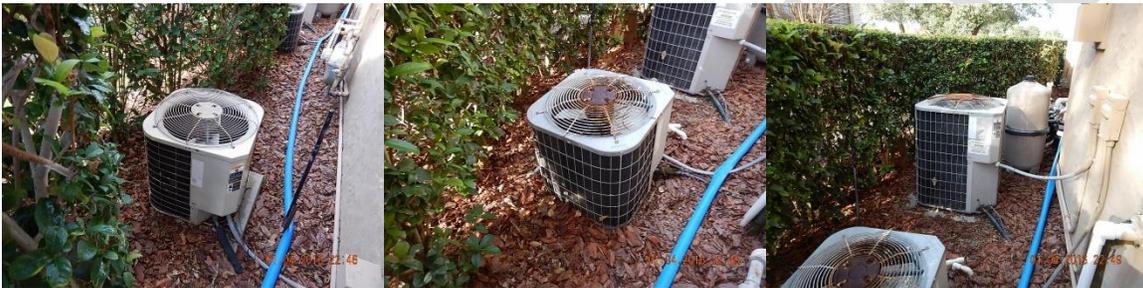
Three of the Condenser Units are installed at the south side of the building

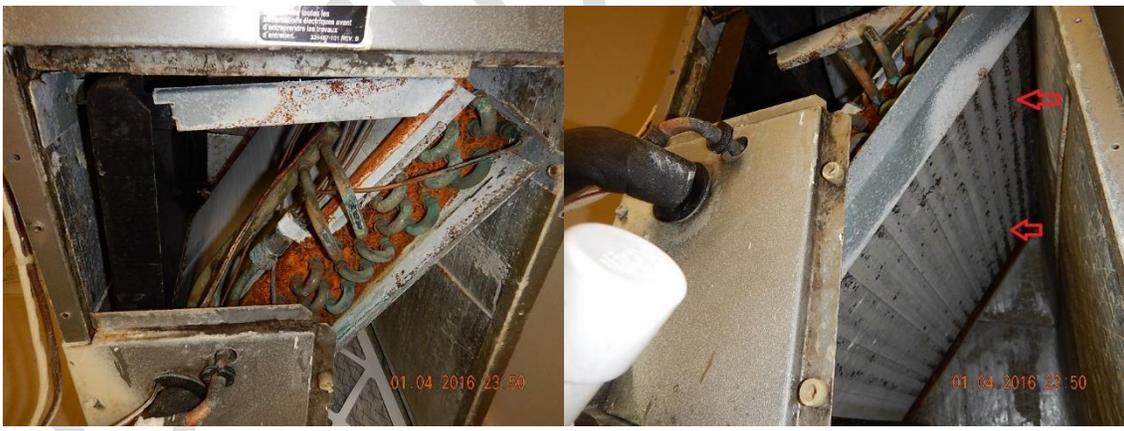
The Coils for the system require further evaluation and service at this time

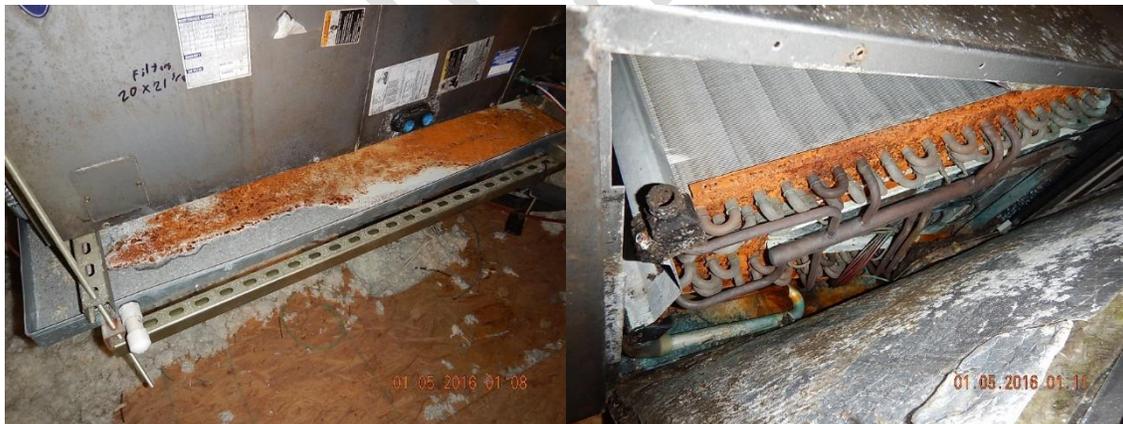
5 Ton Air Handler Unit should be serviced at this time/ Rust was observed in the overflow pan and typical mold stains were observed at the Air Handler Cabinet Areas

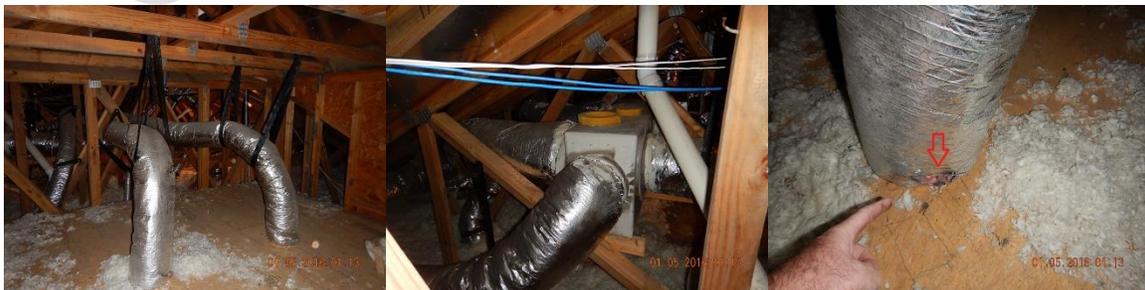
Ducts visible at the Second Story Attic- Minor repair recommended for damaged Duct close to the Attic Access Panel

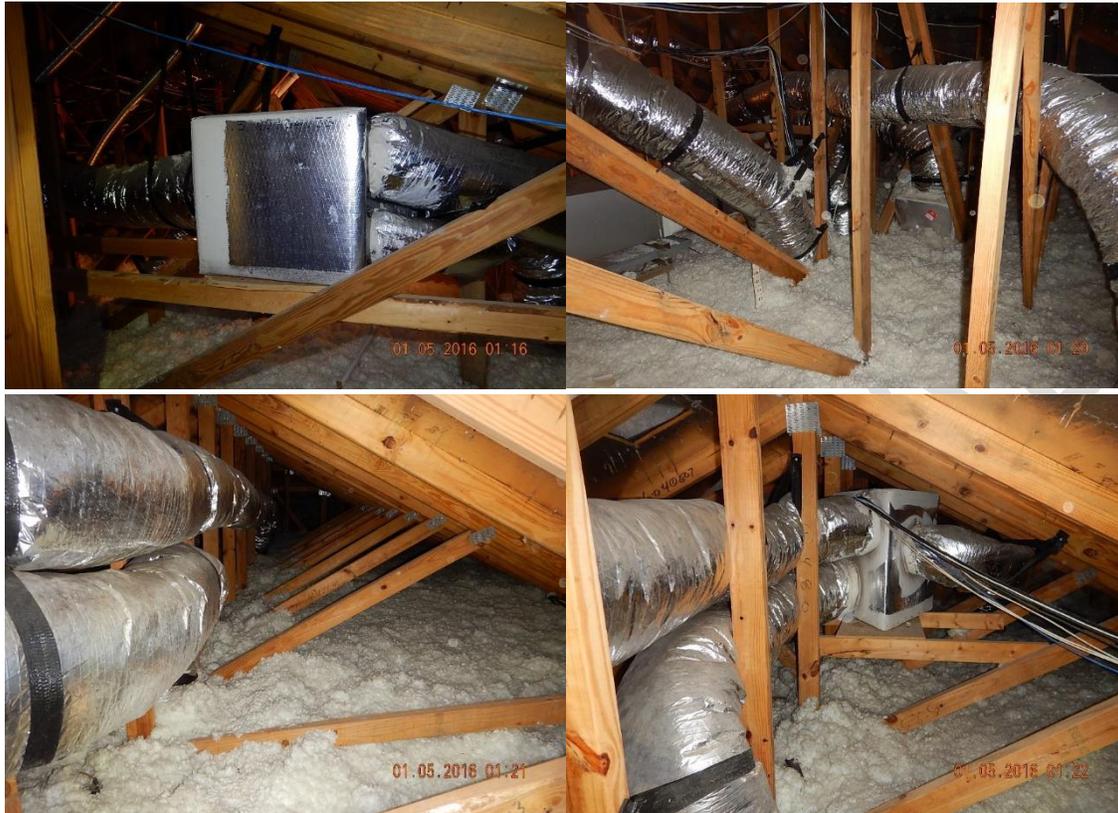
All visible and accessible Ductwork observed at the accessible areas of the Attic appeared to be in good condition

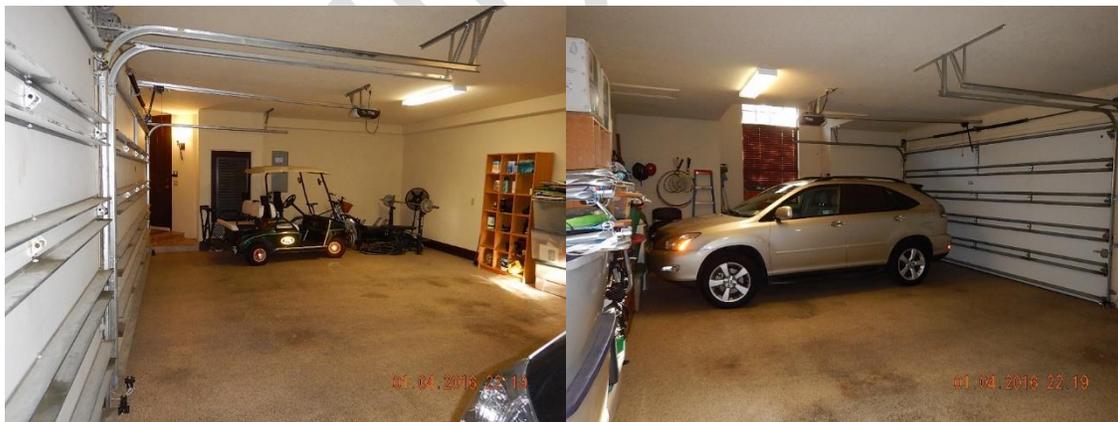
There is a Register installed in the Garage that should be terminated because the installation of the vent breaches the Fire Wall Materials installed separating the Garage from the Living Areas

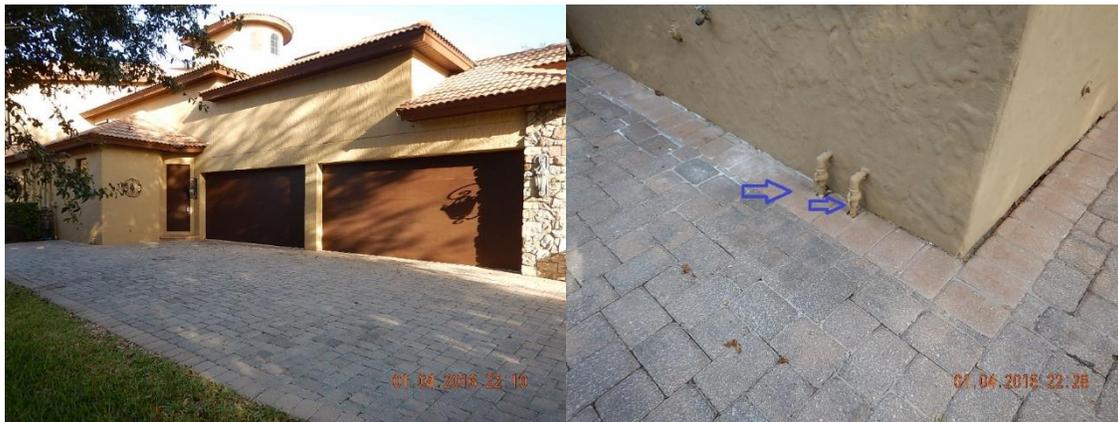
Main Shut off Valve #1 & #2 Location: South Exterior Wall-Southeast Corner at the Laundry Room- Repair or replace (2) Main Water Shut off Valves located at the South Exterior Laundry Room Wall/ The Valves do not fully turn off the water into the home

- Repair or replace (2) Main Water Shut off Valves located at the South Exterior Laundry Room Wall/ The Valves do not fully turn off the water into the home.

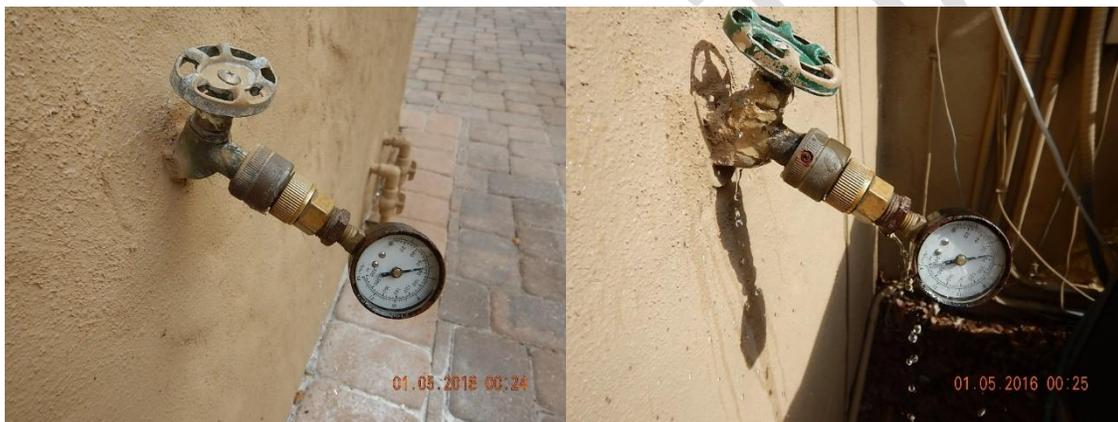
Overall water pressure: 70 PSI- Leak at the Hose Bib at the South Exterior Wall should be repaired at the Pool Area- The Hose Bib leaks at the handle when under pressure

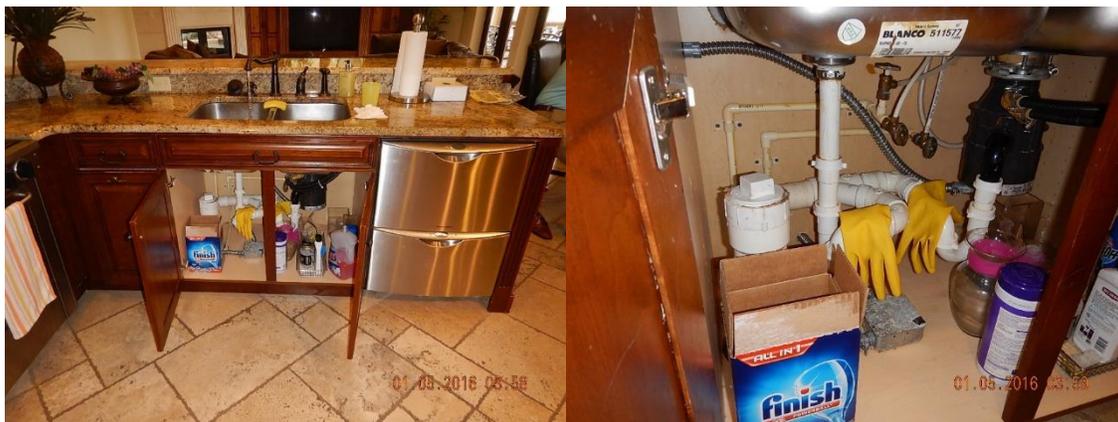
Kitchen Sink- Previous leak stains were noted at the left side Kitchen Sink but no active leaks were present at the time of the Home Inspection/ This location should be monitored over time for reemergence of previous leaking condition

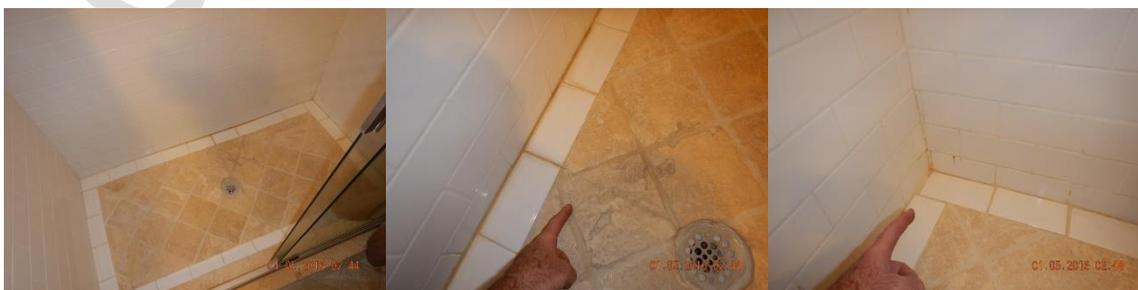
Further evaluate cracks in the Tiles at the Shower and Wall Tiles in the East Second Floor Hallway Bedroom Bathroom/ The cracked tiles may allow water to penetrate and rust the Shower Pan over time

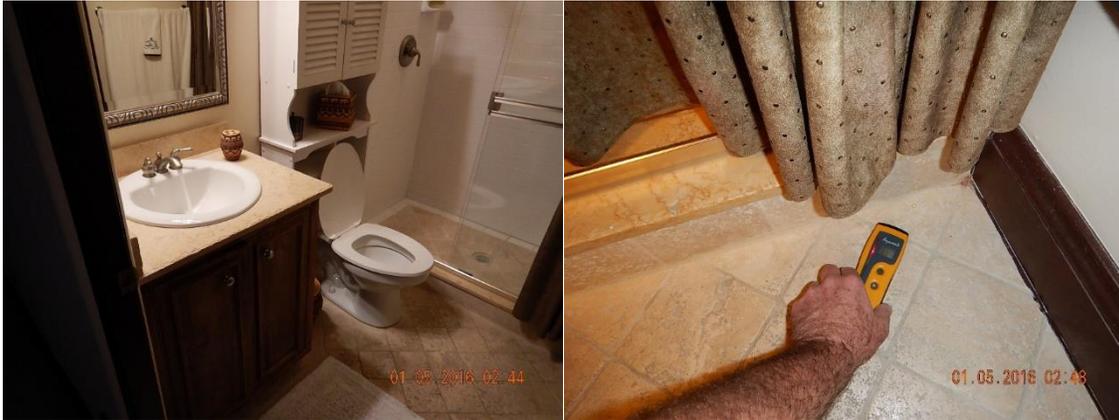
Further evaluate cracks in the Tiles at the Shower and Wall Tiles in the East Second Floor Hallway Bedroom Bathroom/ The cracked tiles may allow water to penetrate and rust the Shower Pan over time/ Active moisture was detected with a Moisture Meter at the time of the Home Inspection at the Bathroom Floor which could be an indication of a problem at the Shower Area at this time

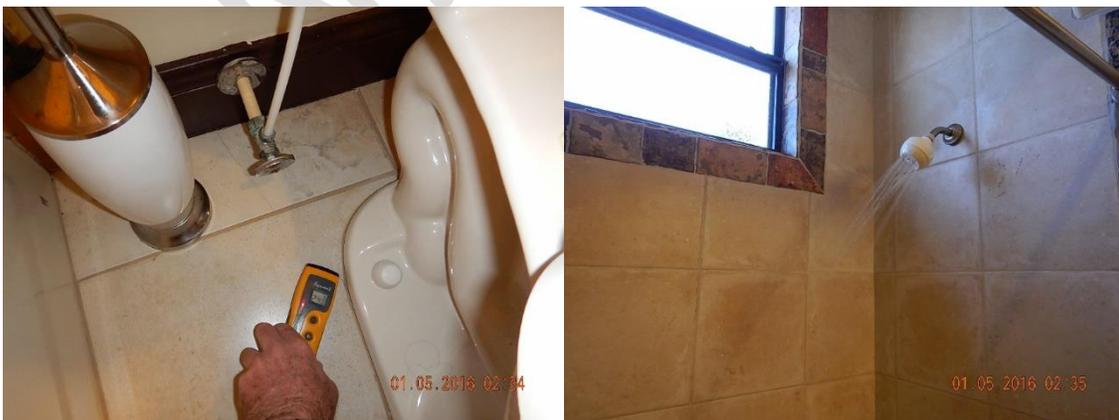
Second Floor Hallway Bathroom Areas- Reset loose Toilet and Wax Ring at the Second Floor Hallway Bathroom/ Active moisture was detected with a Moisture Meter at the Bathroom Floor close to the Toilet which could indicate possible leaking from the Wax Ring at this time

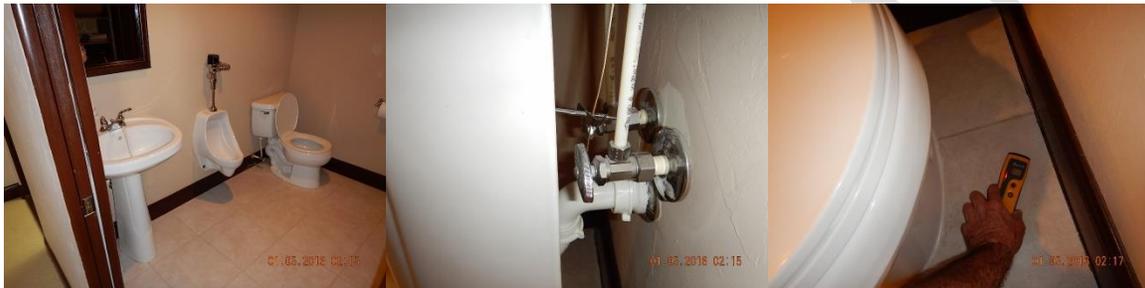
Movie Room Hallway Bathroom Areas- Reset loose Toilet and Wax Ring/ Active moisture was detected with a Moisture Meter at the Bathroom Floor close to the Toilet which could indicate possible leaking from the Wax Ring at this time

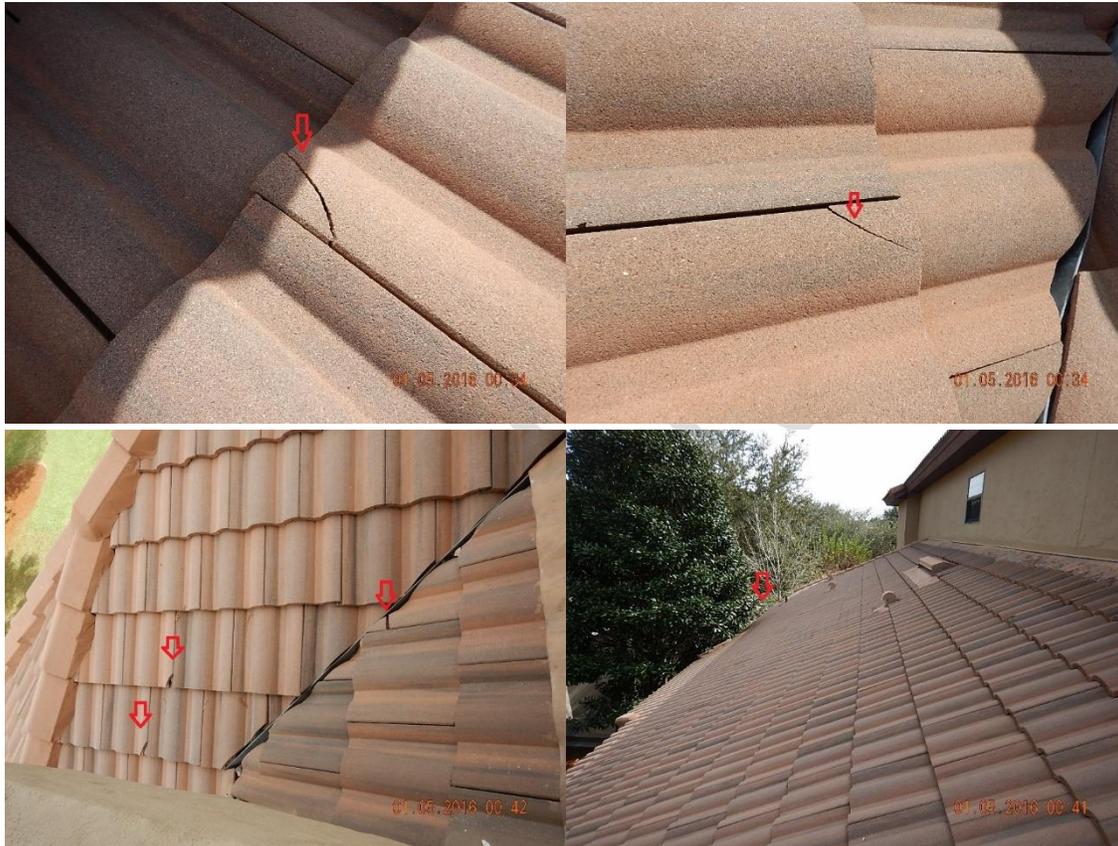
There are several Tiles with minor cracks that were observed at several areas at the Roof and some areas where mortar has cracked. The Roof is due for standard maintenance at this time to repair minor chips and cracks and also to repair minor separation at mortar areas at the Roof Ridge areas

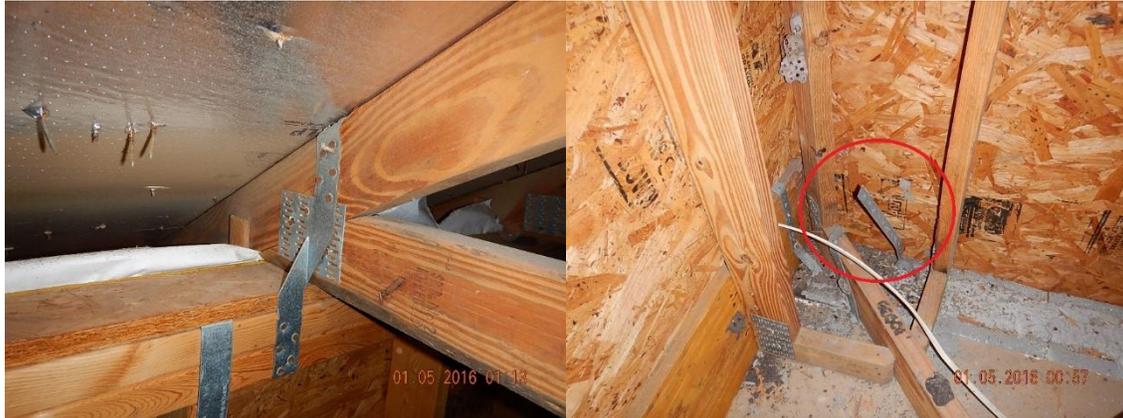
Type of Roof to Wall Connectors: Standard Metal Straps/ Good condition at accessible areas of the Attic- I observed one strap in the Garage Attic at the South Wall that is not fastened to the Wood Frame Wall/ We recommend having a qualified contractor evaluate the loose Strap and properly secure it at the Frame and Wall

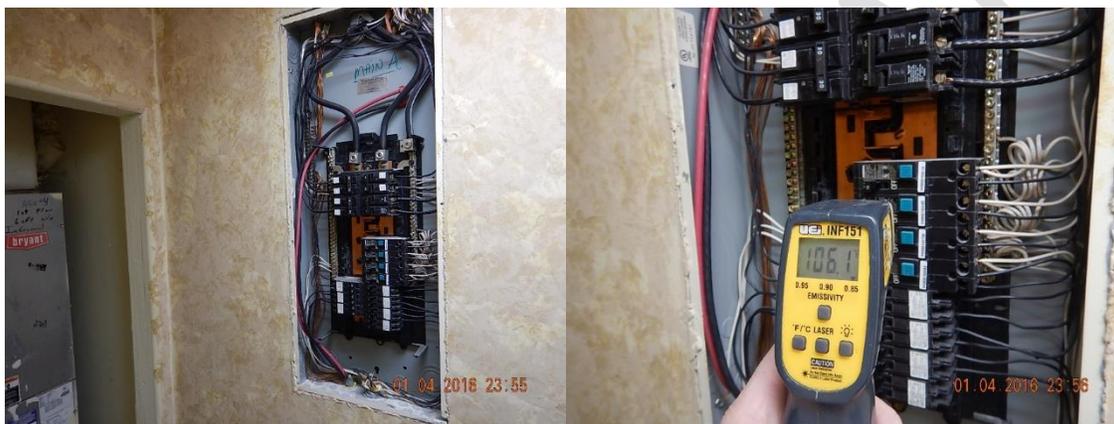
Visible and accessible wiring appeared to be in good condition at the time of the Home Inspection- Infrared Thermometer indicated elevated temperatures at the AFCI Breakers

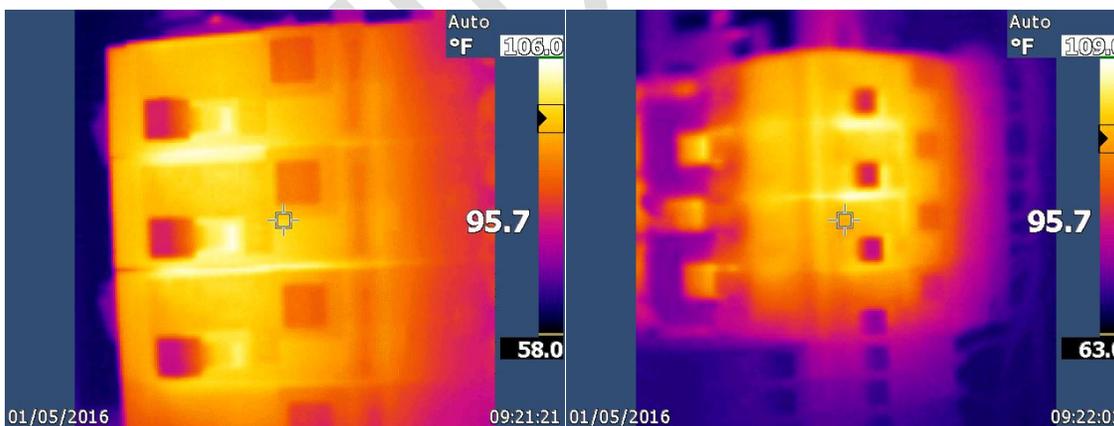
This prompted me to take Infrared Photos of the Panel which also illustrated the AFCI Breakers were running hot

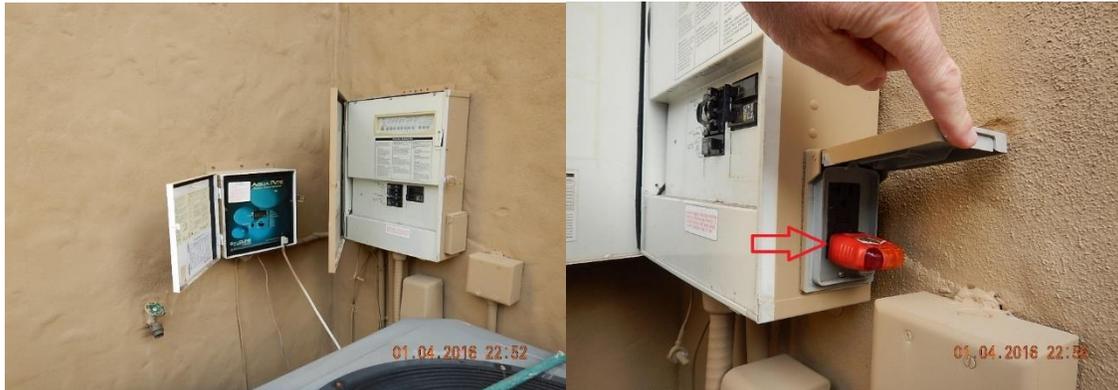
GFCI Receptacle is not tripping when tested at the Pool Panel

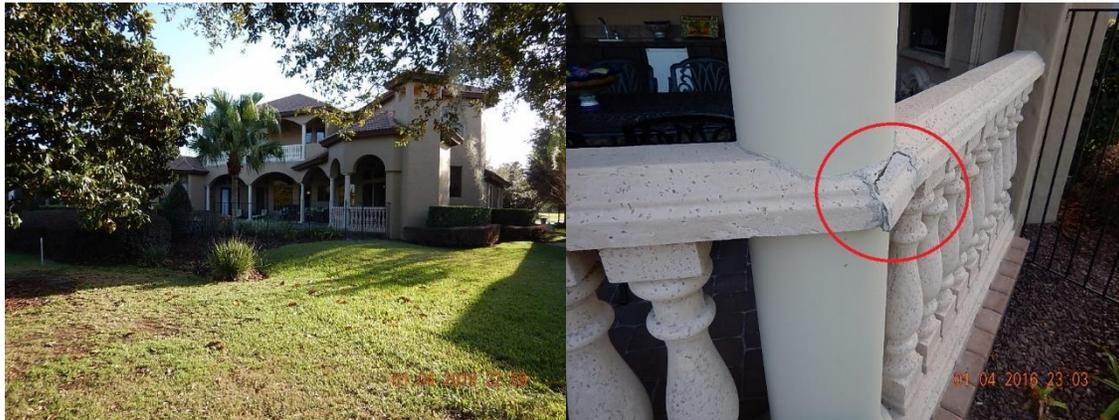
Damaged Rail at Rear Patio Area

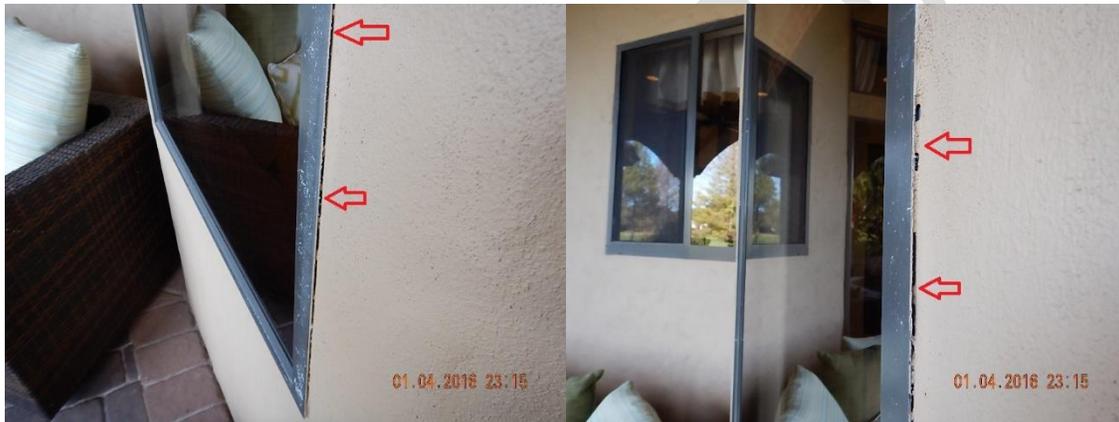
Voids at windows at Back Exterior Patio Wall

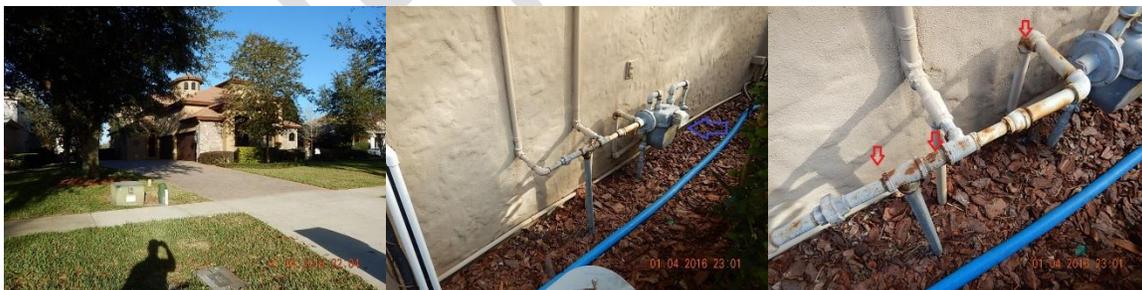
Rust at Gas Lines at the South Exterior Wall

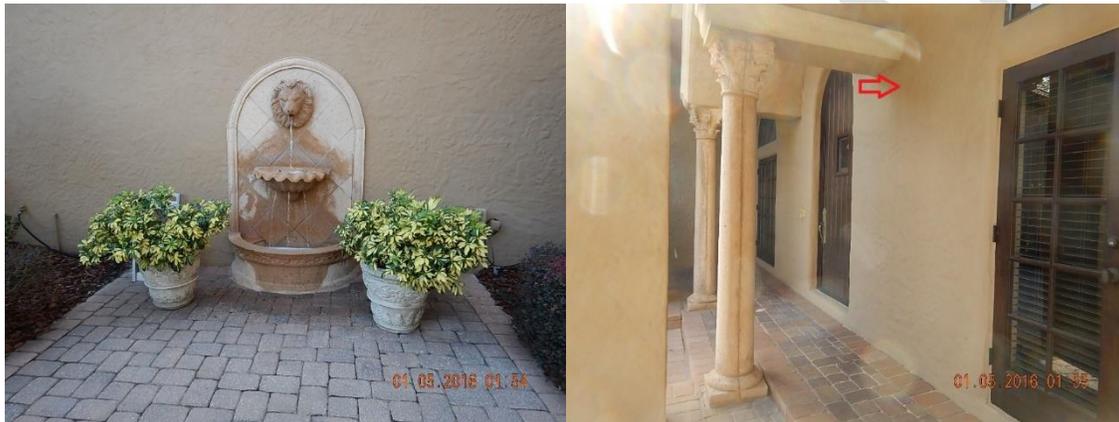
Front Entry Porch Areas- Previous leaking from the Second Floor Front Balcony

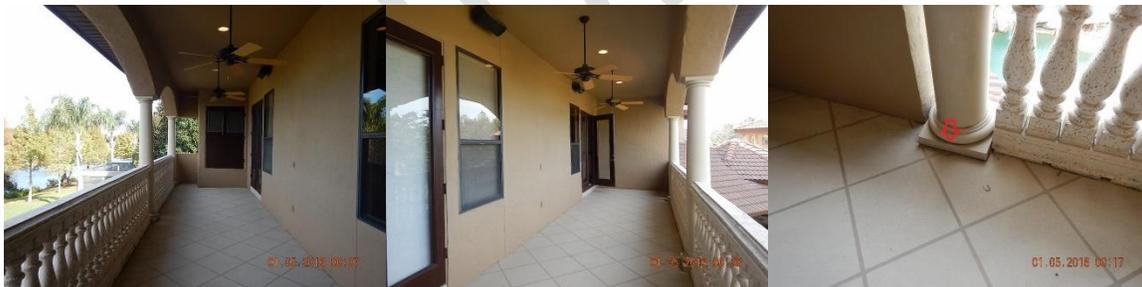
West Second Story Balcony Areas- Soft area with ants at the southwest corner

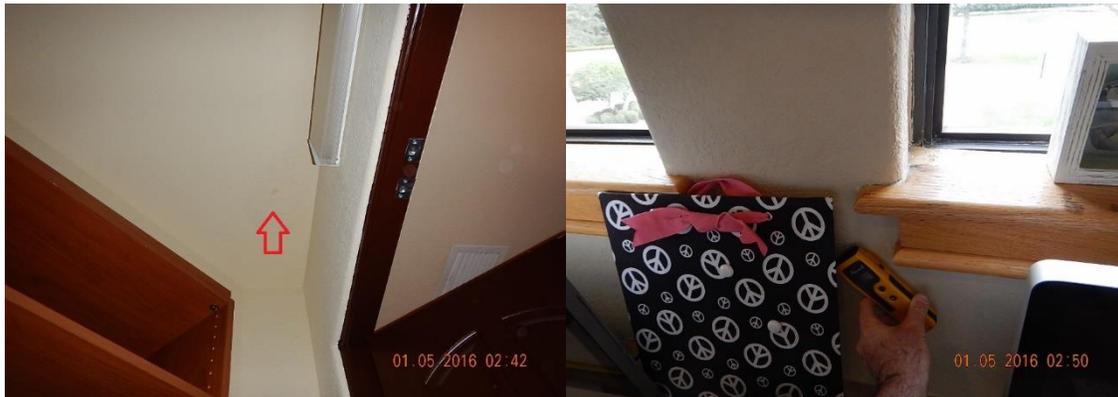
Evidence where previous moisture may have been present in the Bedroom Closet at the East Hall Bedroom and at the bottom left corner of the window in the Second Floor Study were tested with a Moisture Meter and found dry at the time of the Home Inspection indicating the areas have not been recently wet

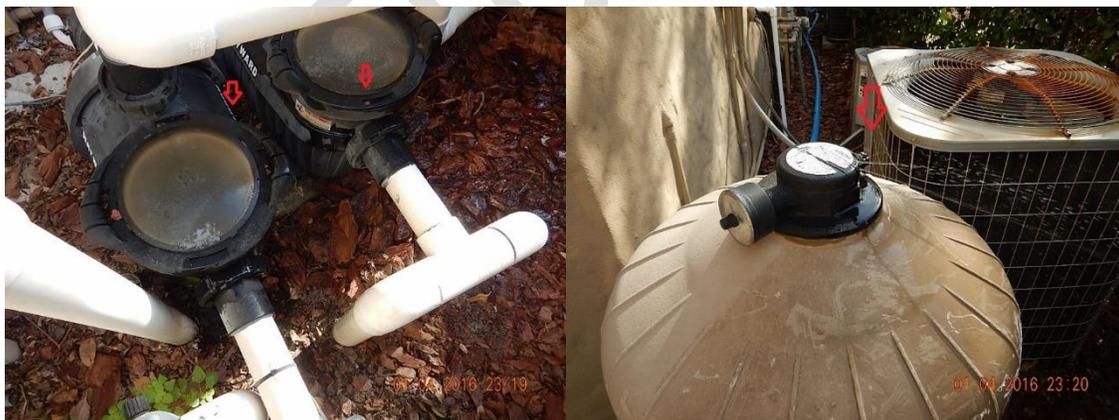
Pool Equipment- Leaking at the Pool Pumps and Filter Pressure Gauge
