Property Inspection Report

000 Main St., Orlando, FL 00000

Date of Inspection: 11/16/2018 Time: 1300

Age of Home: Built 2007 (11 years) Size: 2362 Sq Ft

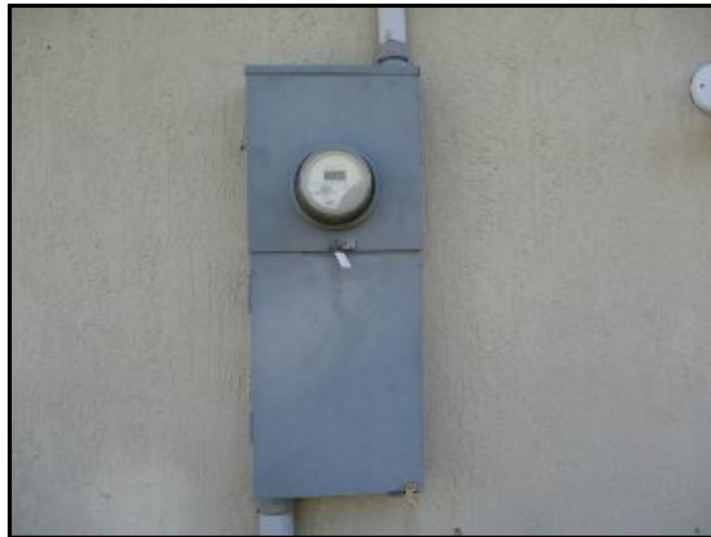
1.1. There is an underground service lateral noted.

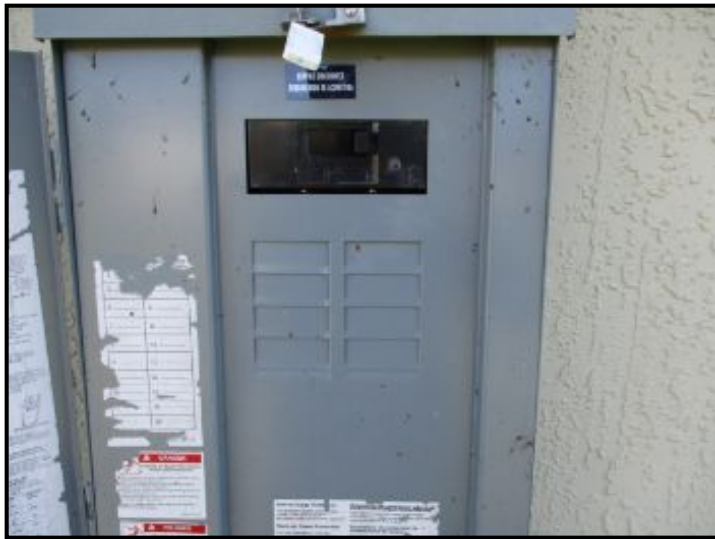
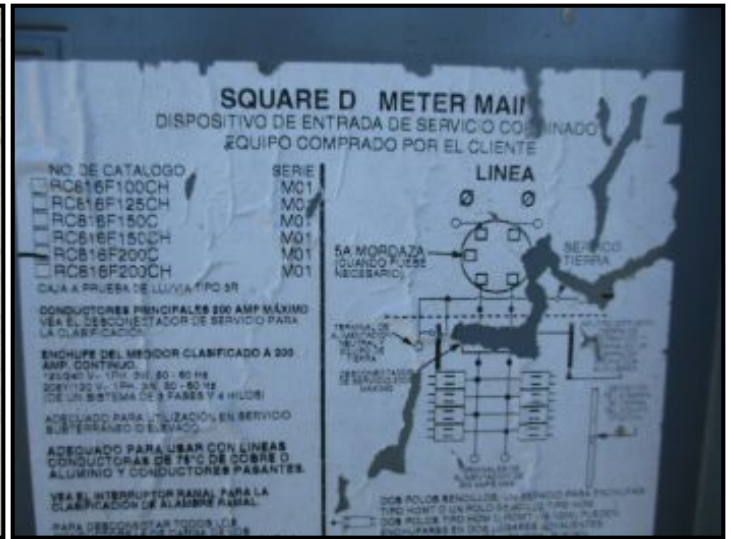
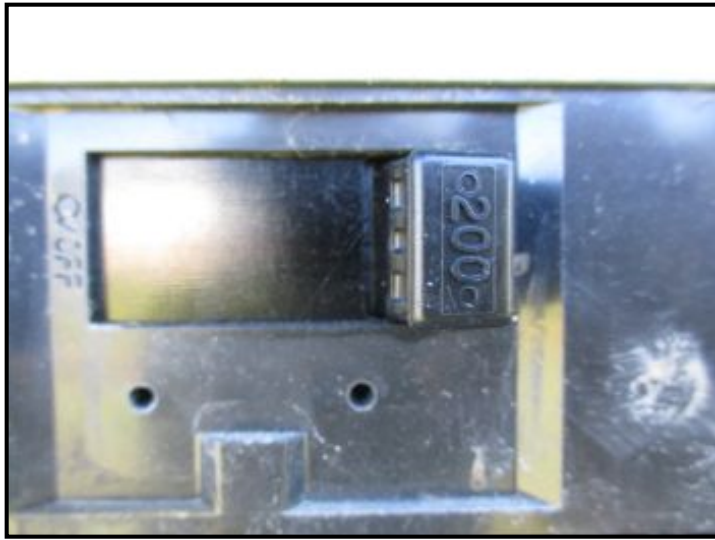
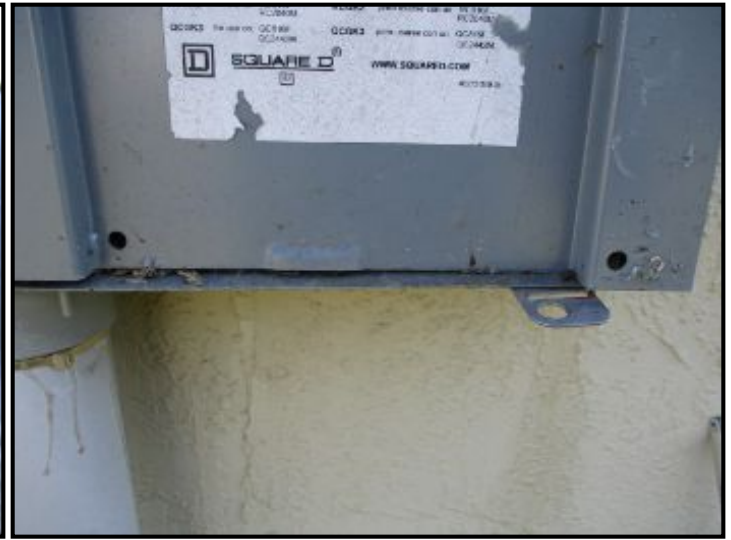
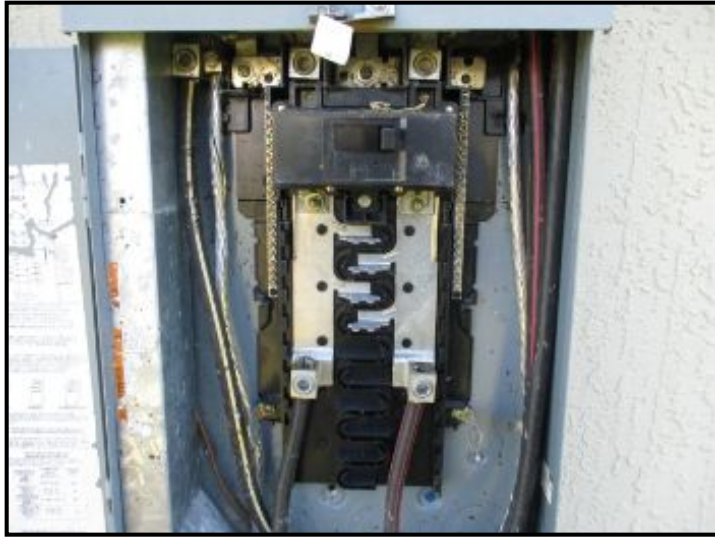
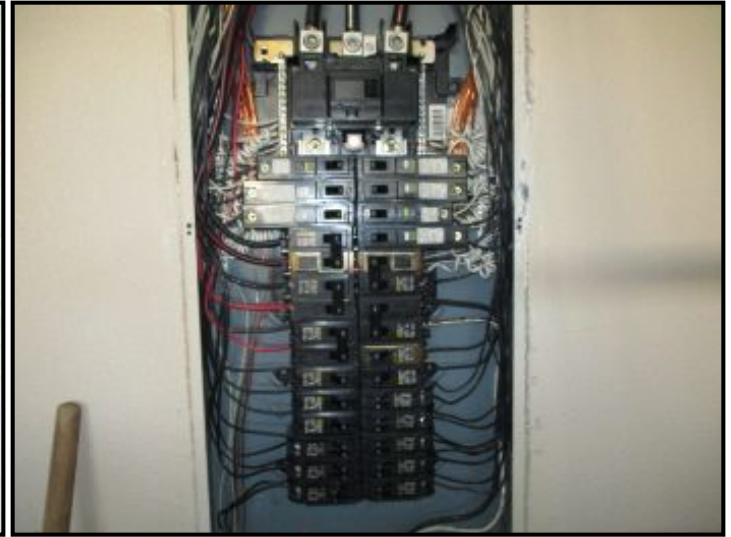
2. Electrical Service Panel(s)

2.1. Panel cover for main panel electrical box screw(s) missing. Recommend replacing panel screws with correct flat tip panel screws

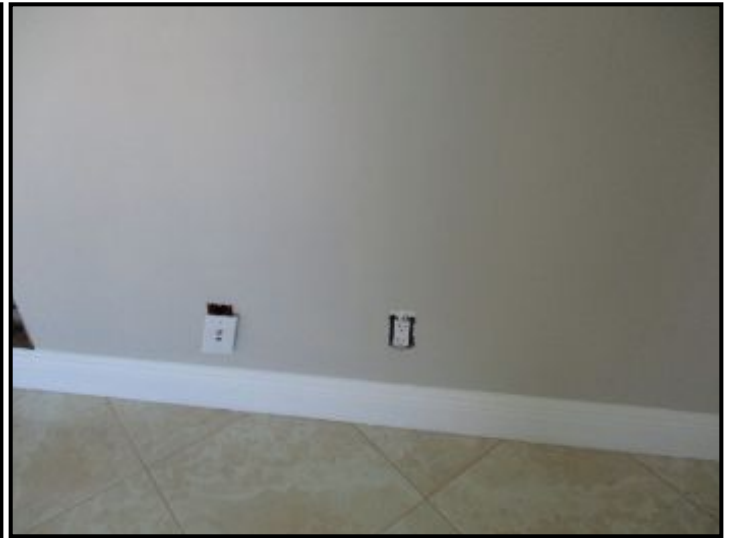
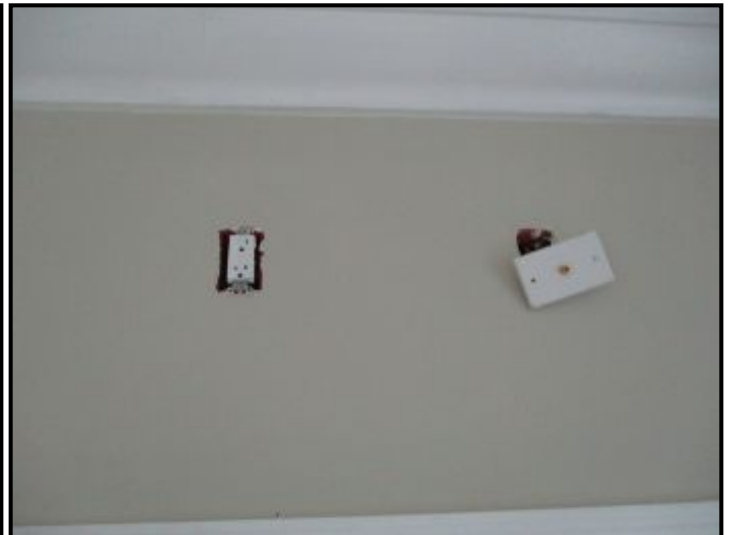
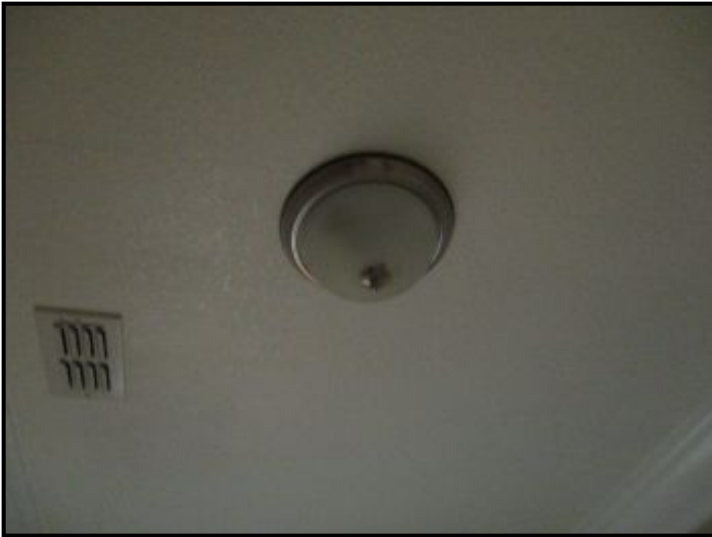
- 5.1. Switch plate missing/ missing screws at . This could be a safety issue, recommend replacement of damaged or missing cover right as soon as possible, front bedroom, all of them

- 5.2. Outlet cover(s) missing/ damaged front bedroom . This could be a safety issue, recommend replacement of damaged or missing cover right as soon as possible

- 5.3. GFI outlets at kitchen counter not secured.
- 5.4. Light fixture or bulb apparently inoperable at utility room Change bulb(s) and check. If still not working, we recommend having a certified electrician evaluate for repair or replacement

- 5.5. Light fixture or bulb apparently inoperable at utility room master bathroom toilet area Change bulb(s) and check. If still not working, we recommend having a certified electrician evaluate for repair or replacement

- 5.6. All exterior light fixtures are missing bulbs, could not test
- 5.7. Switch for garbage disposal is not secured to wall at kitchen counter

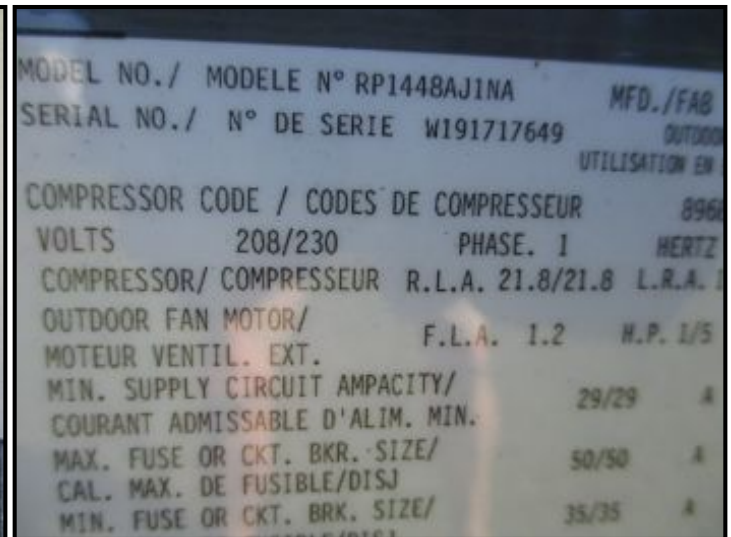
2. AC Compress Condition

- 2.1. Appeared functional at the time of inspection.

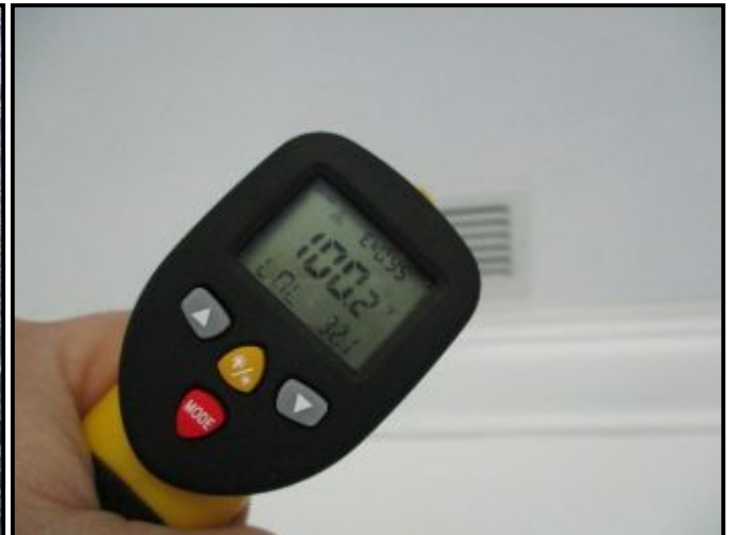
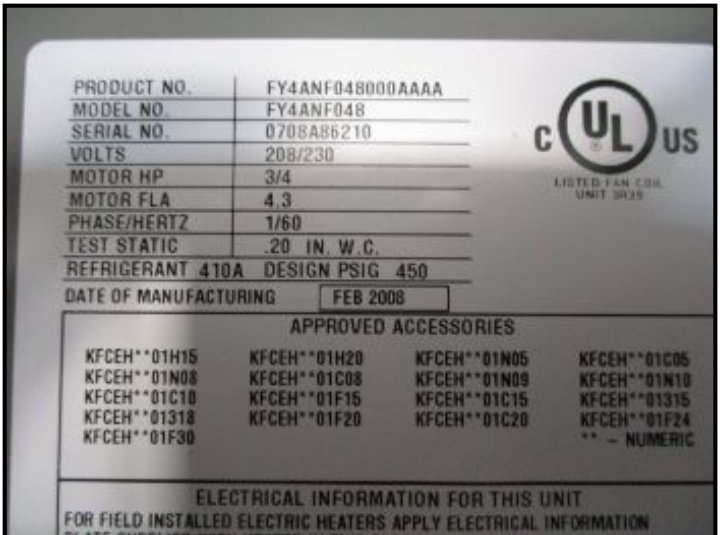
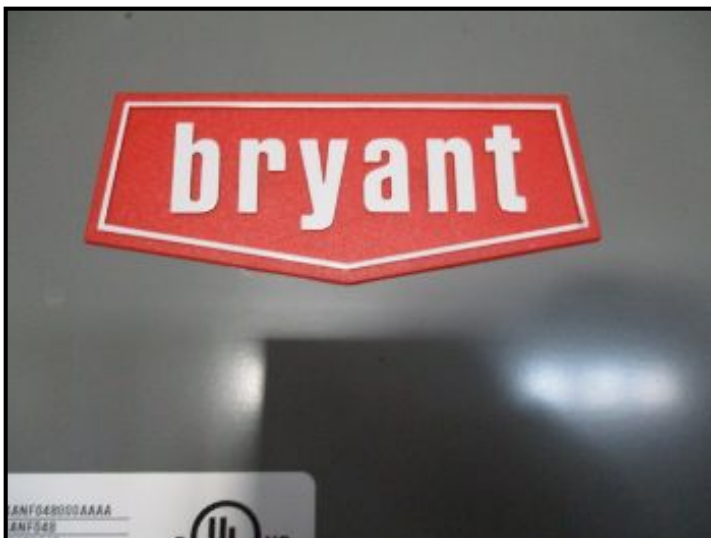
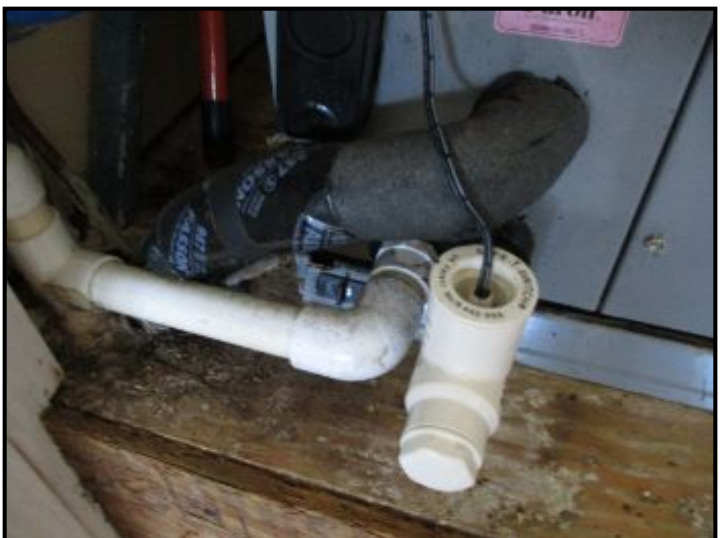
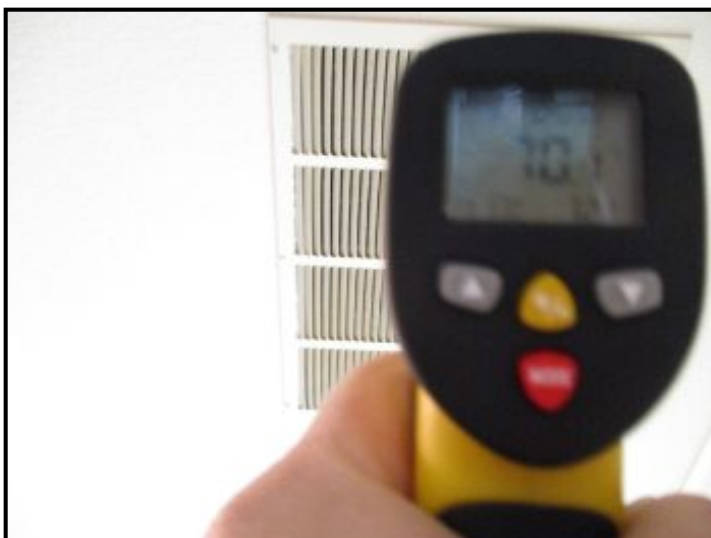
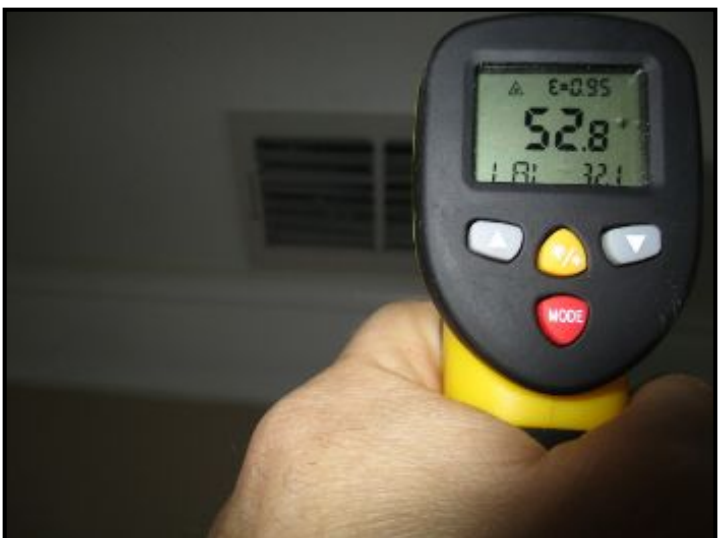
3. Air Handler Condition

- 3.1. Air handler was inspected and appears to be in good functional condition at time of inspection.
- 3.2. Float switch is installed at condensation line
- 3.3. Coils are clean,
- 3.4. The condensation line terminates at exterior next to compressor.
- 3.5. The typical temperature differential split between supply and return air in an air conditioner of this type is 15 - 20 degrees F. This system responded and achieved an acceptable differential temperature of 18 degrees F, 53/71
- 3.6. Heat return Temperature: 100°

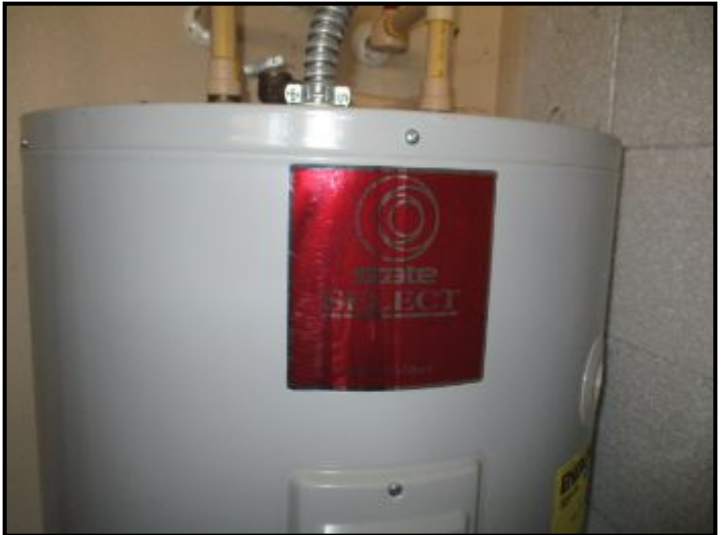
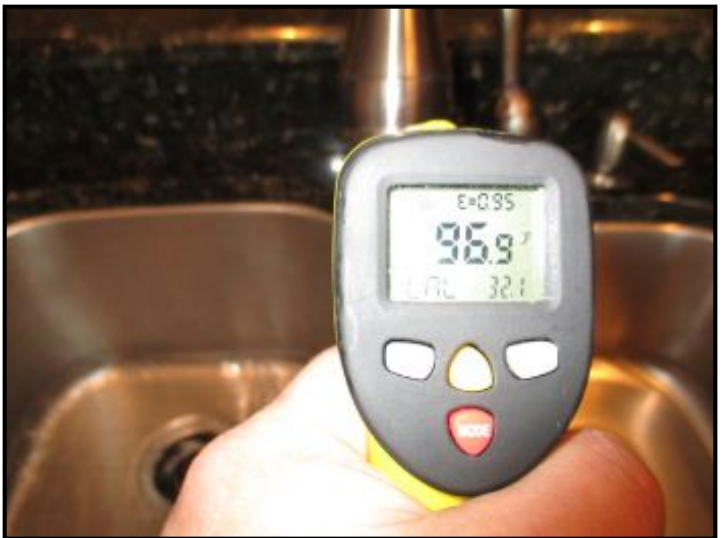
2. Water Heater Condition

- Heater Type: Electric
- Brand Name: State Select
- Gallon Capacity: 50 gallons
- Age of water heater: 2008
- Water temperature observed to be: 97 degree F. This is satisfactory. Recommended temp should be set at 110-122 degrees F to prevent scalding, extend water heater life, and improve energy efficiency and conservation.
- The heater is located in the garage.

- 2.1. The Water Heater appeared functional and in operational condition as it provided Hot Water to the Kitchen and Bathrooms during the Home Inspection.

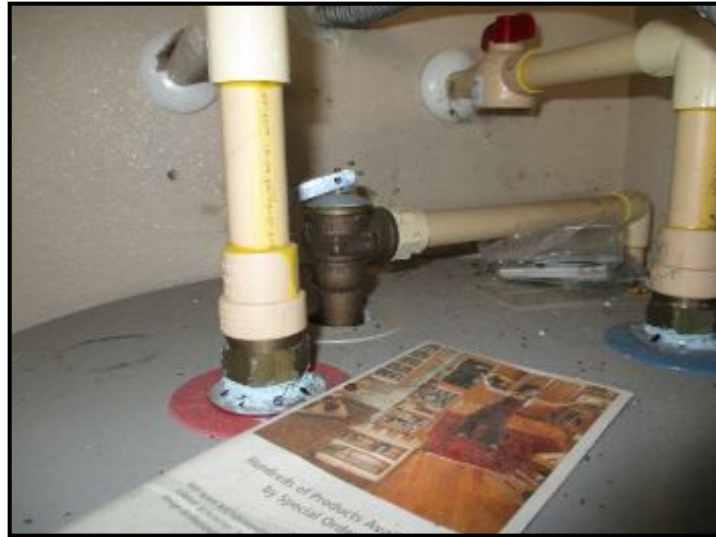
3. TPRV

3.1. A Temperature Pressure Relief Valve (**TPR Valve**) present. This safety valve releases water (and thus relieves pressure) if either the temp or pressure in the tank gets too high. The TPR valve discharge tube must be made of copper, iron, or CPVC (NOT regular PVC). It must terminate within 6" above the floor or to the exterior--the end cannot be threaded or have a fitting.

3.2. Temperature Pressure Release (TPR) valve and discharge pipe -- functional and in satisfactory condition.

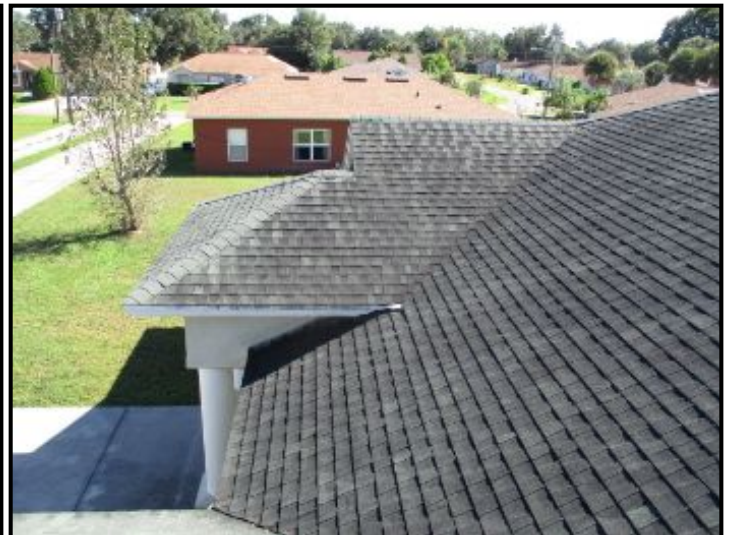
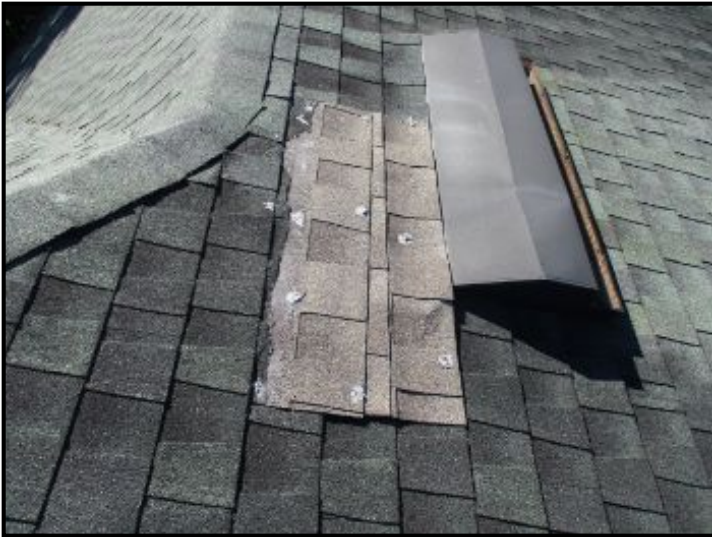
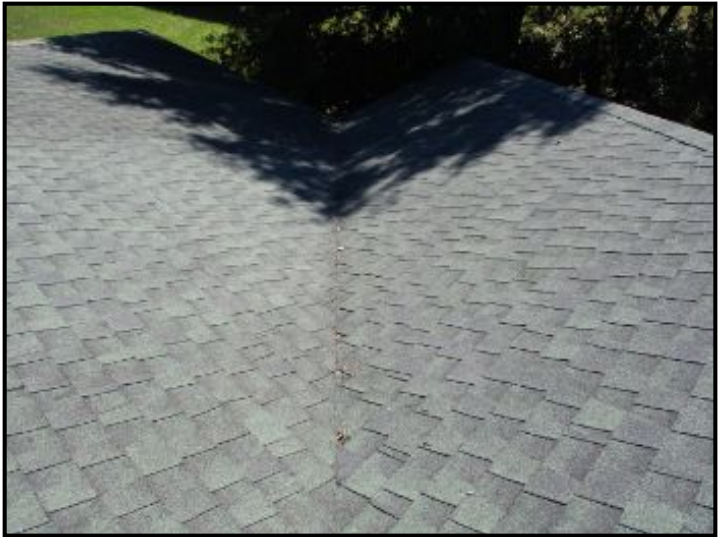
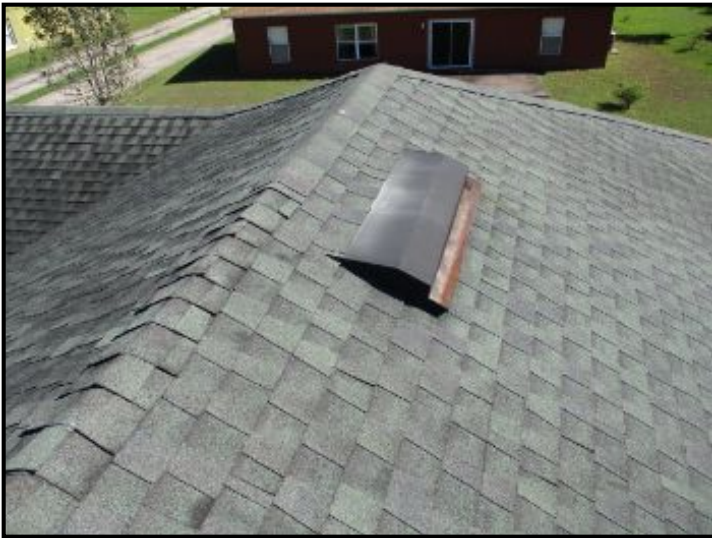
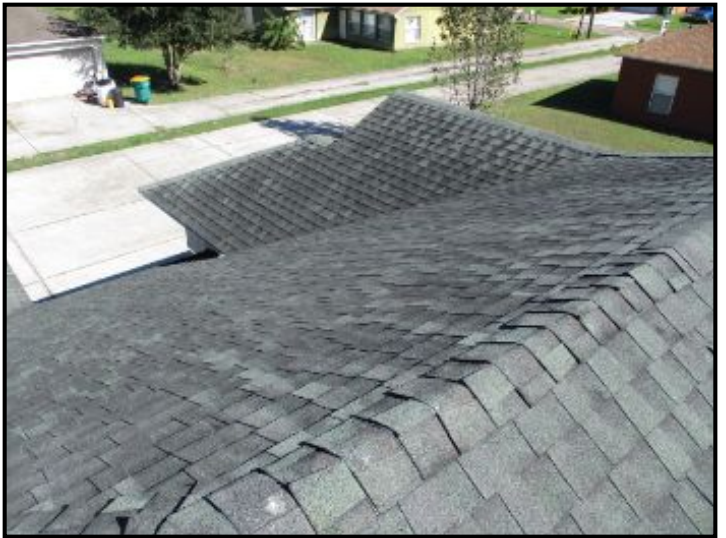
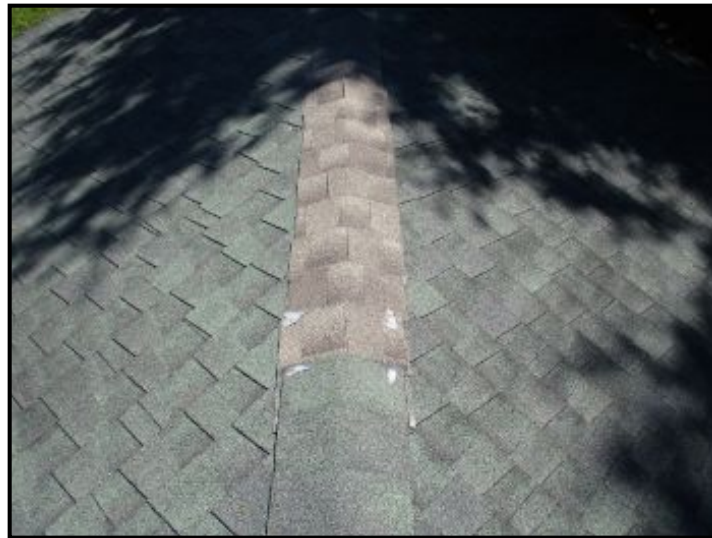
1. Roof Condition

- Type of roof noted:Hip
- Visually inspected by walking the roof.
- Roof is believed to be original roof, after permit search in which none was found. Age of roof is believed to be 11 years old.

- Architectural fiberglass composite shingles noted. This is a style of asphalt or fiberglass shingles that has a shadow design. It is thicker than the 3-tab shingles, and does not have notches cut through the shingle. Instead, there are usually two layers, with the stone on the top of the shingle embedded in a pattern that resembles shadow lines on the roof. They definitely give your roof a different sort of look. The life expectancy for this type of shingle in the state of Florida is 15 to 20 years.

1.2. Some shingles have been replaced in the past, west side of roof and east side at ridge. Recommend consulting with roofer to see if replacement was done properly

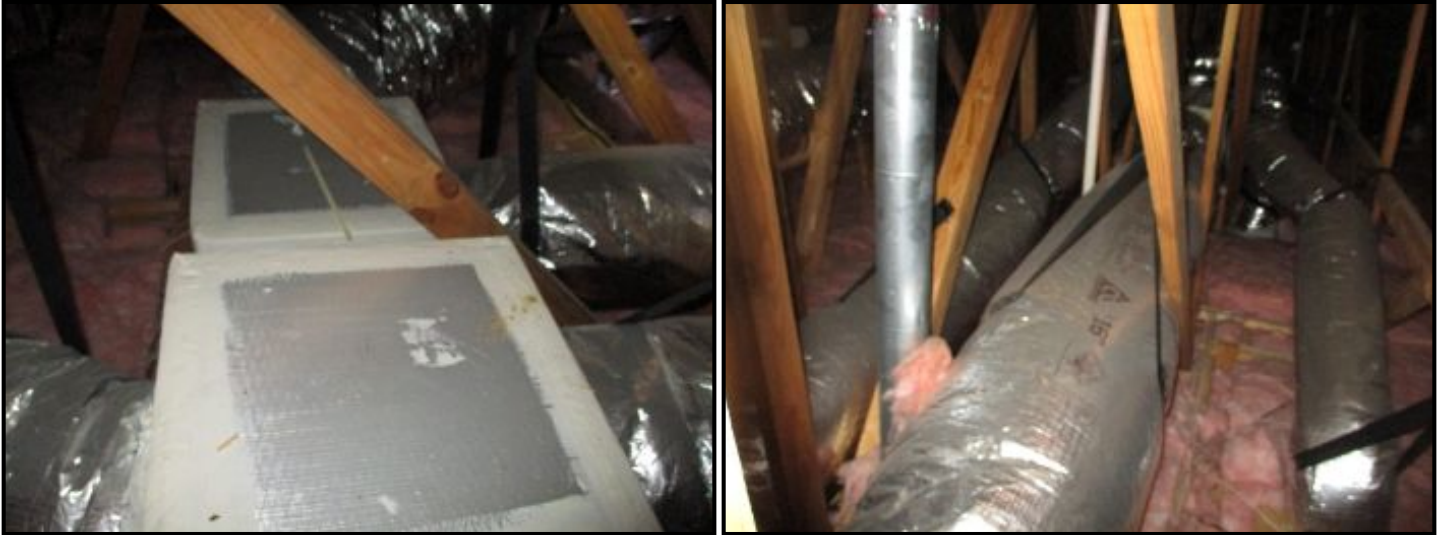
5.1. Insulated flexible duct work noted, appears in good condition

5.2. Duct Board material noted, appears in good condition

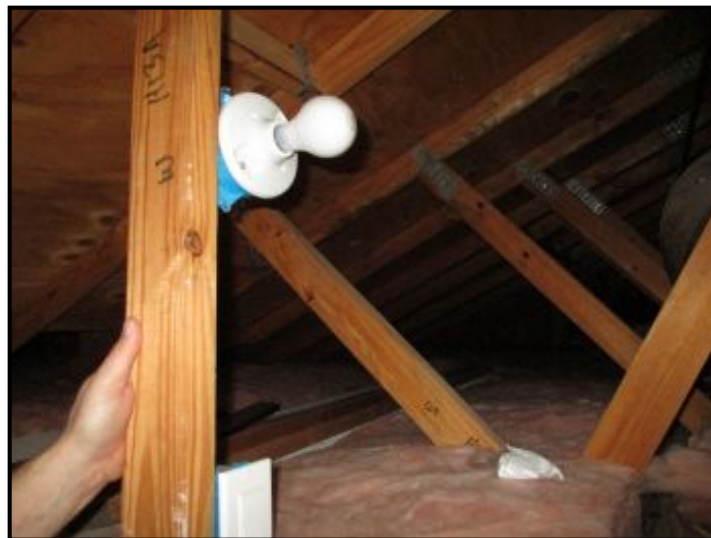
6. Electrical

6.2. Light fixture not working at time of inspection. Possible spent bulb. Suggest client verify fixture for proper operation prior to closing.

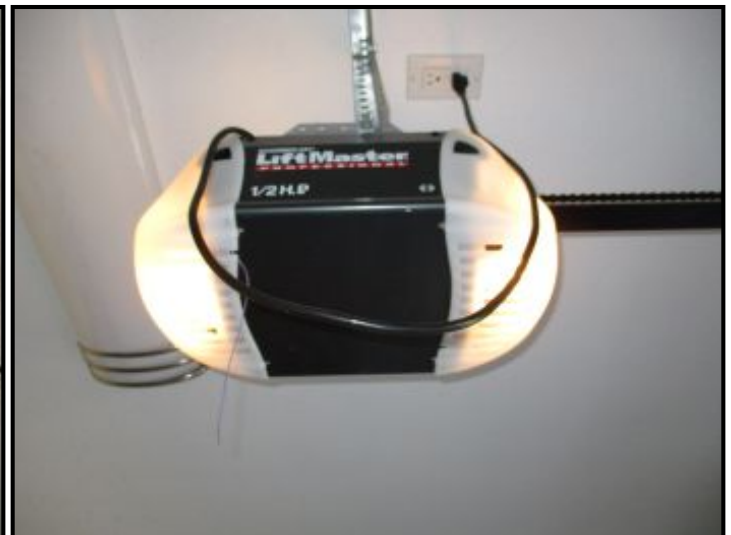
4.2. Garage door would not go back down after lifting with opener, had to disengage opener and lower door manually. eye beams may not be lined up correctly

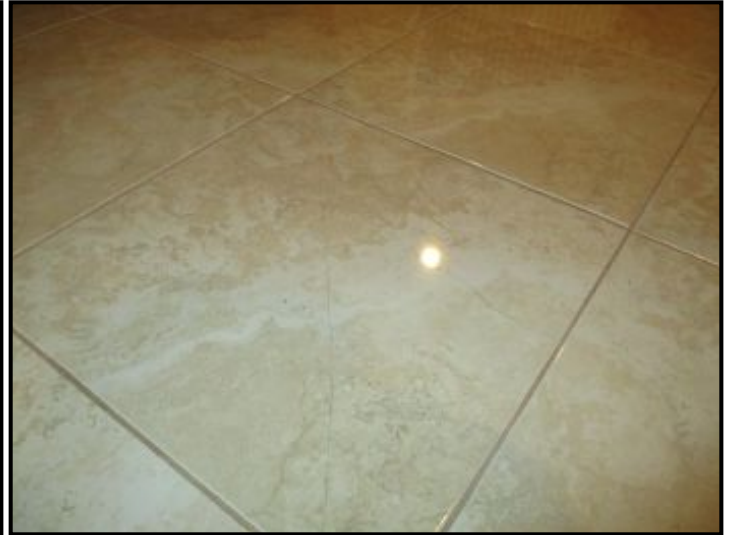
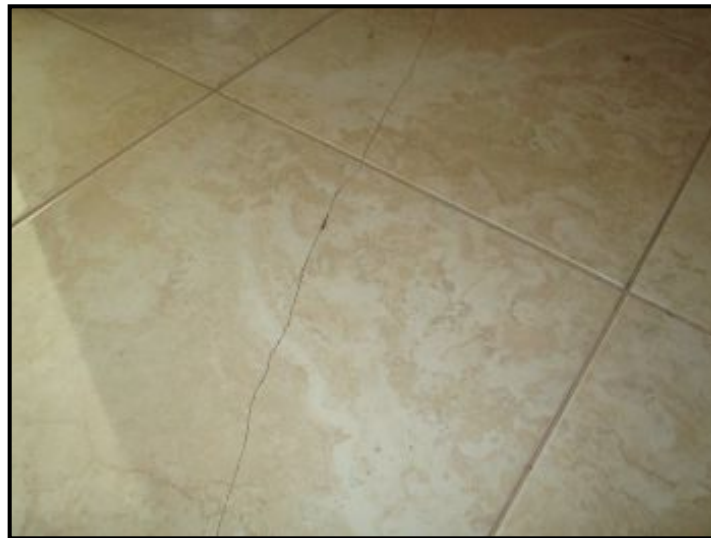
2. Floor Condition

2.1. Cracked tiles noted. In living room area

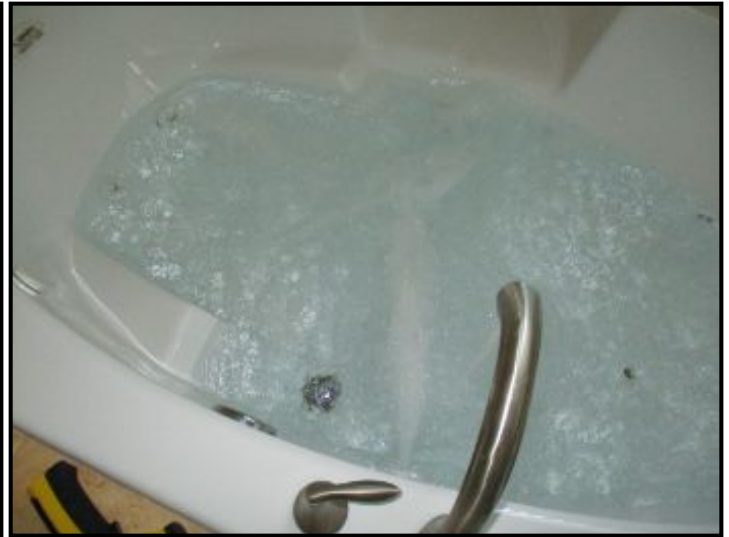
7. Bath Tubs

Whirlpool tub observed. Tub was filled to a level above the water jets and operated to check intake and jets. The tub was then drained to check for leaks and/or damage. Pump and supply lines were not completely visible or accessible. GFCI's were present and was tested. The items tested appeared to be in serviceable condition. If a more detailed report is desired, the client is advised to consult a licensed plumber for a complete review prior to closing.

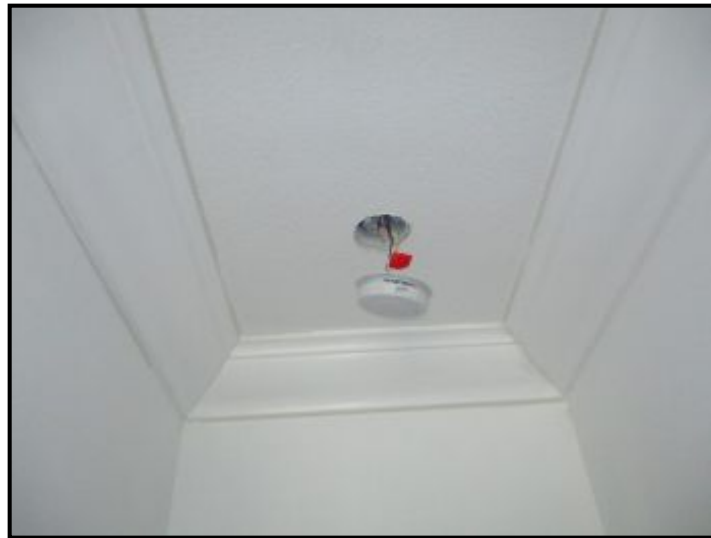
•SAFETY CONCERN: The smoke alarm n far right bedroom hanging by wires

•SAFETY CONCERN: The smoke alarm(s) did not operate when tested. You need to be alerted in case of a fire. Recommend repair or replacement of the smoke alarm. Alarm in center bedroom

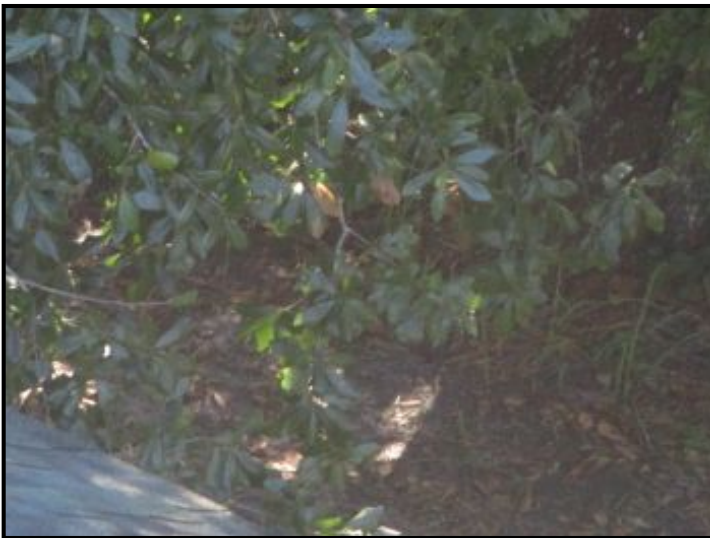
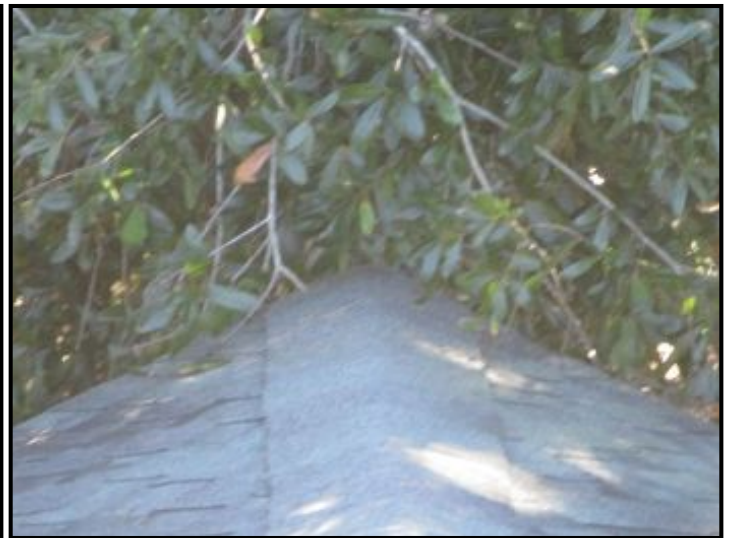
3.2. Tree limbs within 10 feet of roof should be trimmed away to provide air and sunlight to roof, while minimizing debris & dampness.

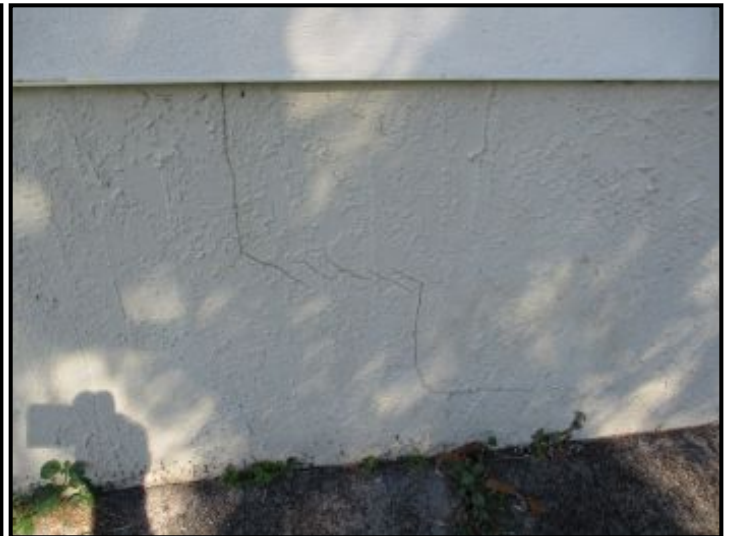
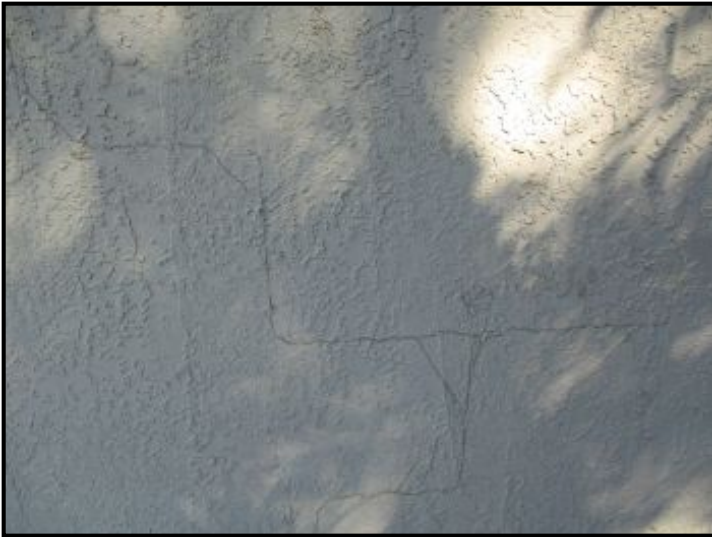
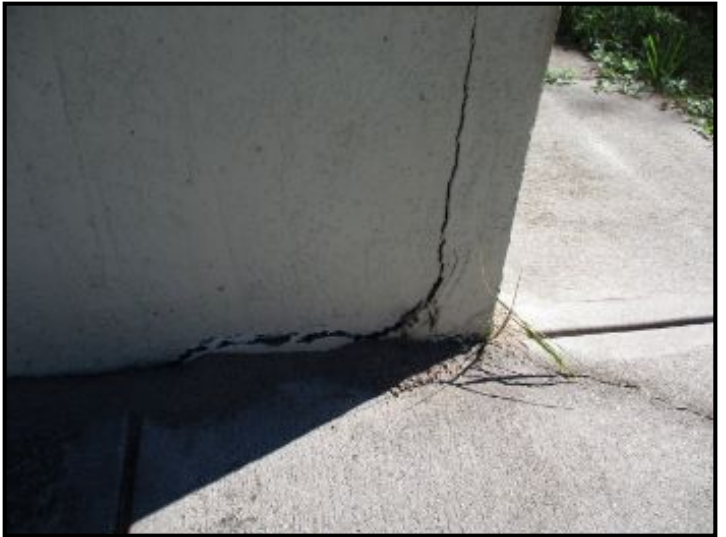
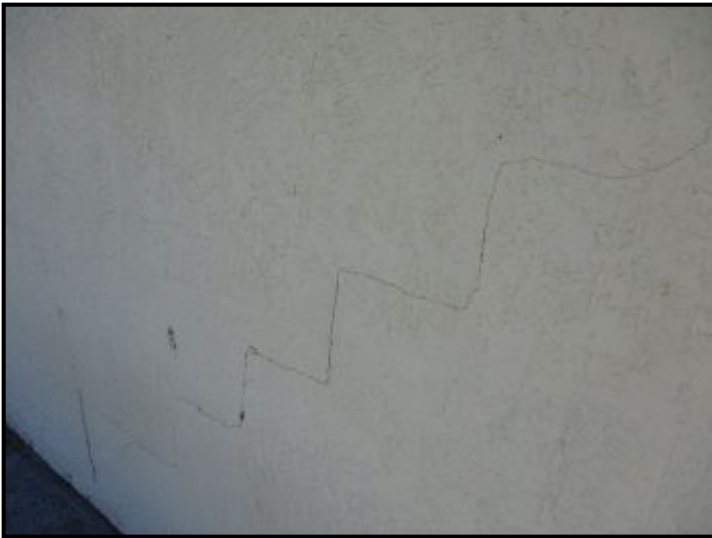
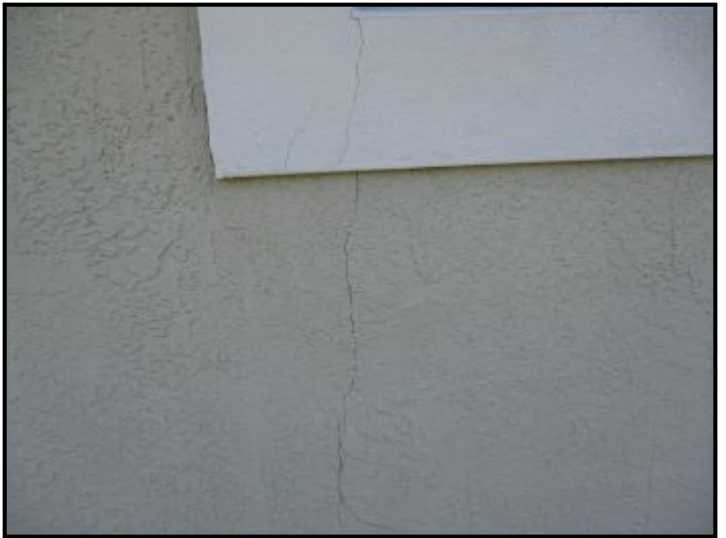
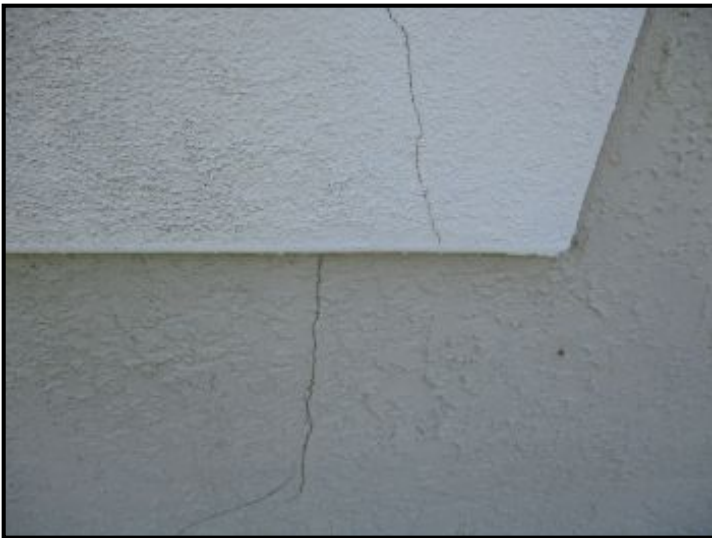
3.1. The stucco appeared in ok and serviceable condition at time of inspection. A lot cracking was observed at time of inspection. seal as soon as possible to keep water from penetrating into the interior walls.

Location: large cracks at corners of house, several smaller cracks around structure

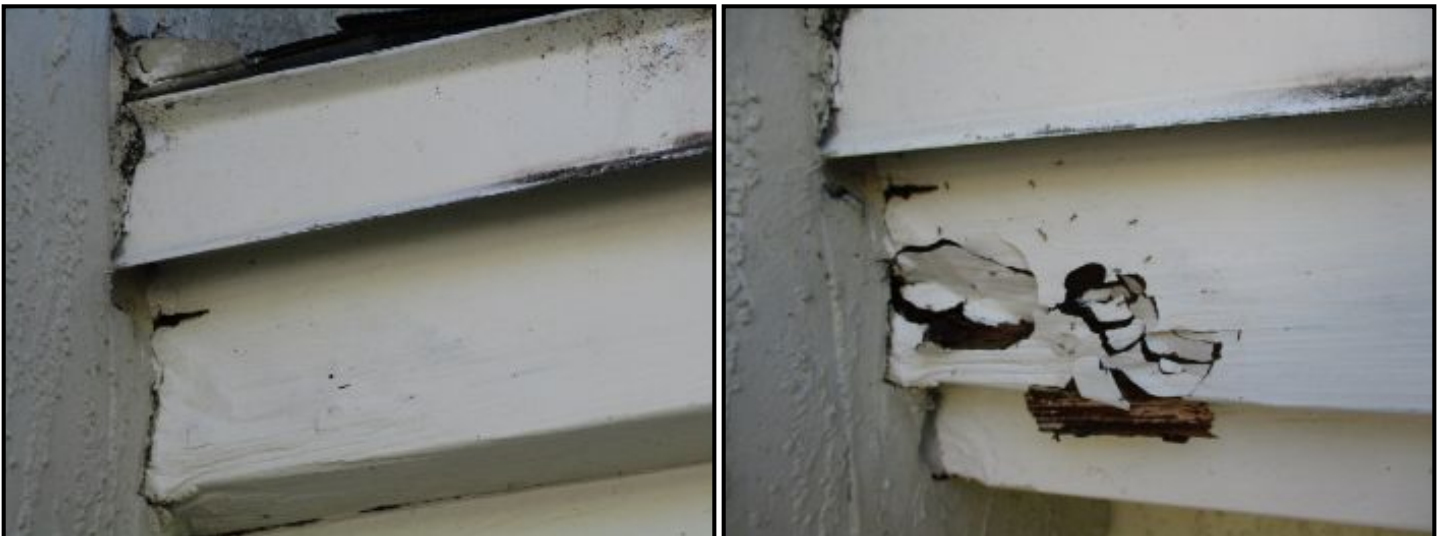
4. Eaves & Fascia

4.3. Moisture damage, wood rot, observed. Recommend review for repair as necessary. To fascia board at right of front entrance
