*Home Inspections by Paul J. Magrone Inc.*

## Inspection Conditions/ Invoice

**Building Type/ Stories:** One Story Single Family Home

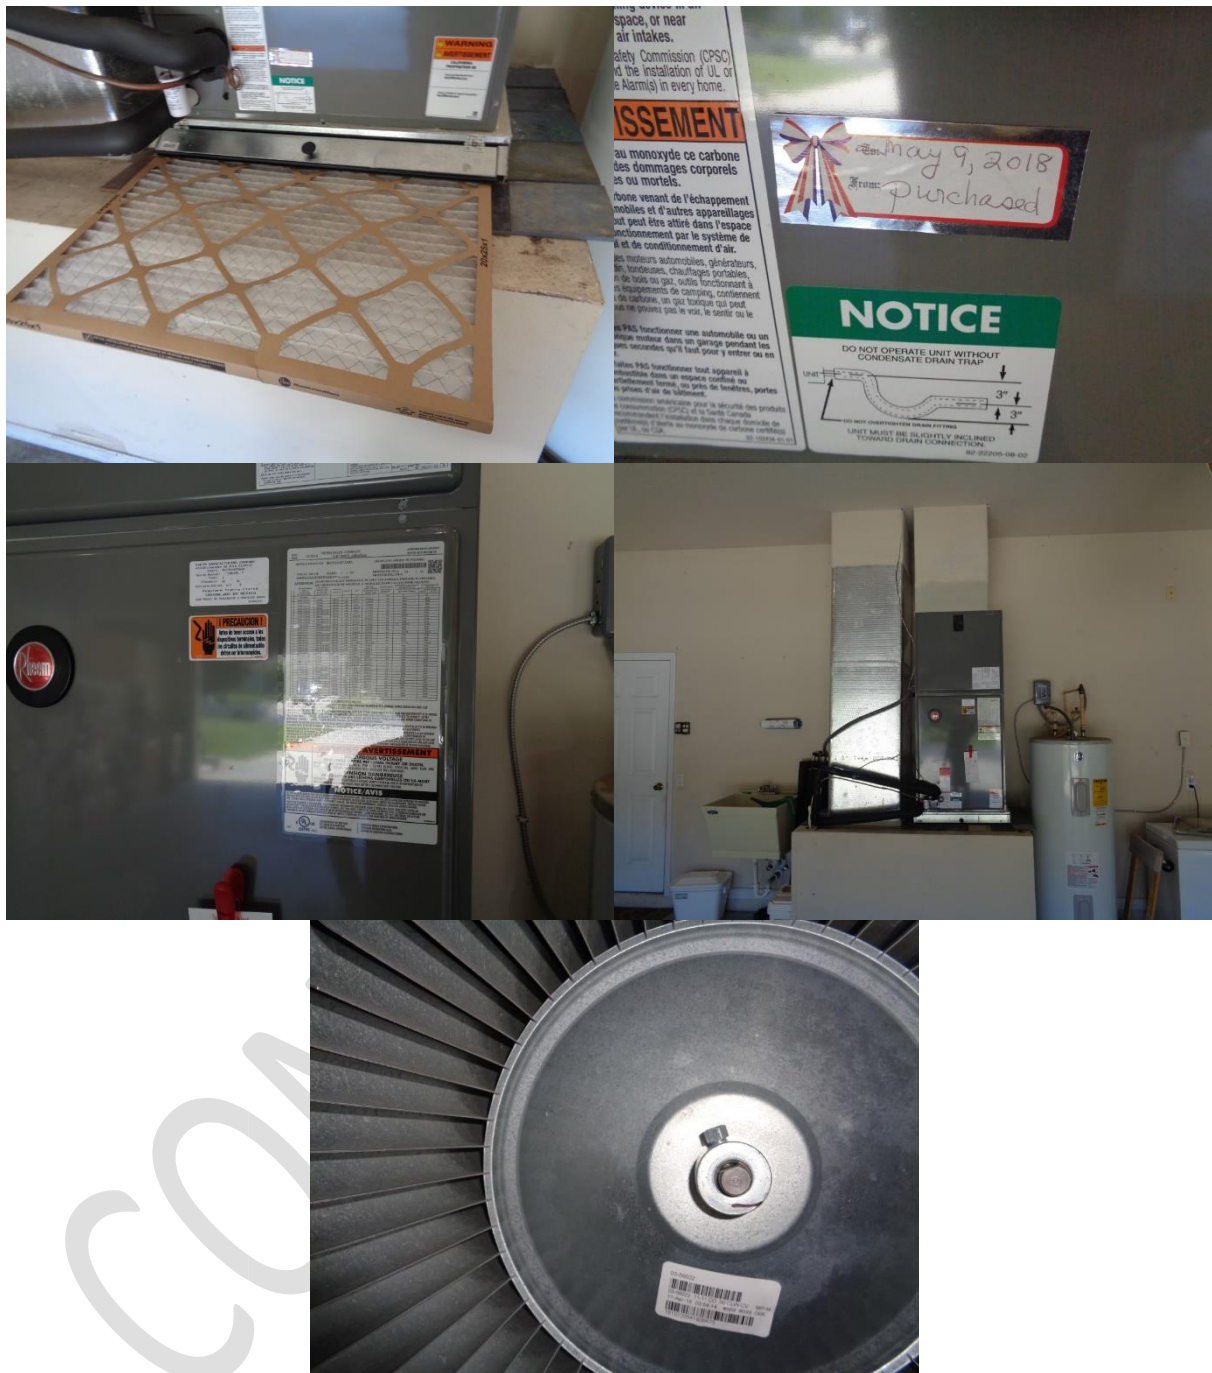
Visible and accessible components of the HVAC System appeared to be in good condition/ The system was operated in the heat and cool settings to confirm function

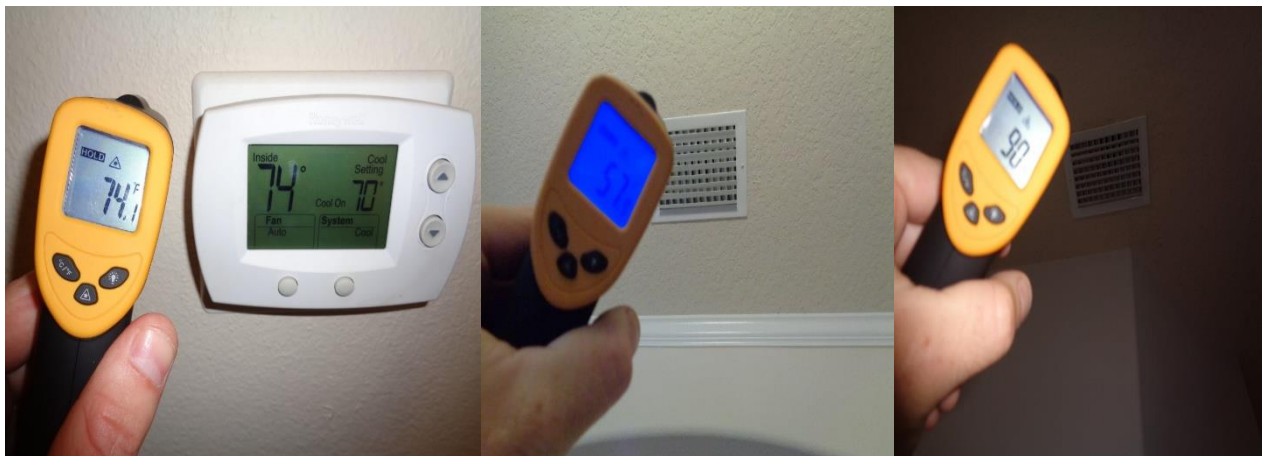
Infrared Thermometer illustrates that the system provided heating and cooling when operated from the Thermostat during the Home Inspection/ The left photo is the temperature inside the house at the Thermostat/ The middle photo is the temperature of cool air returning at the vents when the system was operated in the cool cycle/ The right photo is the temperature of hot air returning at the vents when the system was operated in the heat cycle

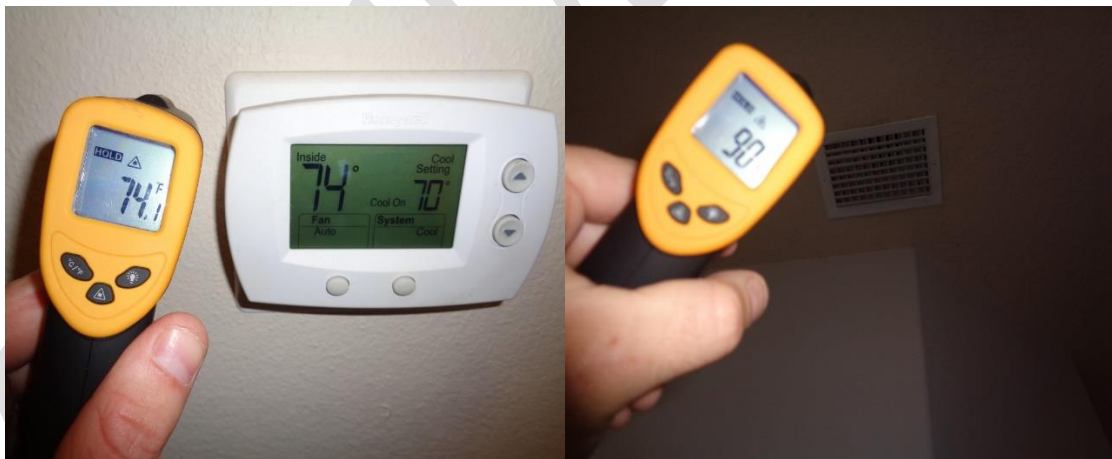
The heat function of the heat pump system did not operate correctly at time of inspection and we recommend a certified contractor evaluate the installation of the thermostat and proper function of the heat pump

- The heat function of the heat pump system did not operate correctly at time of inspection and we recommend a certified contractor evaluate the installation of the thermostat and proper function of the heat pump

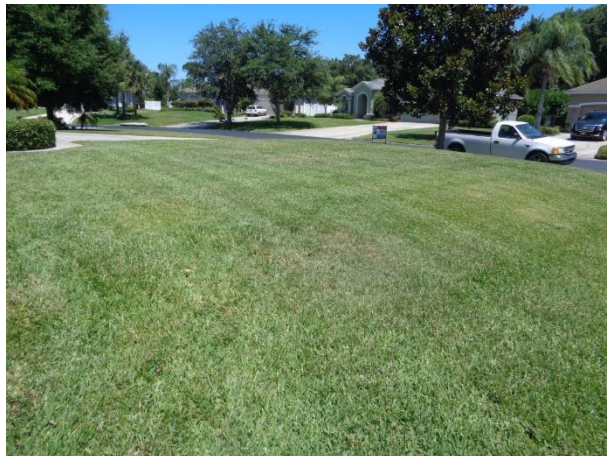
**Septic System Location:**

**Septic System Recommendations:** If there is not recent official certification documentation available from the seller, we recommend having a professional septic inspection and service performed

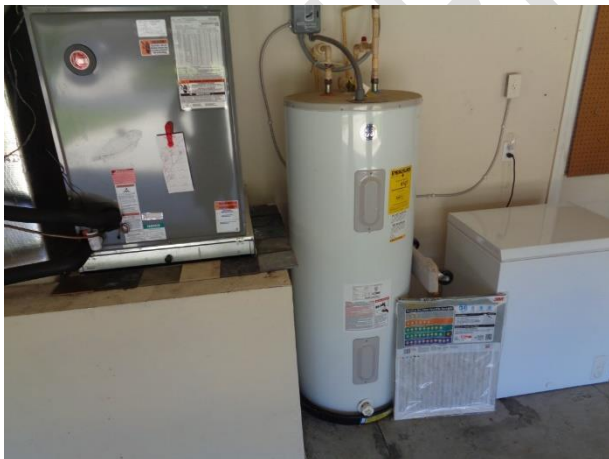
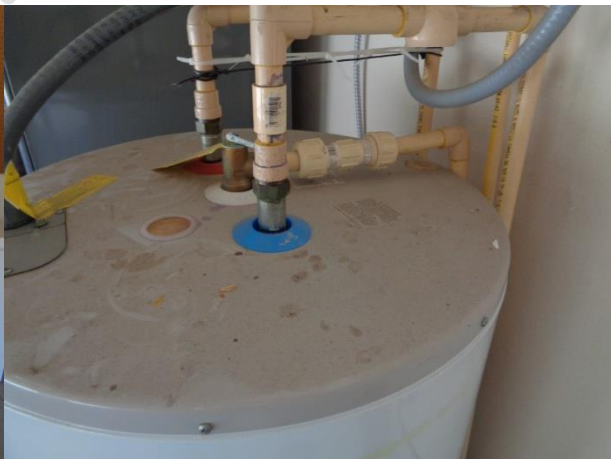
**Interior Plumbing/ Kitchen/Bathrooms/ Fixtures:** Functional/ Good condition

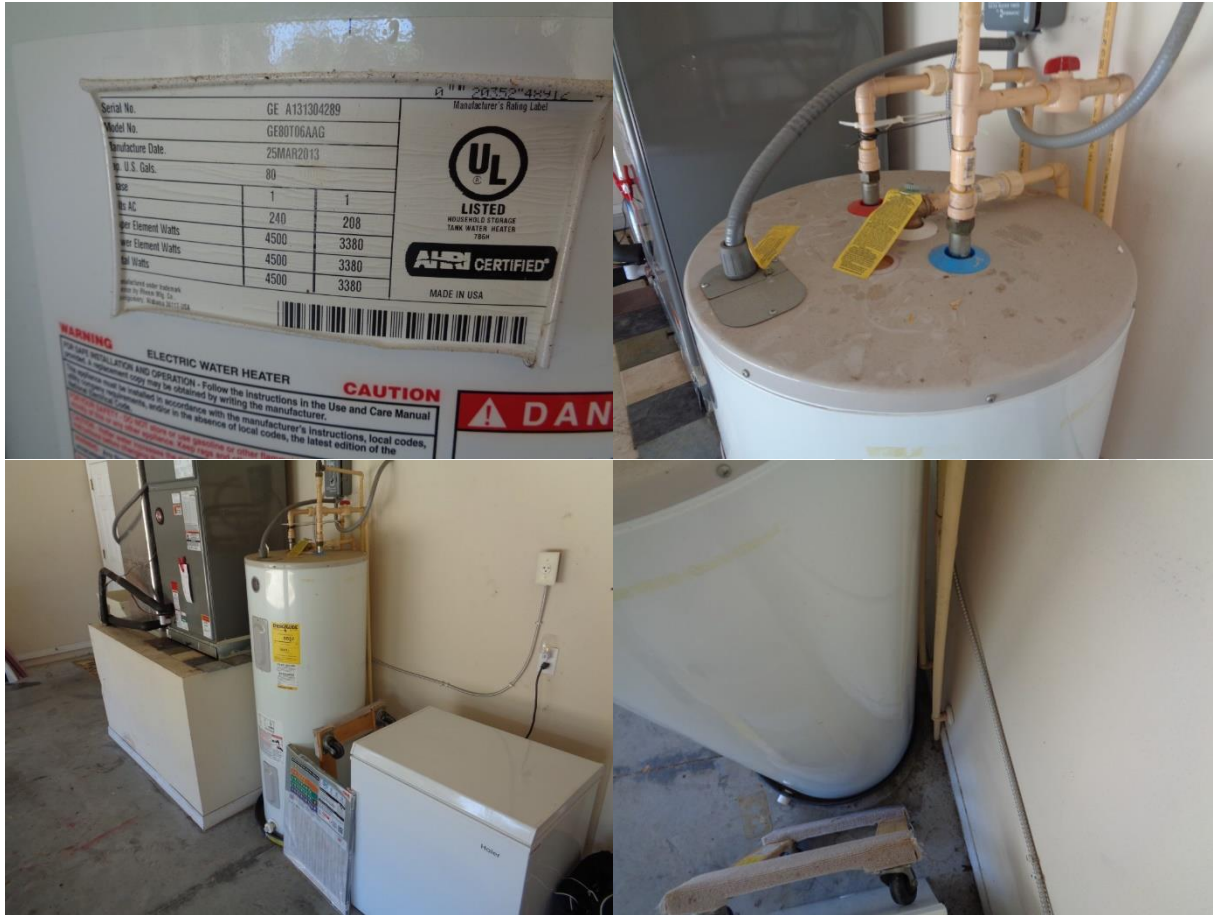
**Water Heater Fuel Type - Water Heater Manufacturer - Water Heater Size**

**Note:** The Water Heater appeared functional / good condition as it provided Hot Water to the Kitchen and Bathrooms

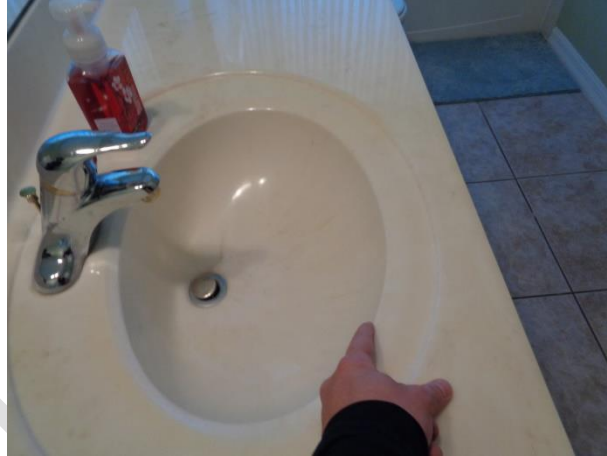
No overflow protection at the sinks throughout home at time of inspection and we recommend they are installed by a certified plumbing contractor.

- No overflow protection at the sinks throughout home at time of inspection and we recommend they are installed by a certified plumbing contractor.

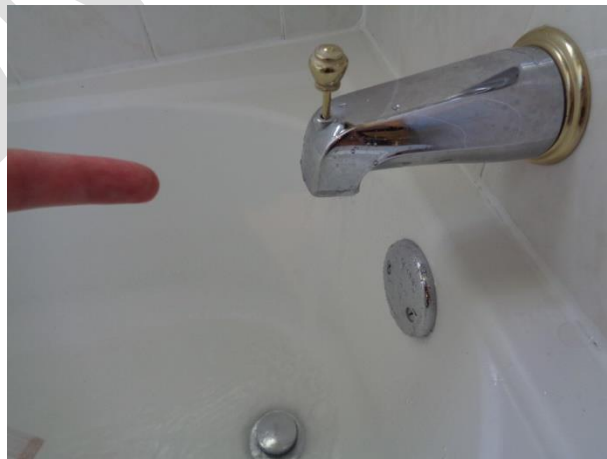
Shower diverter did not operate correctly in the southwest bathrooms should be repaired

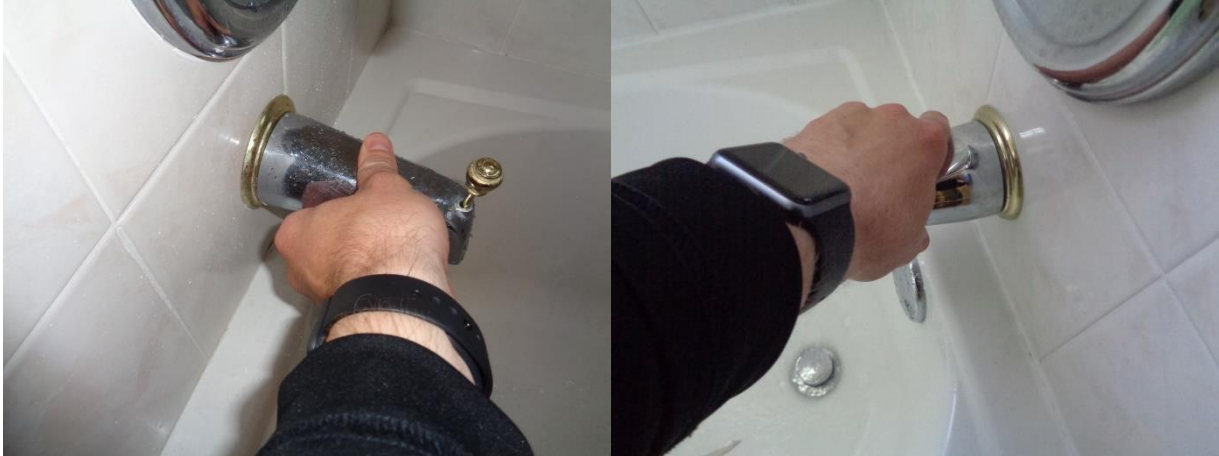
Tub faucet fixtures in both the northwest and southwest bathrooms are loose in wall and we recommend a certified plumbing contractor evaluate the systems for proper function and make any repairs necessary

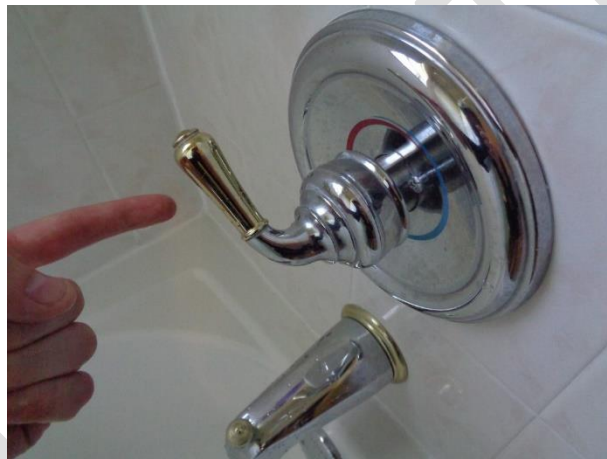
No hot water at the southwest hallway shower at time of inspection and we recommend it be evaluated by a certified plumbing technician for leaks, proper function and make any repairs necessary.

- No hot water at the southwest hallway shower at time of inspection and we recommend it be evaluated by a certified plumbing technician for leaks, proper function and make any repairs necessary.

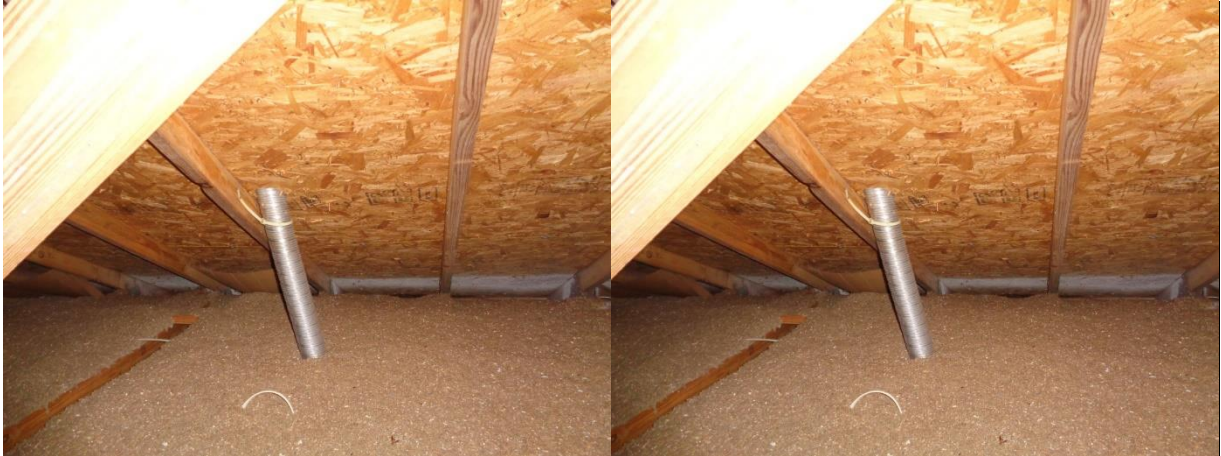
North and south hallway bathroom exhaust vent did not produce strong air flow at time of inspection and we recommend that certified general contractor evaluate the system for proper function, leaks and make any repairs necessary. Note: they appeared to be sealed in the attic area and did produce some air flow.

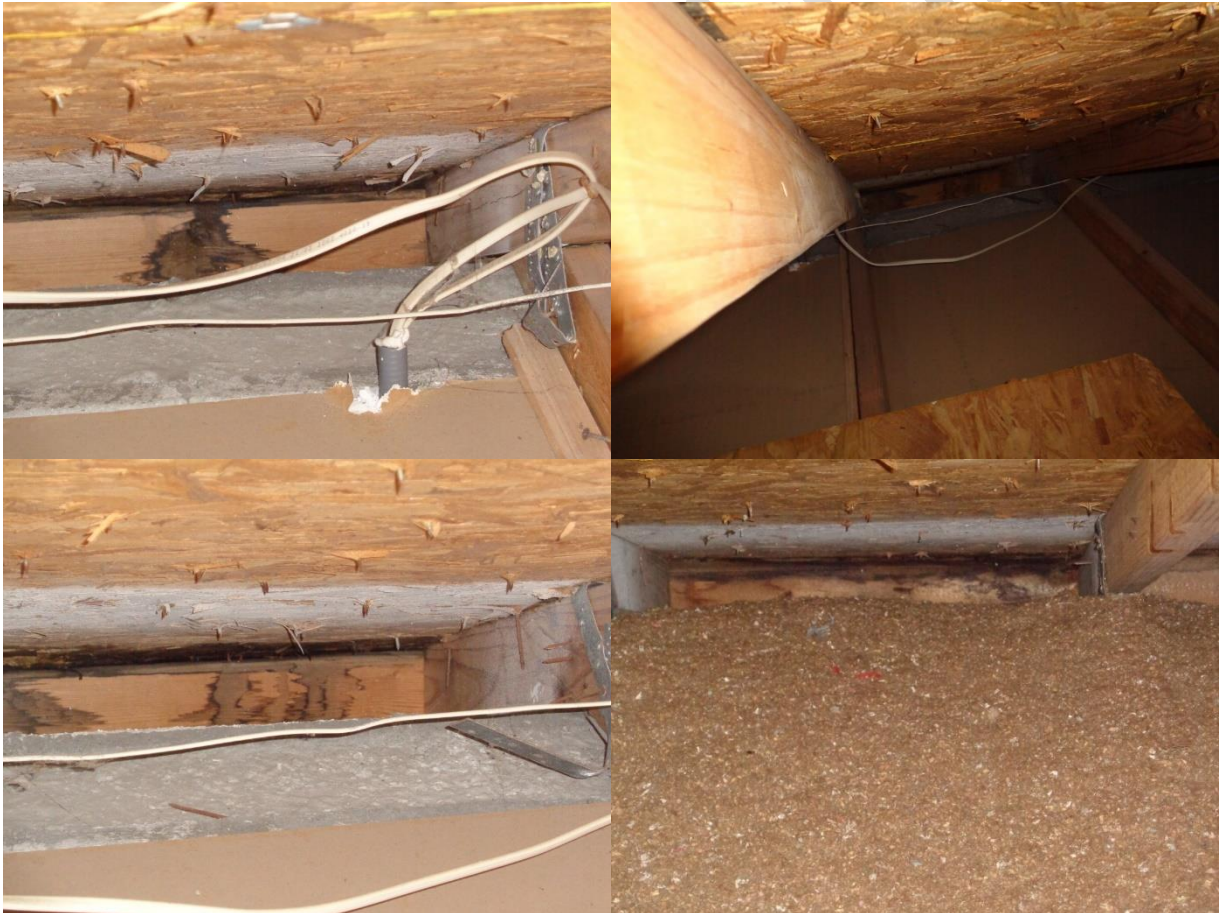
Evidence of discoloration and active moisture in the northeast and west soffit area of the attic space present at time of inspection. Discolored areas were not accessible at time of inspection and could not check it with a moisture meter. We recommend the area be evaluated by a certified contractor for proper function and make any repairs necessary

- Evidence of discoloration and active moisture in the northeast and west soffit area of the attic space present at time of inspection. Discolored areas were not accessible at time of inspection and could not check it with a moisture meter. We recommend the area be evaluated by a certified contractor for proper function and make any repairs necessary

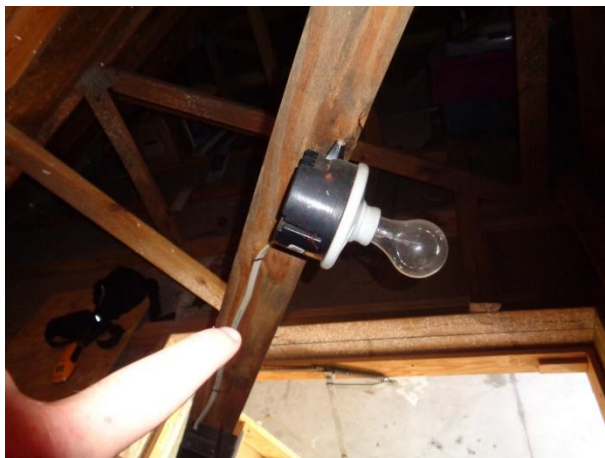
Install Light Bulb for the garage Attic Access Area Light Fixture

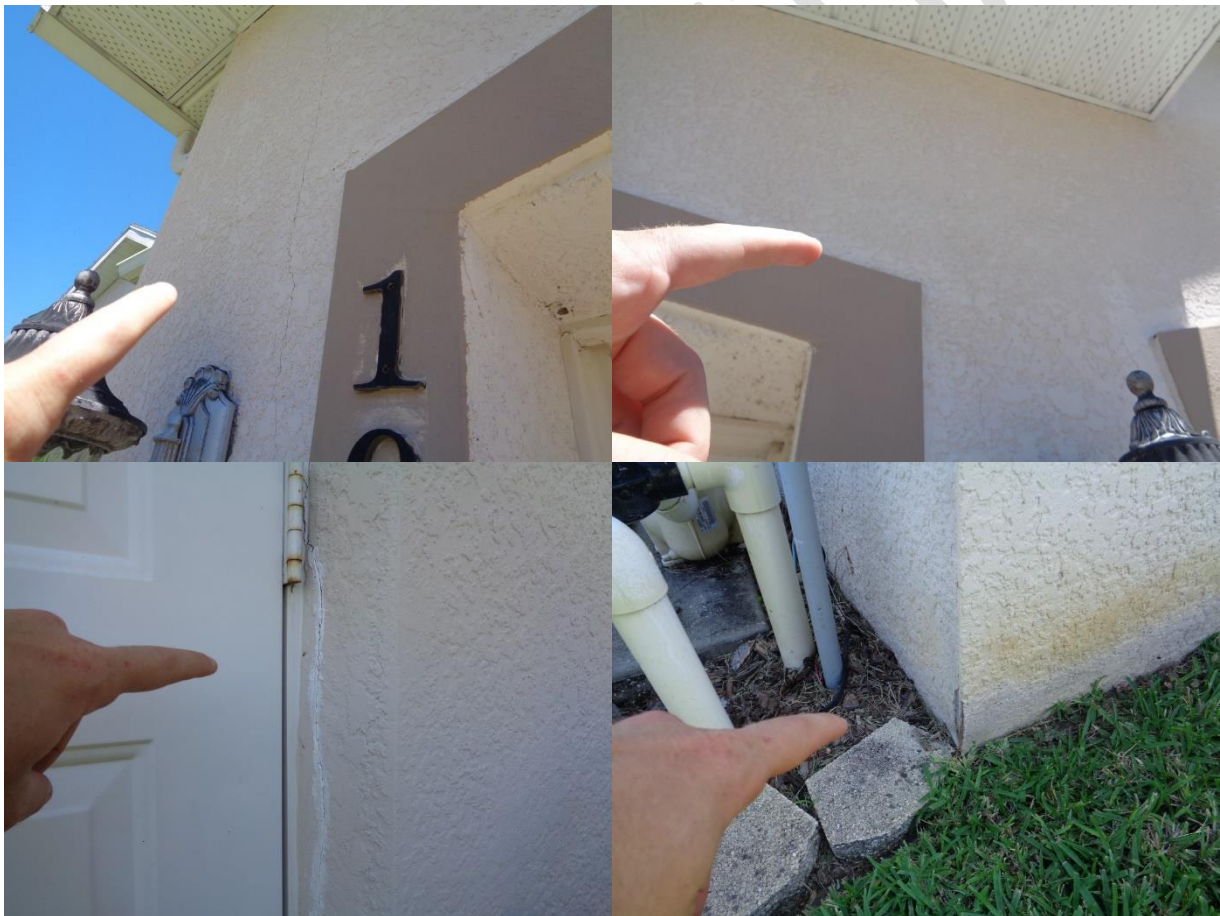
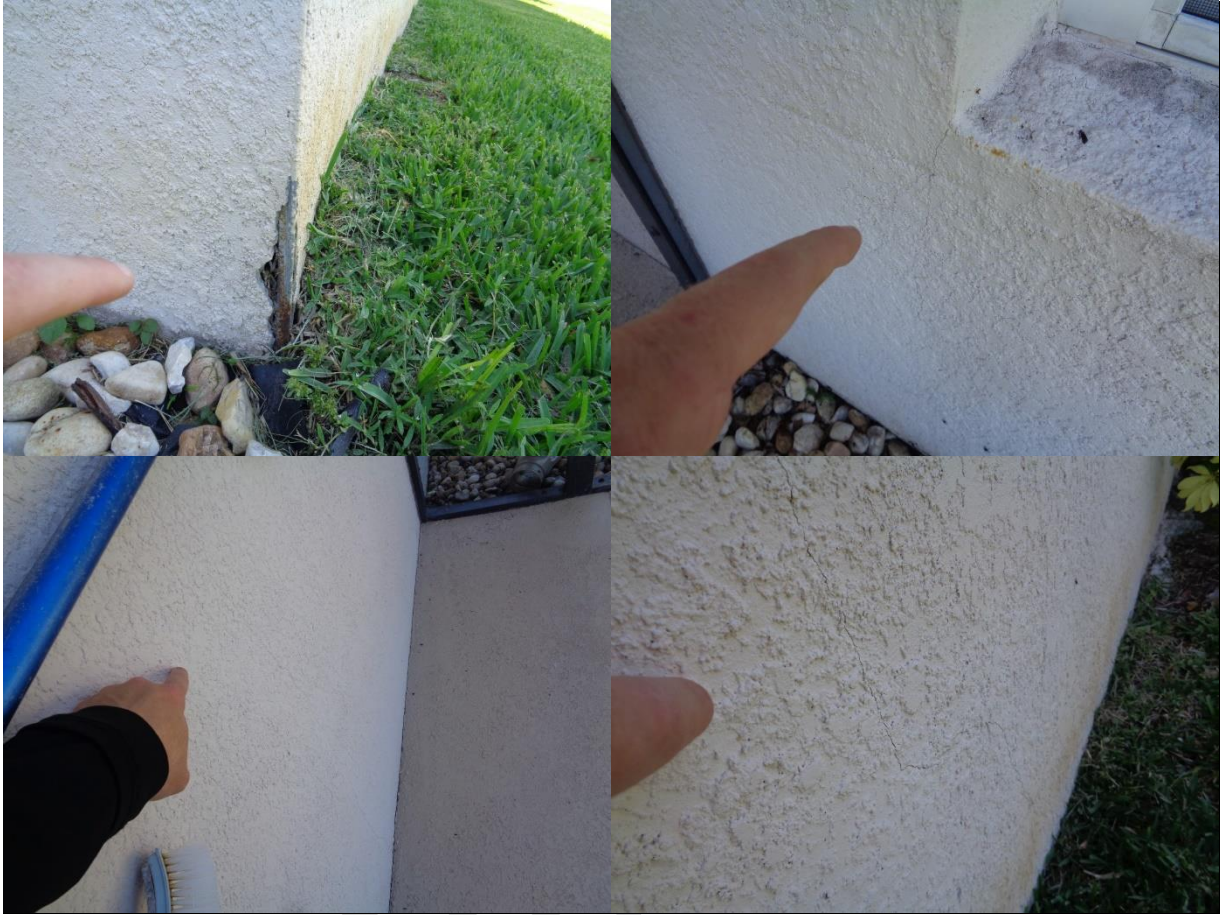
- I observed minor settlement cracks on the all sides of the home particularly near the window sills and rear porch ceiling. All cracks / area should be sealed to prevent water penetration during wind driven rains. All visible Settlement Cracks appeared within tolerance at the time of this inspection. Settlement Cracks should be sealed to prevent water penetration.

I observed minor settlement cracks on the all sides of the home particularly near the window sills and rear porch ceiling. All cracks / area should be sealed to prevent water penetration during wind driven rains. All visible Settlement Cracks appeared within tolerance at the time of this inspection. Settlement Cracks should be sealed to prevent water penetration.

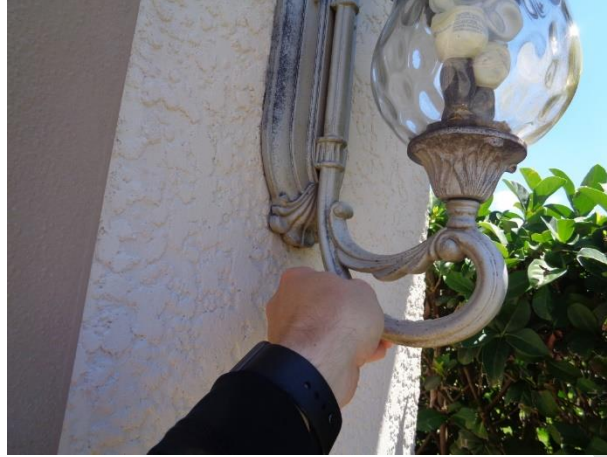
Front exterior wall mounted light fixtures were loose at time of inspections and should be secured and sealed.

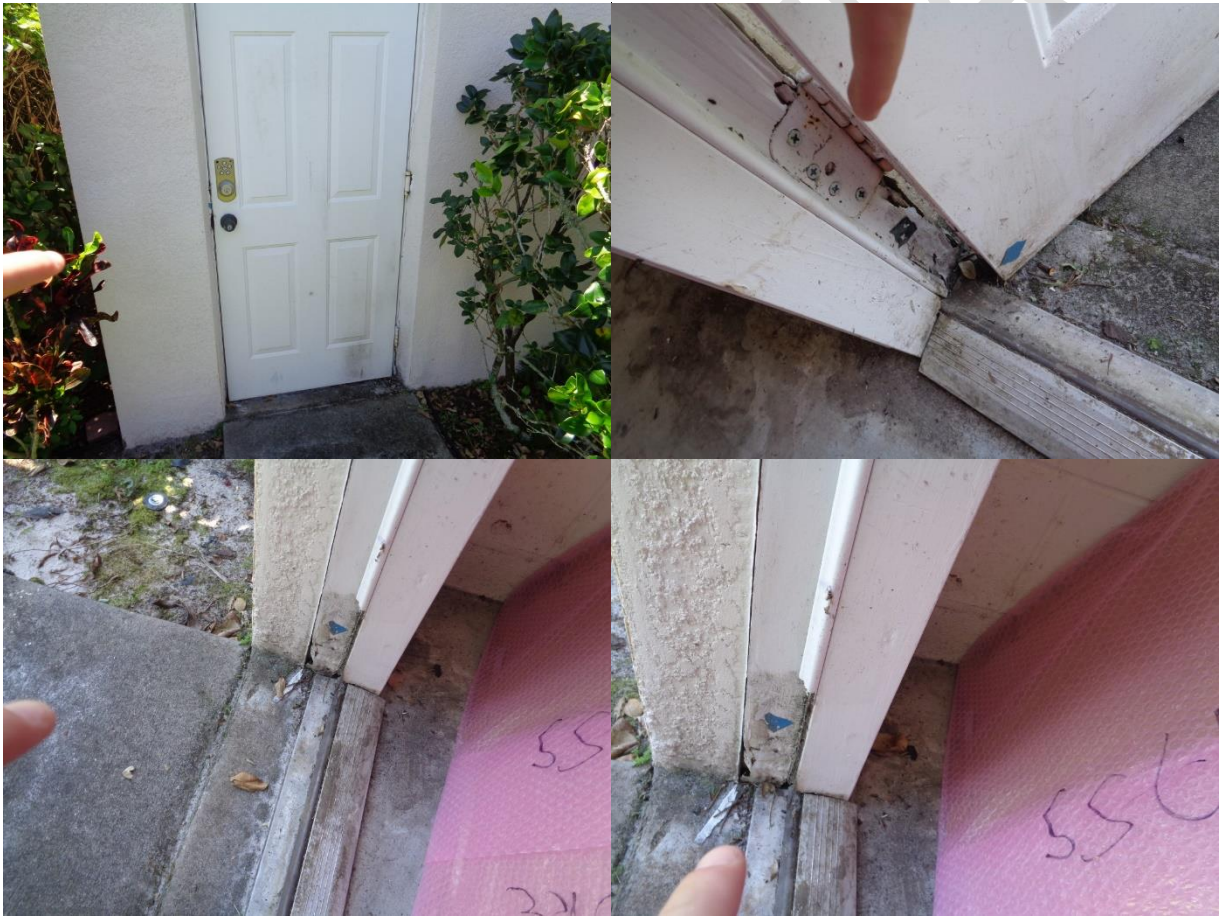
Damage trim and wood present around exterior personal garage door should be evaluated and repaired by a certified contractor.

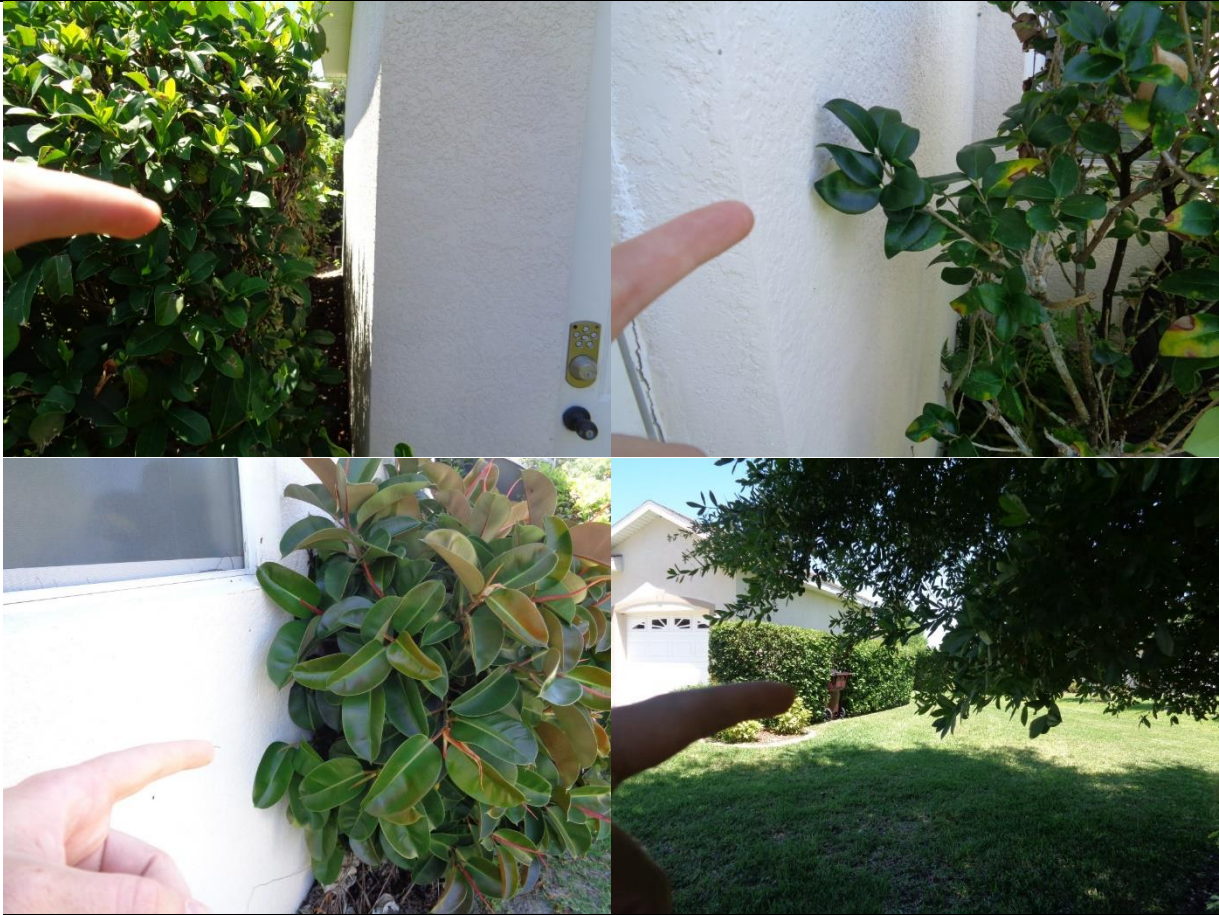
We suggest having a qualified contractor maintaining all vegetation from making contact with the exterior walls of the home, and low hanging branches. Vegetation prolongs moisture, causes premature wear of construction materials, and creates a path for unwanted insects to cross over the home's treated foundation barrier.

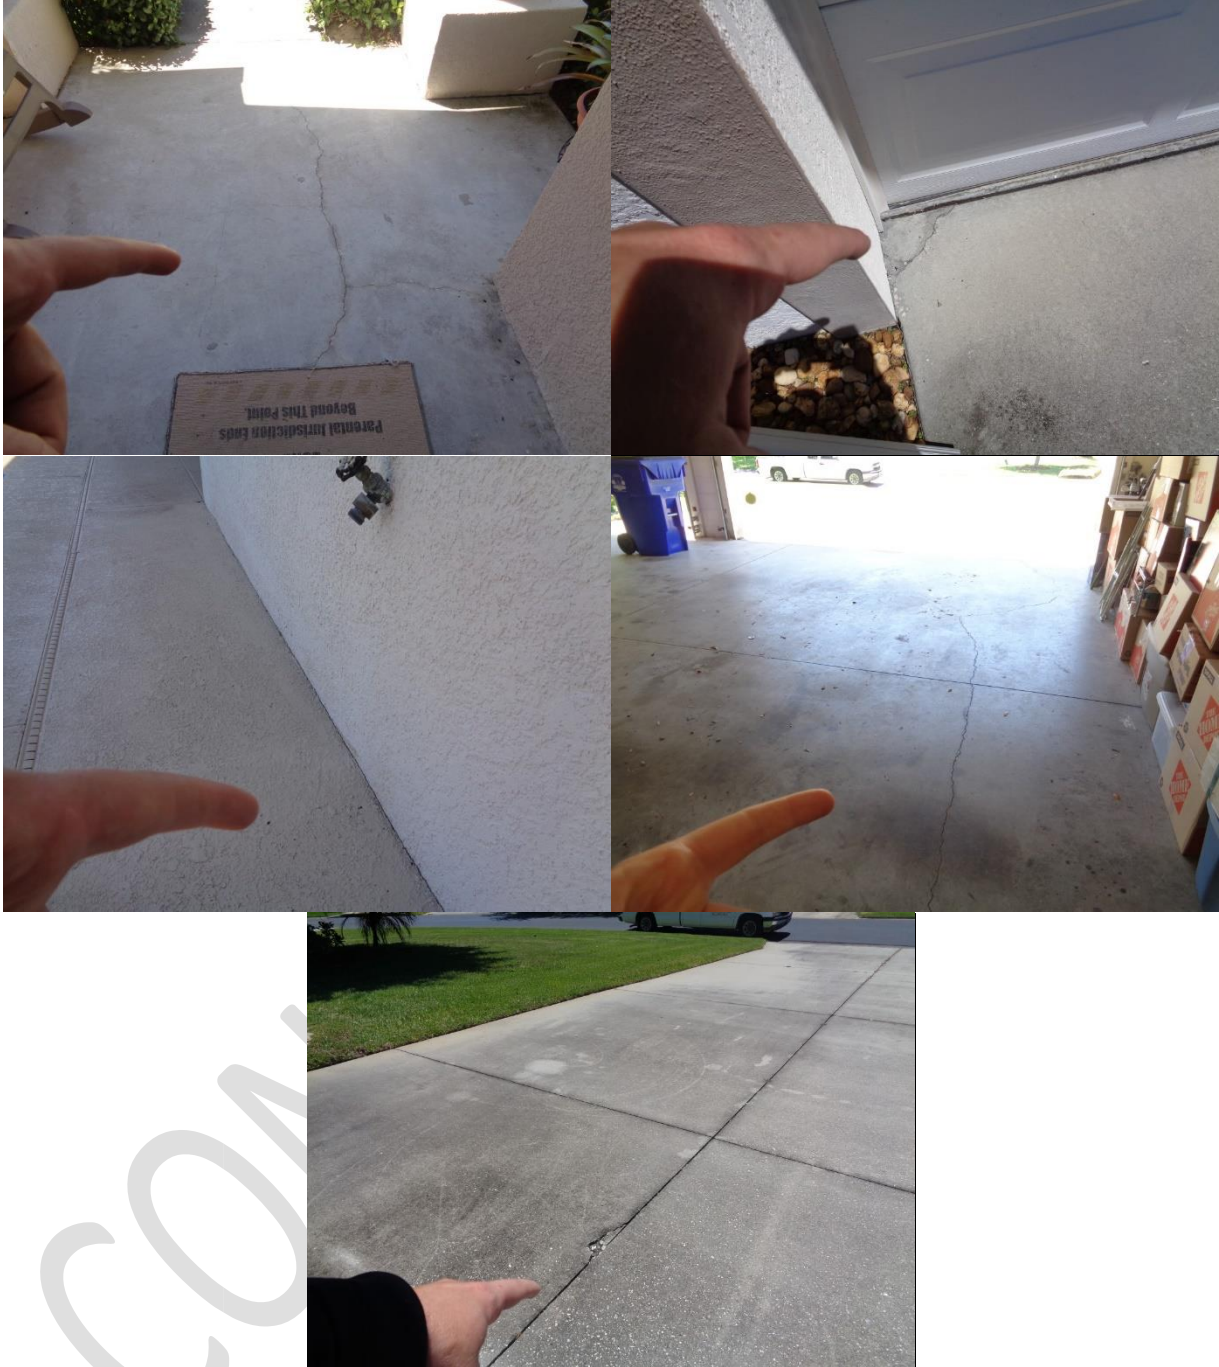
Common/ Typical Settlement cracks were observed in the driveway, garage floor rear patio and walkways. Settlement cracks are fairly typical and in most cases harmless as long as they are maintained by keeping them sealed. We recommend a certified contractor evaluate the area and make any repairs necessary.

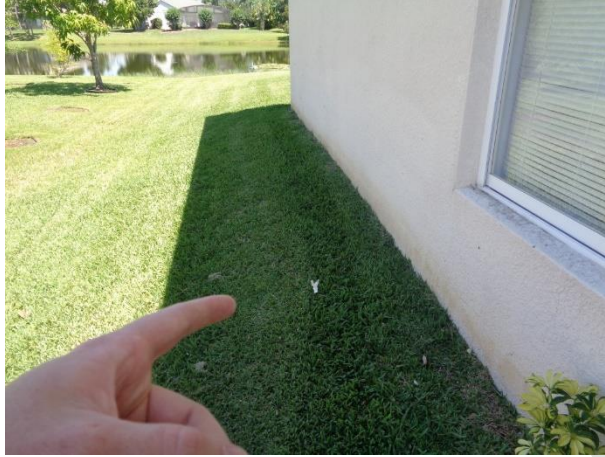
Erosion has occurred at the perimeter of the foundation. This is likely because there are not gutters / gutter diverters installed to control water runoff from the roof. Eroded areas should be filled with Gravel and stabilized. I would suggest adding gutters / gutter diverters to this home to help redirect rainwater from the foundation of the home.

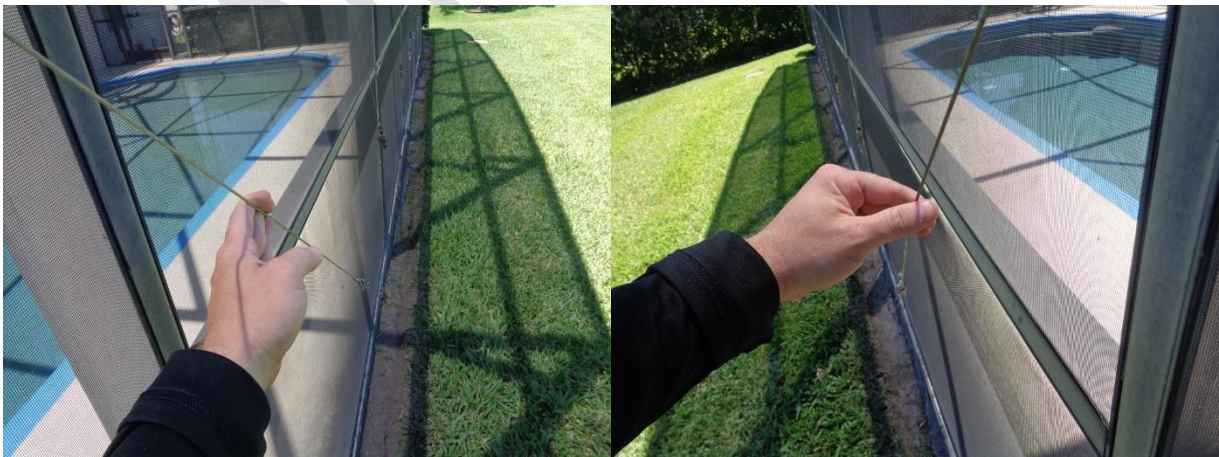
Hurricane straps appear to have evidence of rust present and appear to be loose. We recommend that a certified contractor evaluate the hurricane straps for proper function and make any repairs necessary

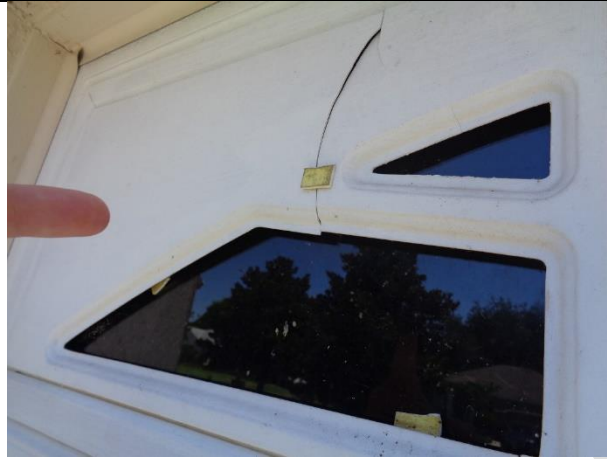
Damage to garage door window frame present at time of inspection and should be repaired

- Damage to garage door window frame present at time of inspection and should be repaired.

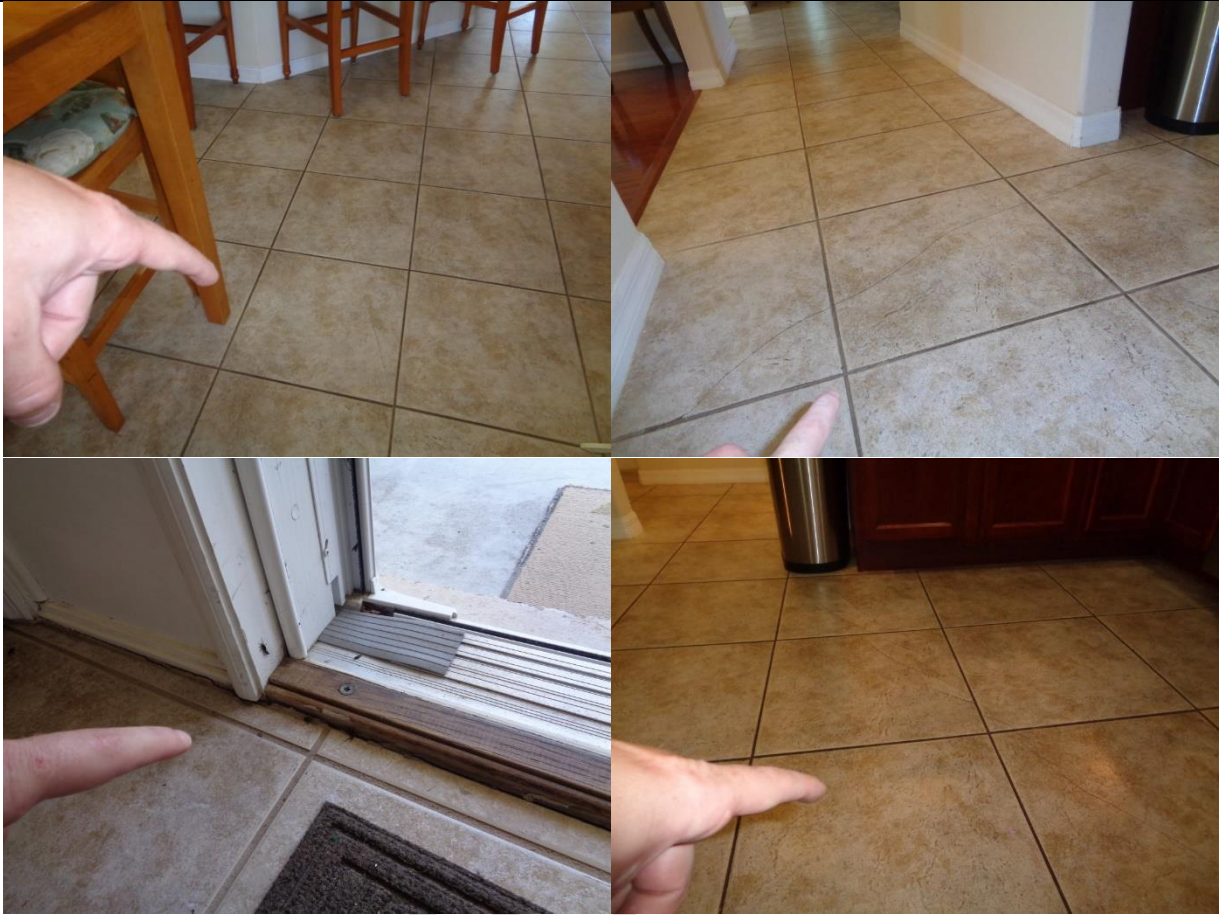
Crack in grout at the front door and crack in tile throughout the kitchen area at time of inspection and we recommend a certified contractor evaluate the windows for proper function and make any repairs necessary

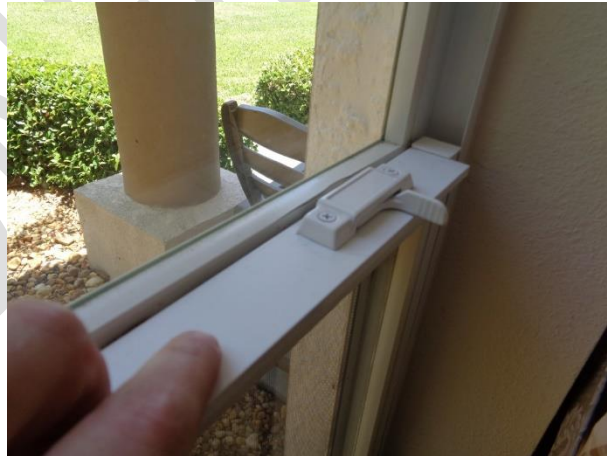
Window in the dining room did not close / operate correctly at time of inspection and we recommend a certified contractor evaluate the windows for proper function and make any repairs necessary

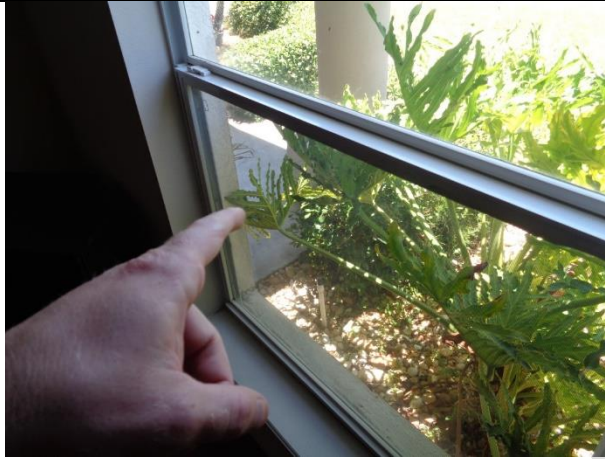
Window in the west entry room did not stay open / operate correctly at time of inspection and we recommend a certified contractor evaluate the windows for proper function and make any repairs necessary

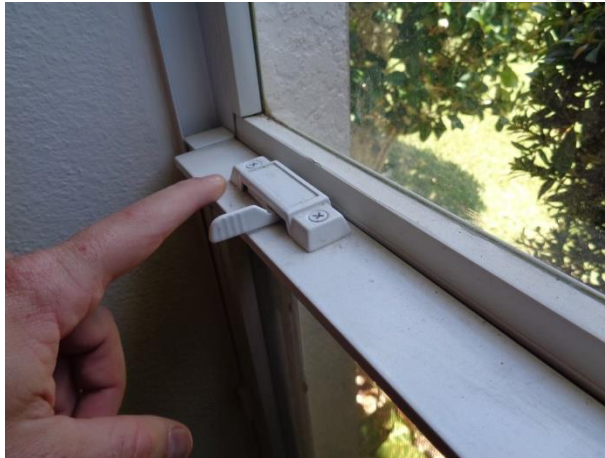
Window in the southwest bedroom did not lock / operate correctly at time of inspection and we recommend a certified contractor evaluate the windows for proper function and make any repairs necessary

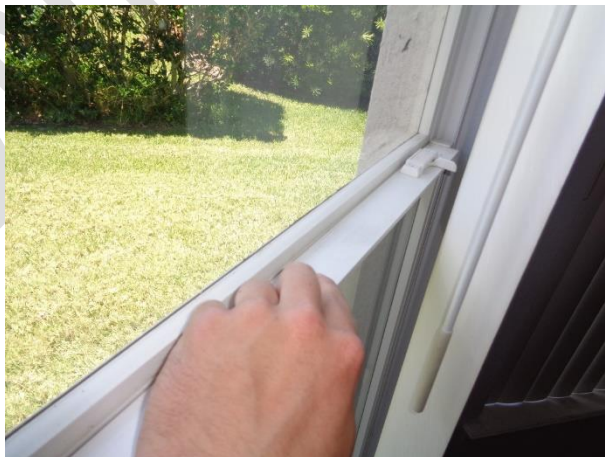
West bay window in the kitchen did not lock / operate correctly at time of inspection and we recommend a certified contractor evaluate the windows for proper function and make any repairs necessary

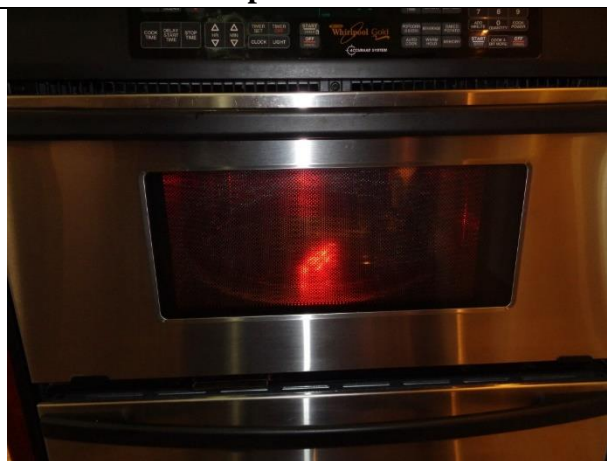
Built in microwave oven turn table did not rotate at time of inspection and we recommend verifying proper operation with the previous owner before occupancy

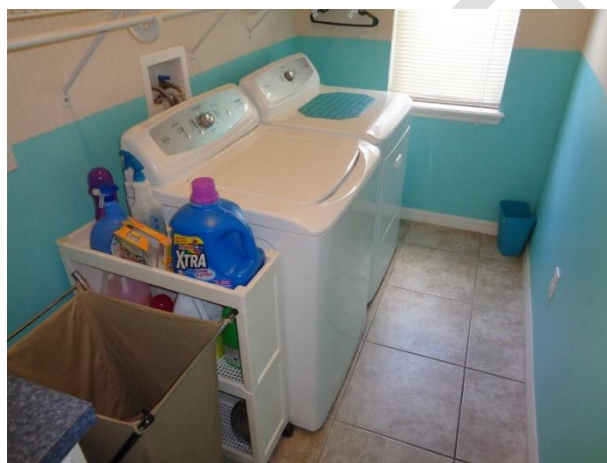
We recommend putting a Water pan underneath the Washing Machine to prevent damage inside the Home in the event of leaking from the Washing Machine. The Pan should be connected to conduit that terminates at the exterior of the building/ This recommendation is to protect the flooring in the Laundry Room

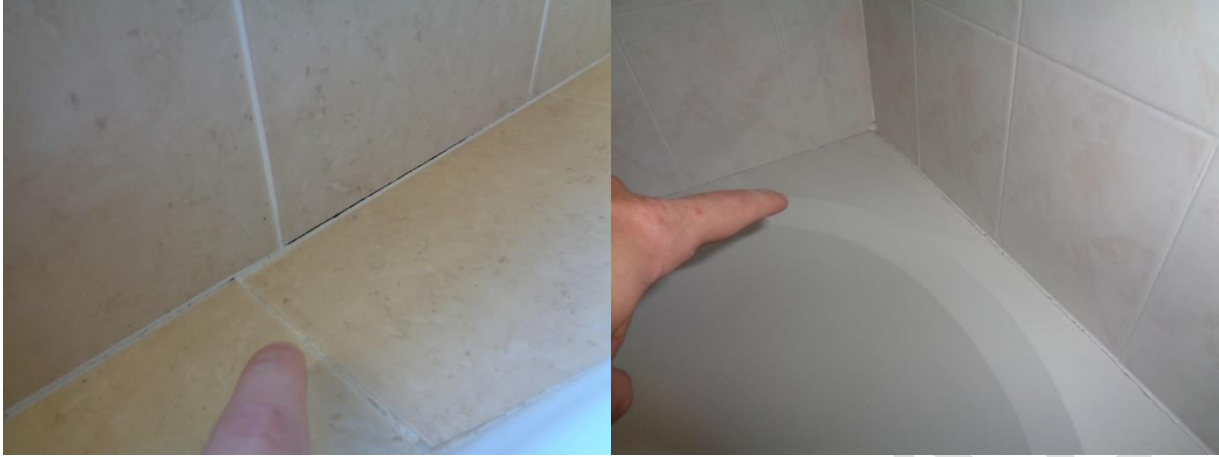
The Kitchen and Bathrooms have not been recently maintained/ we recommend having these Counter, Shower, Floor, and Tub Areas serviced prior to regular use. Re-caulking and Grouting is recommended at multiple areas at this time.

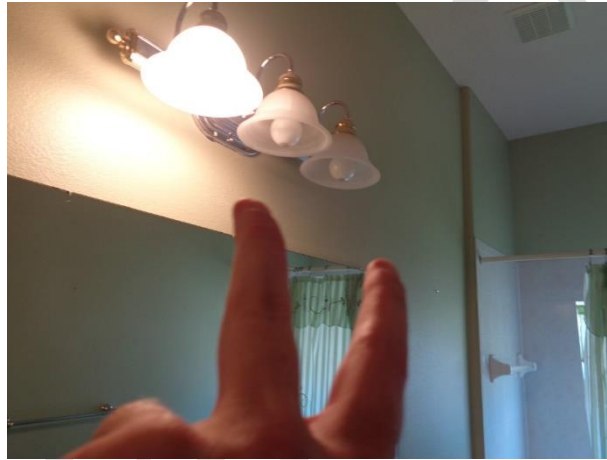
Bulb missing or did not illuminate in southwest bathroom at time of inspection and should be replaced

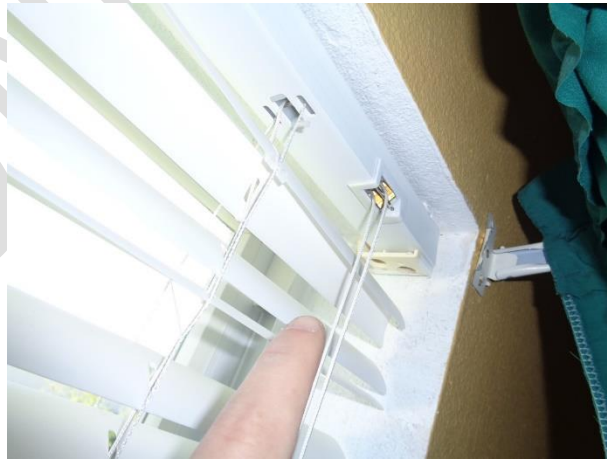
Blinds in the west bedroom did not operate correctly at time of inspection and should be repaired or replaced

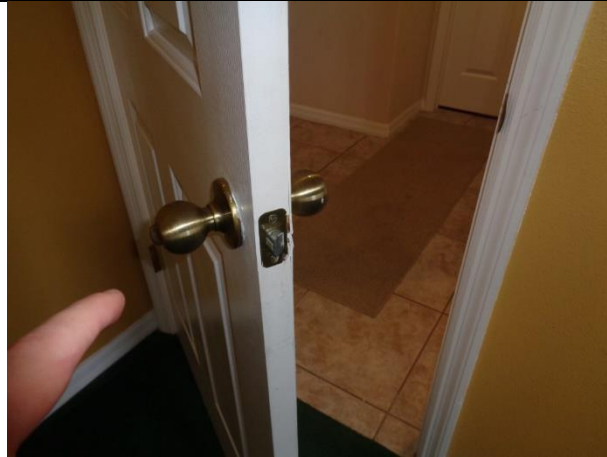
Locking mechanism for the door handle in the west bedroom did not lock at time of inspection and should be repaired

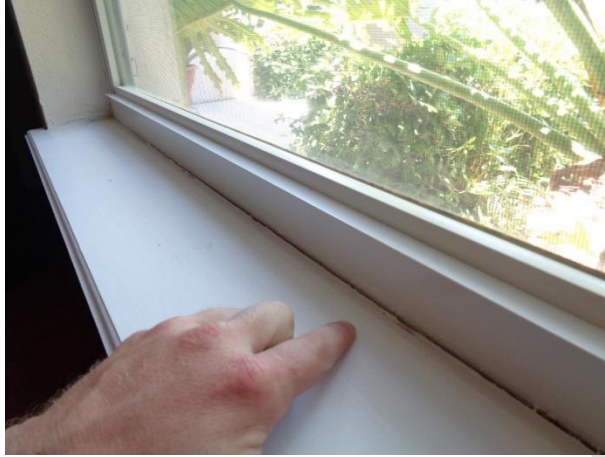
Settlement cracks present in the window corners of the dining room and west entry room at time of inspection and should be repaired. Note: the cracks appeared to be cosmetic in nature

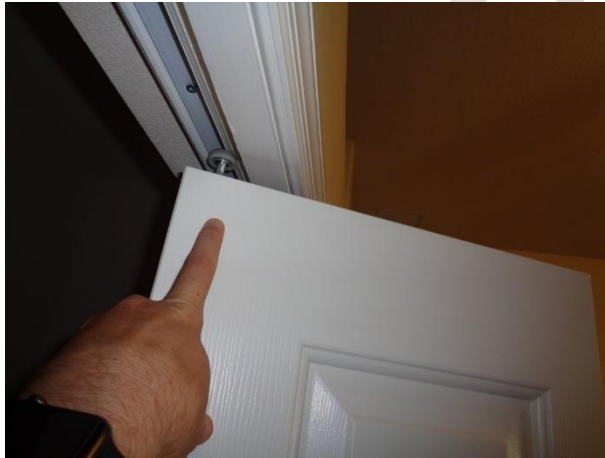
Bi-fold door was not hung properly in the southwest bedroom at time of inspection and should be repaired

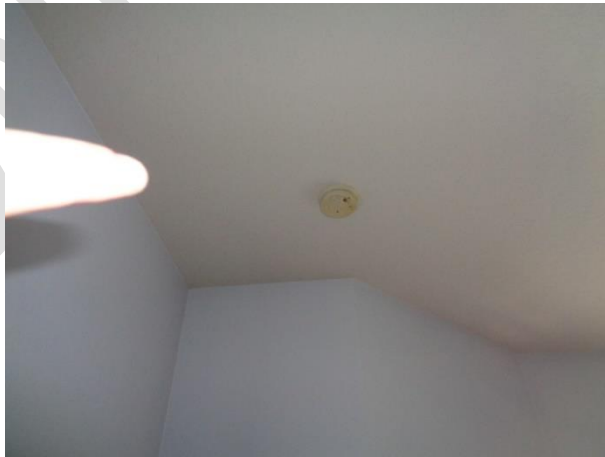
Smoke Detectors had missing batteries at time of inspection and should be installed in the home according to current standards
