*Home Inspections by Paul J. Magrone Inc.*

## Inspection Conditions/ Invoice

**Building Type/ Stories:** One Story Single Family Home

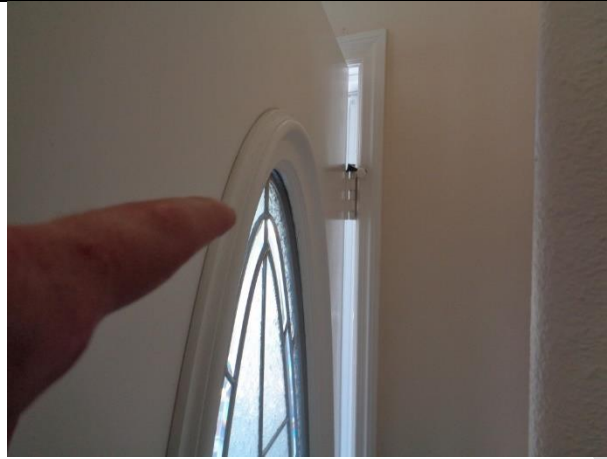
Door stopper did not operate correctly at the front door at time of inspection and should be repaired

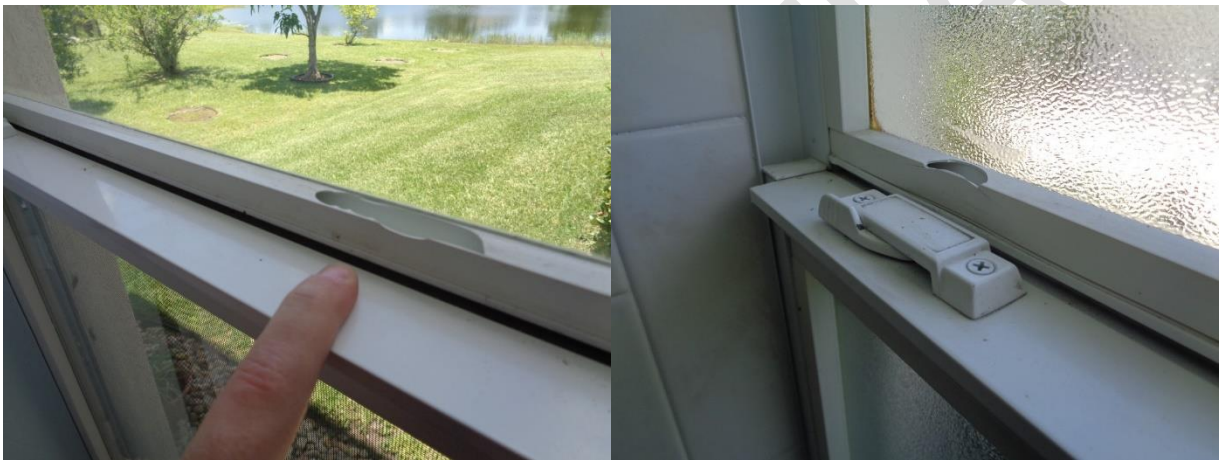
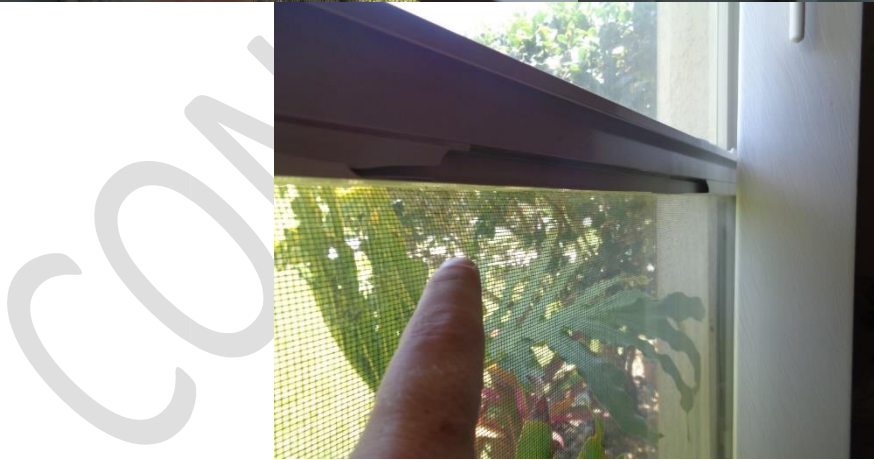
Damage to window frames present throughout home at time of inspection and should be repaired. Note: the cracks appeared to be cosmetic in nature

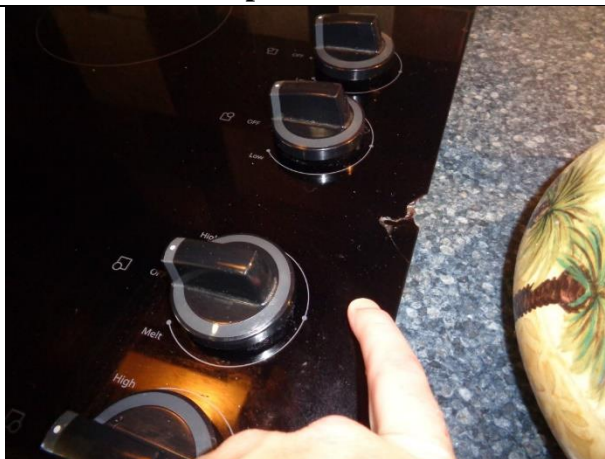
Damage to the stove top present at time of inspection and should be repaired

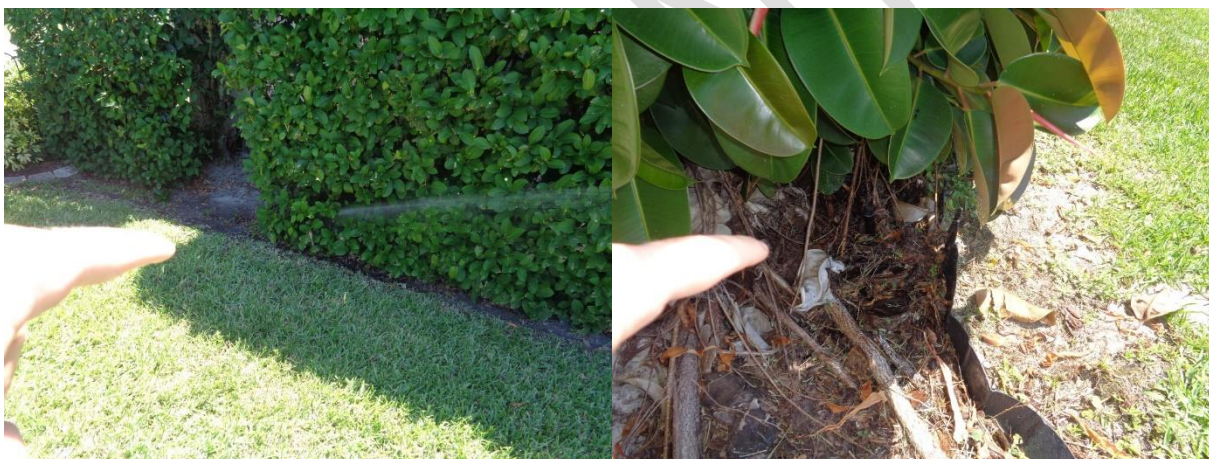
The Irrigation System heads should be serviced from obstruction of vegetation and redirected prior to regular use of the system to not wet: walk ways, driveway, street and the exterior walls of the house

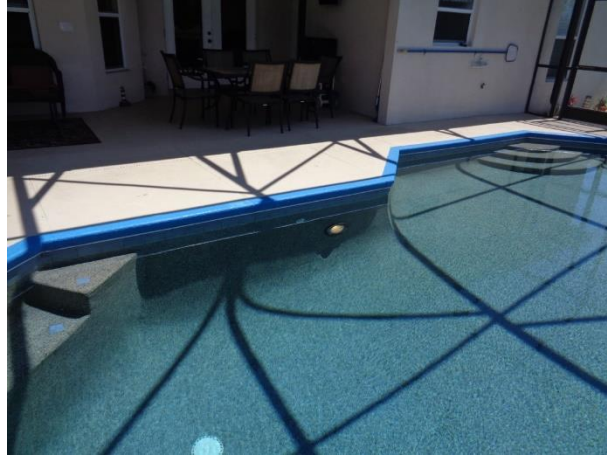
One crack noted on the southwest and north side of the pool's patio surface present and should be sealed

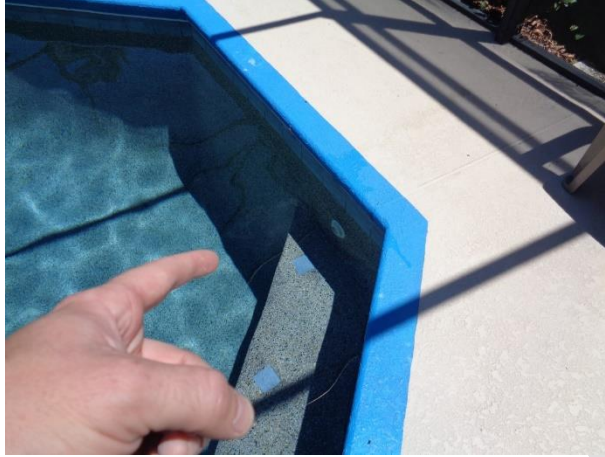
Damage to jet on the south east side of the pool present at time of inspection and should be repaired
