Home Inspection Report

1234 Sample Report
Fort Lauderdale, FL 33308

Inspection Date: January 1, 2017 | 9:00 AM

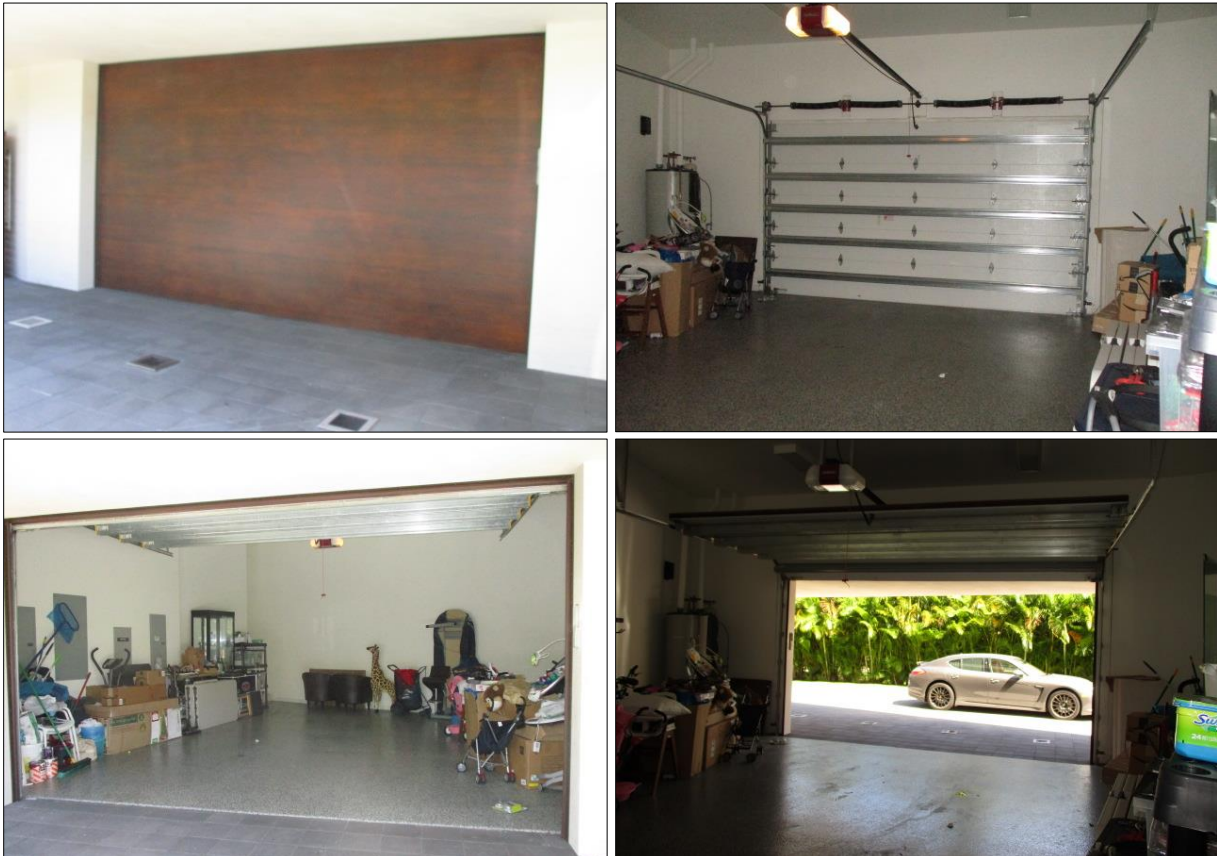
Entry Door & Garage Door

I operated the Garage Door and Opener. The Opener appeared functional as did the Garage Door. The Safety Reverse (Photoelectric Sensor) was tested and appeared functional.

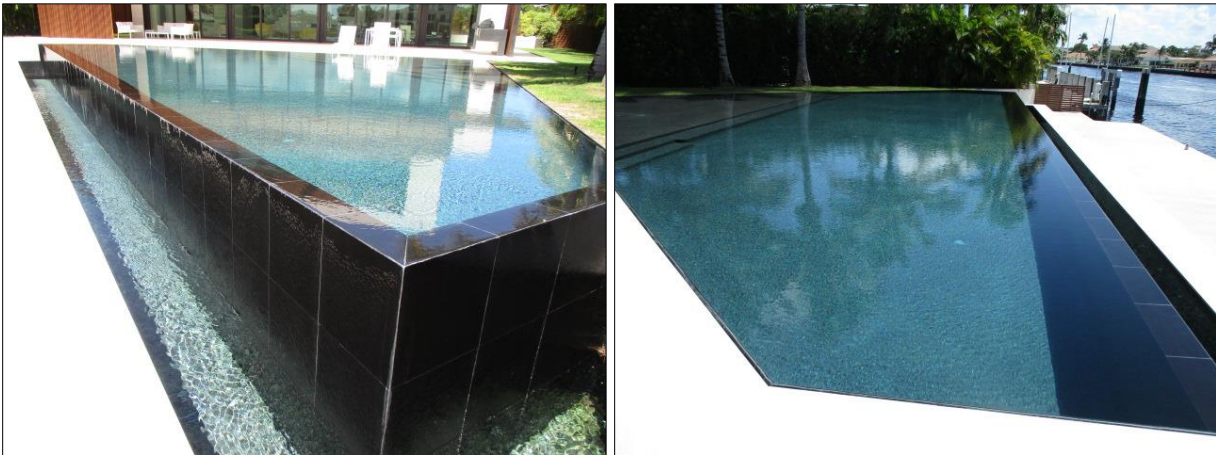
The Pool Water and Surface appeared to be in well maintained condition

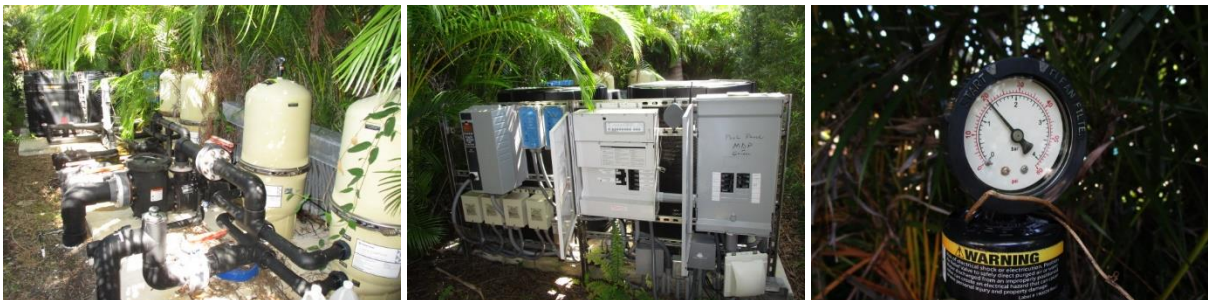
The Pool Pumps, Filters and Control Panels appeared functional

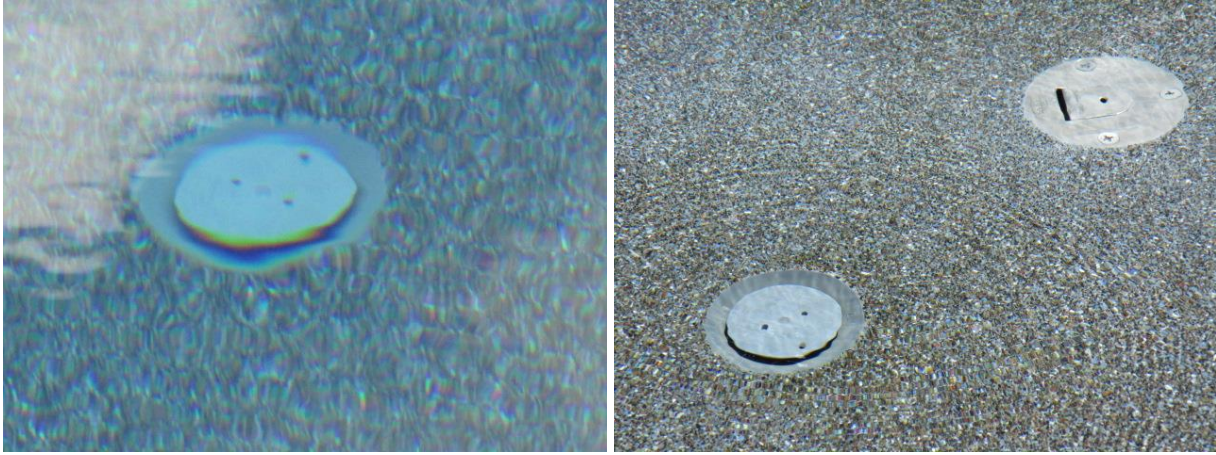
The Drain Covers were in good condition

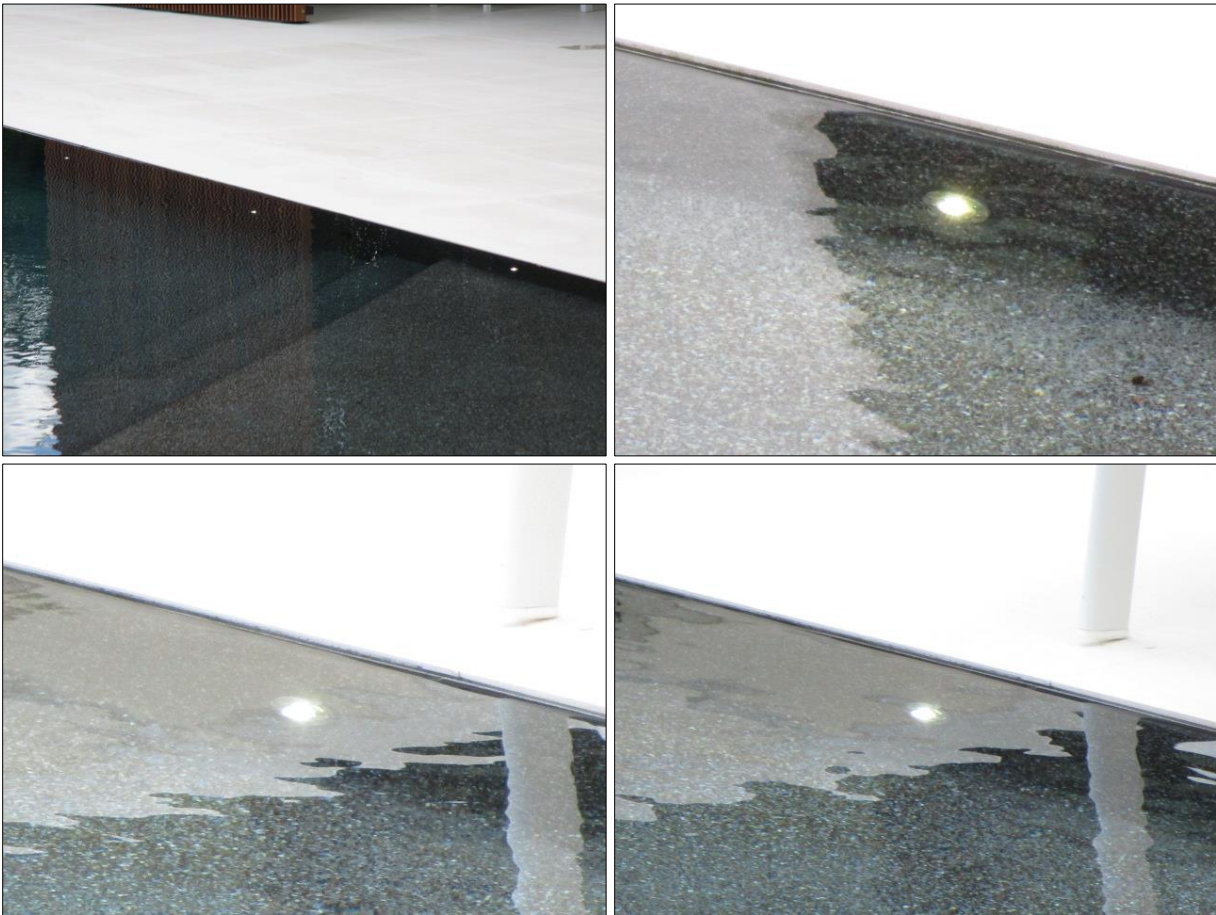
The Pool Lights were functional

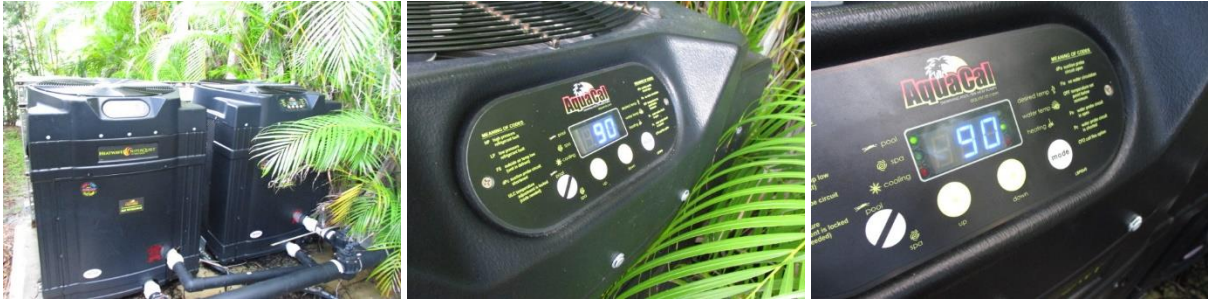
The Pool Heaters were functional

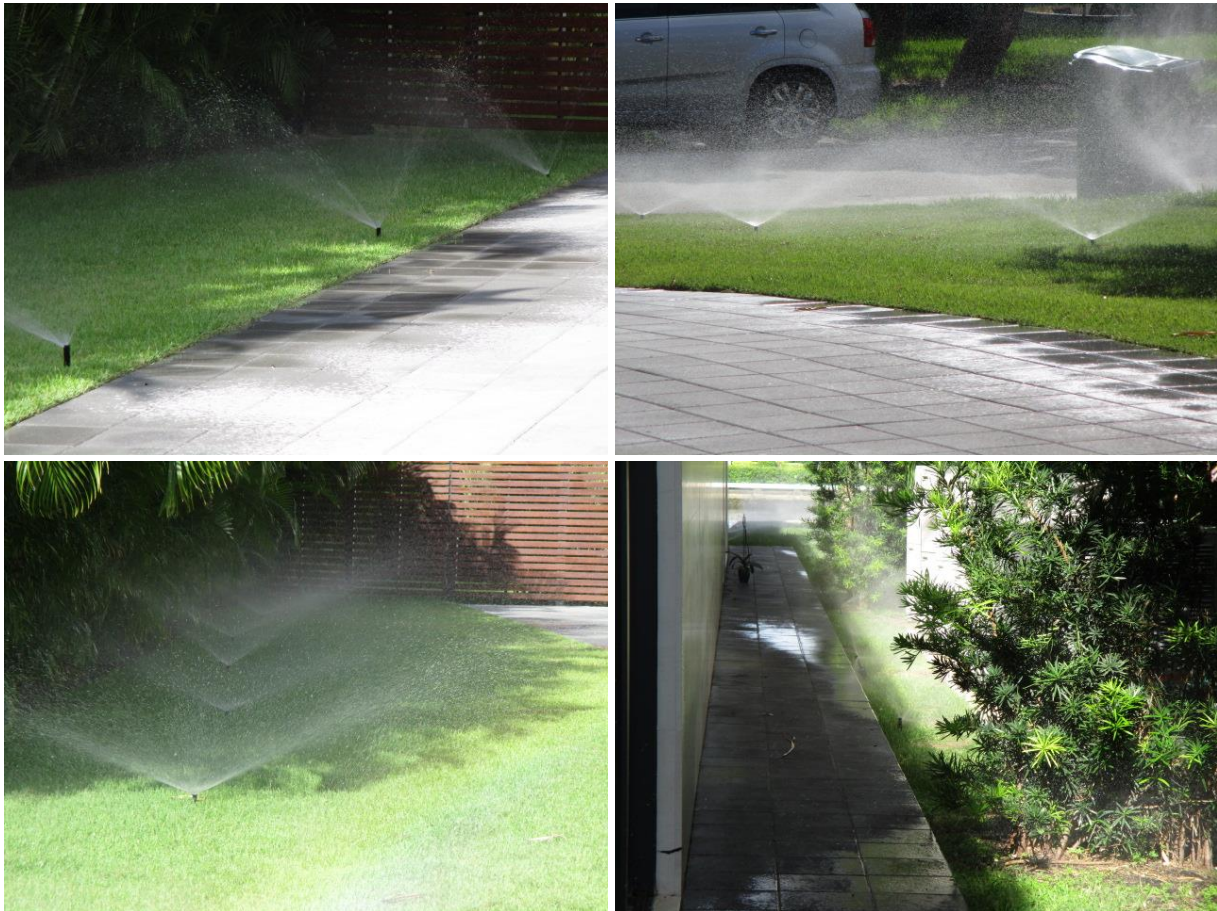
The system was functional at inspection time

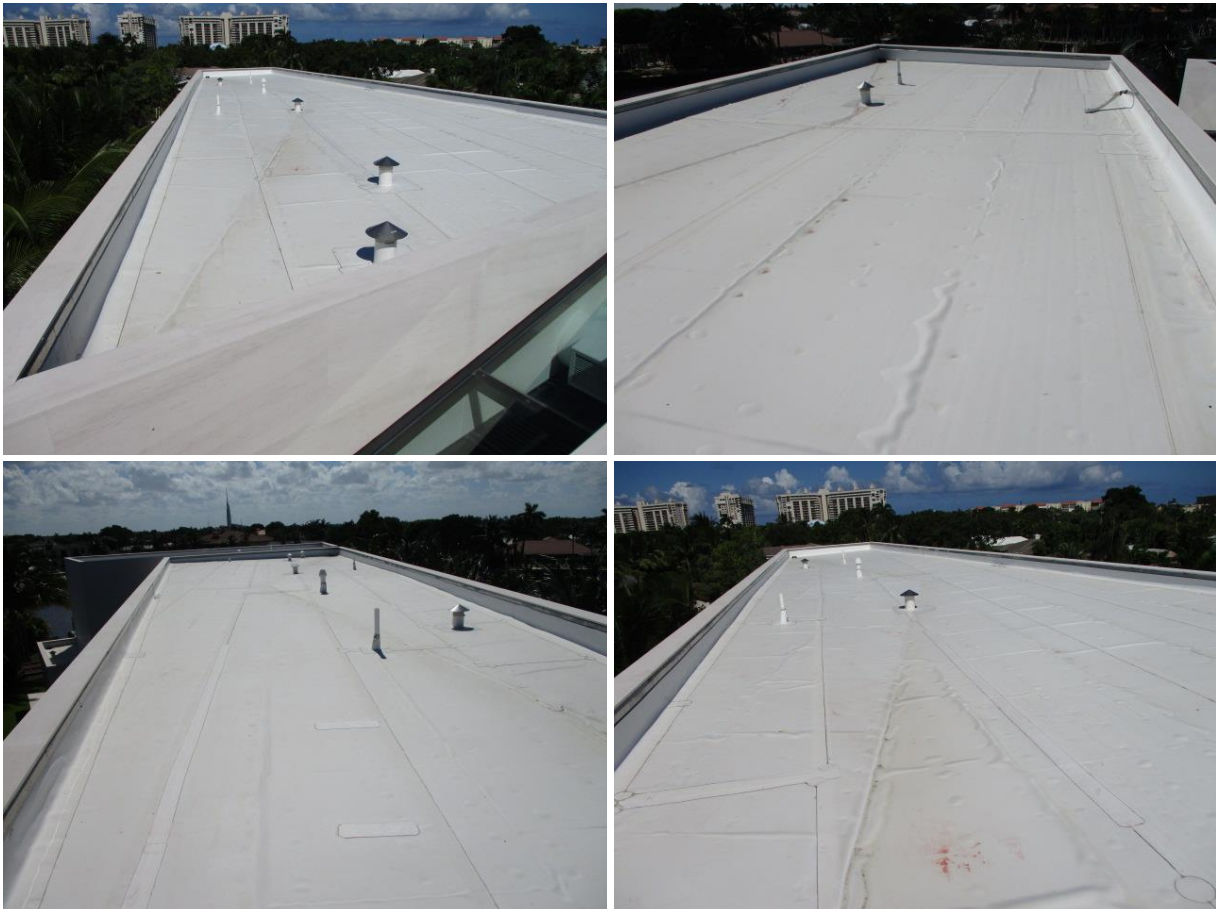
Roof style: Flat | **Type of roof covering:** PVC or TPO Single-Ply Membrane – good condition

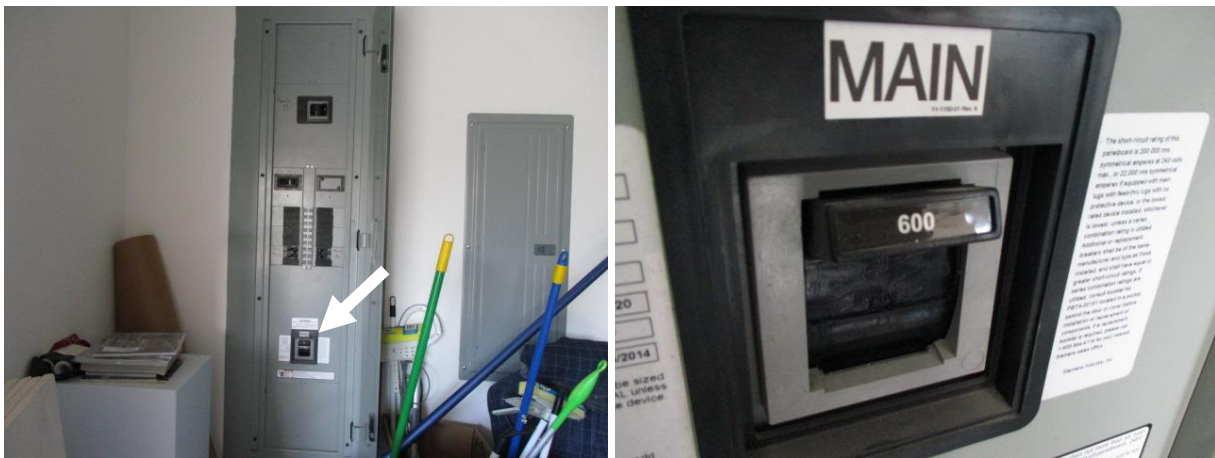
The 600 Amp Siemens **Main Service Disconnect Panel** is at the Garage West wall

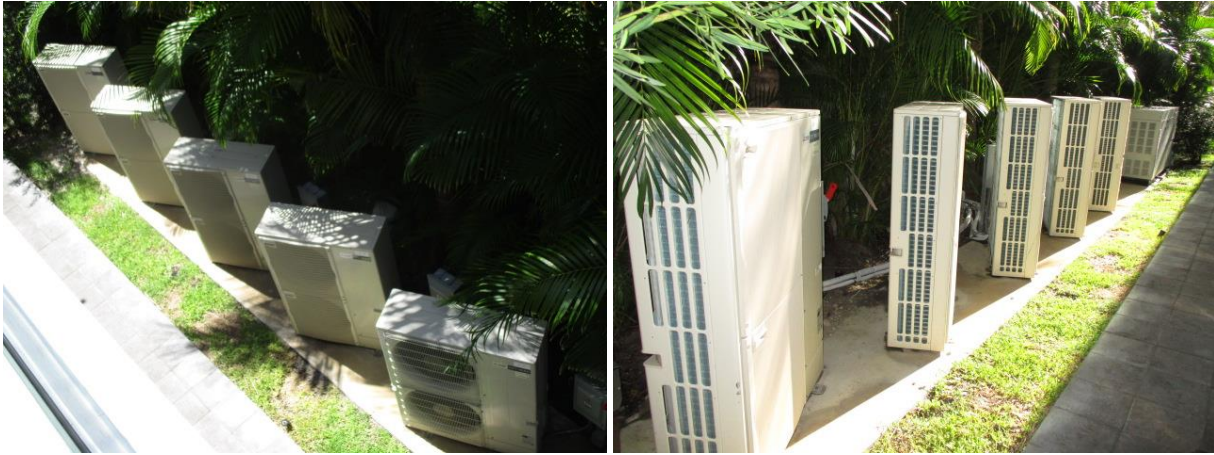
The Condensing Units (CU) are located at the North exterior wall. They are High-performance – High efficiency – low noise level **Mitsubishi Citi Multi Series** Condensers

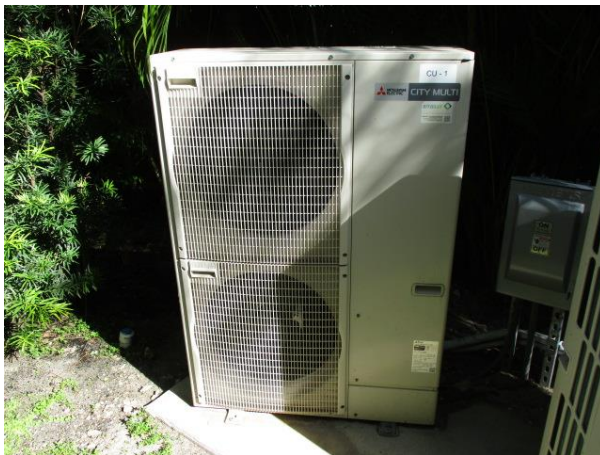
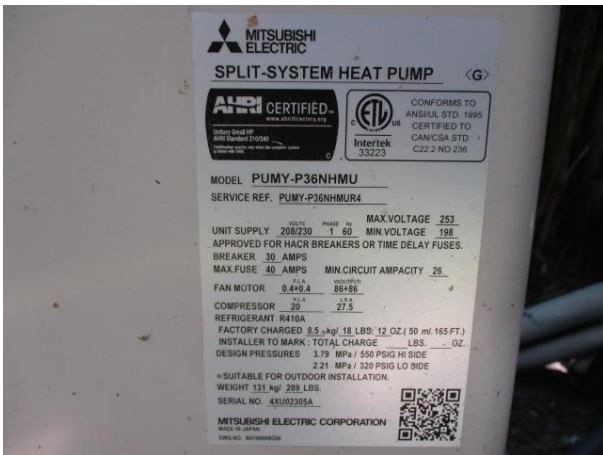
The 3 Ton Mitsubishi **Condenser Unit 1 (CU 1)** is at the North exterior Wall. It was manufactured in 2014 and was installed in 2015. It is paired with the two Air Handlers below.

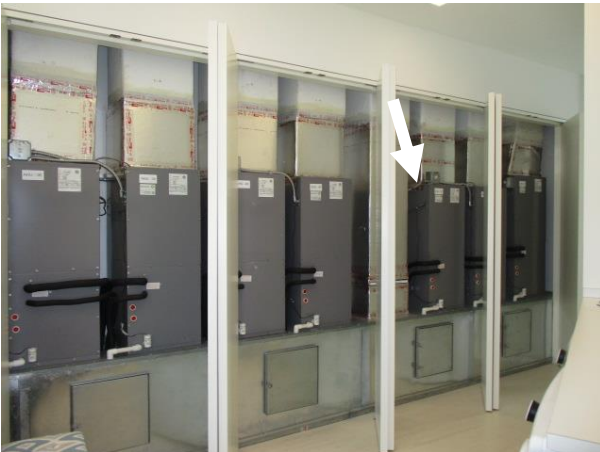
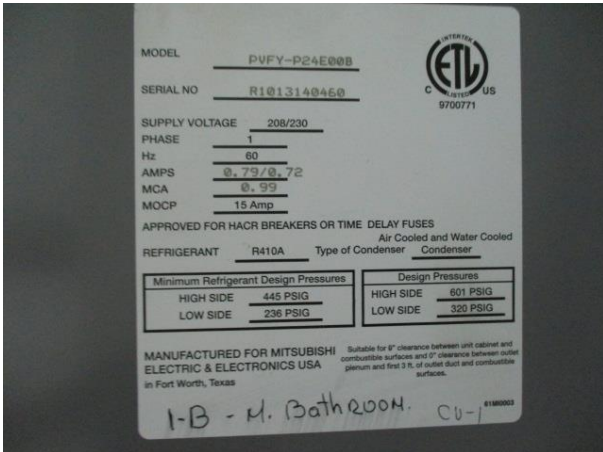
Air Handler Unit 1B (AHU 1B): Mitsubishi | 2 Ton | 2011 (installed in 2015) | *The Air Handler is in the second-floor Utility Room*

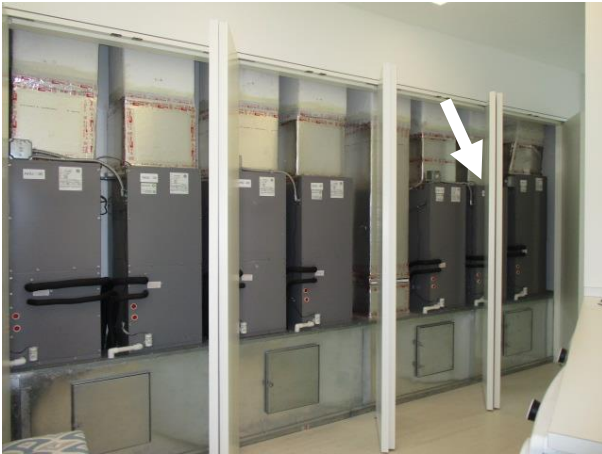
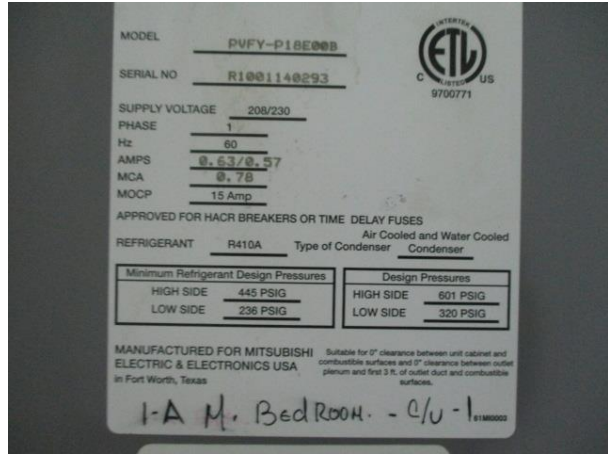
Air Handler Unit 1A (AHU 1A): Mitsubishi | 1.5 Ton | 2011 (installed in 2015) | *The Air Handler is in the second-floor Utility Room*

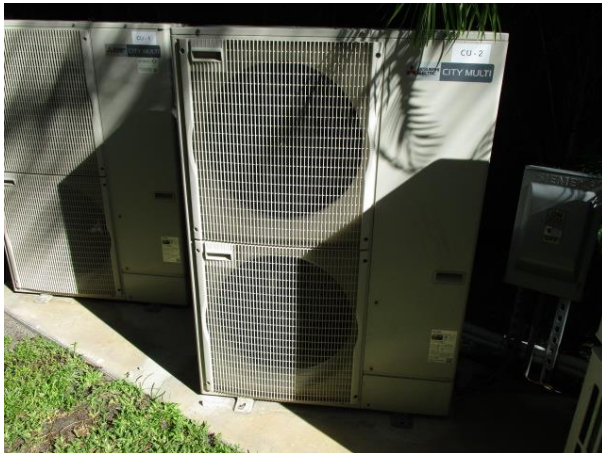
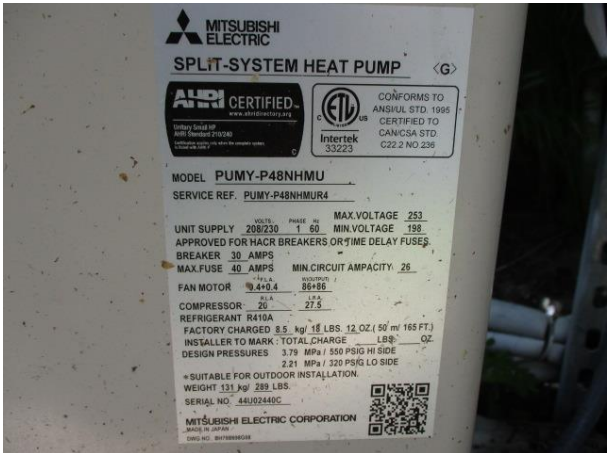
The 4 Ton Mitsubishi **Condenser Unit 2 (CU 2)** is at the North exterior Wall. It was manufactured in 2014 and was installed in 2015. It is paired with the two Air Handlers below.

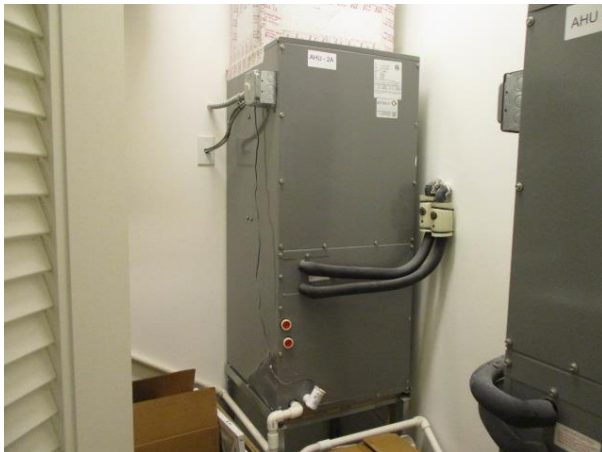
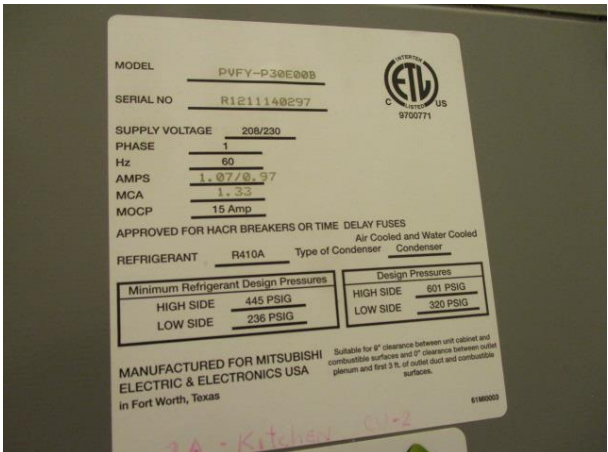
Air Handler Unit 2A (AHU 2A): Mitsubishi | 2.5 Ton | 2011 (installed in 2015) | *The Air Handler is in the first-floor HVAC Room*

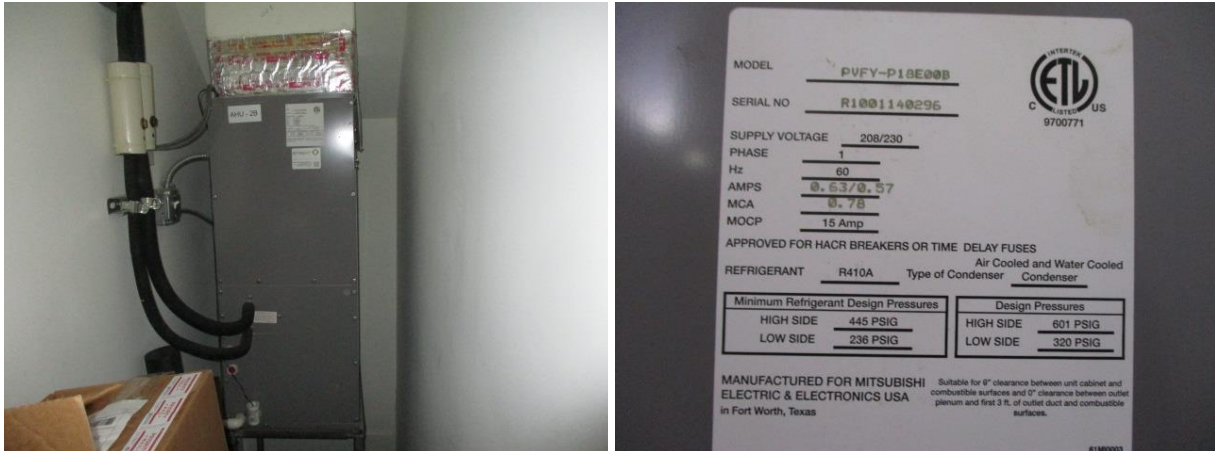
Air Handler Unit 2B (AHU 2B): Mitsubishi | 1.5 Ton | 2011 (installed in 2015) | *The Air Handler is in the first-floor Gym, under the stairwell*

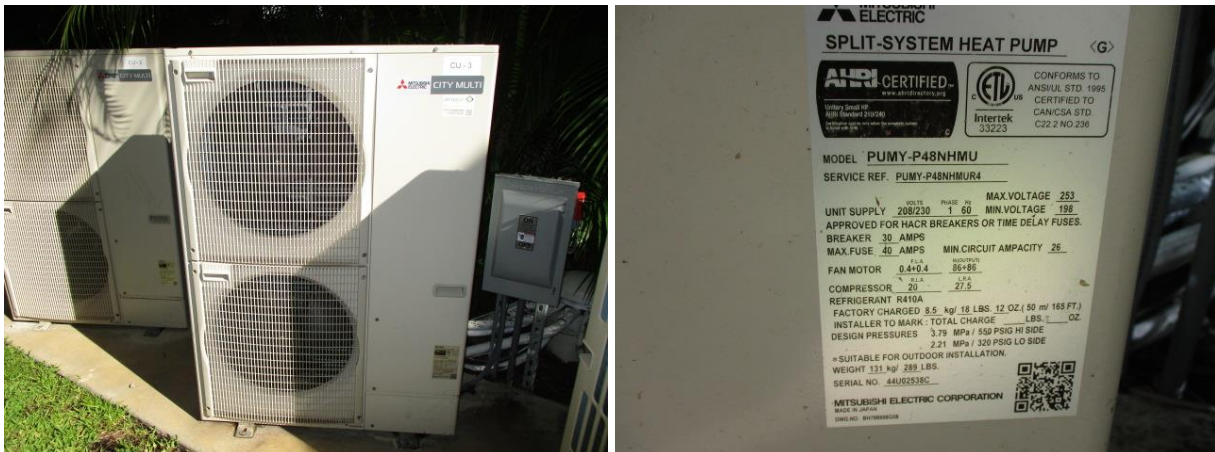
The 4 Ton Mitsubishi **Condenser Unit 3 (CU 3)** is at the North exterior Wall. It was manufactured in 2014 and was installed in 2015. It is paired with the two Air Handlers below.

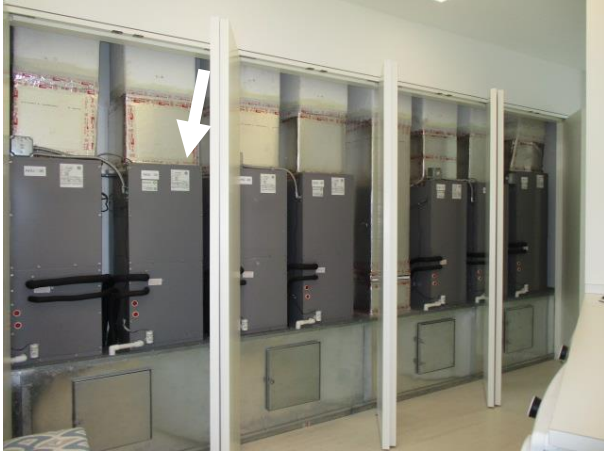
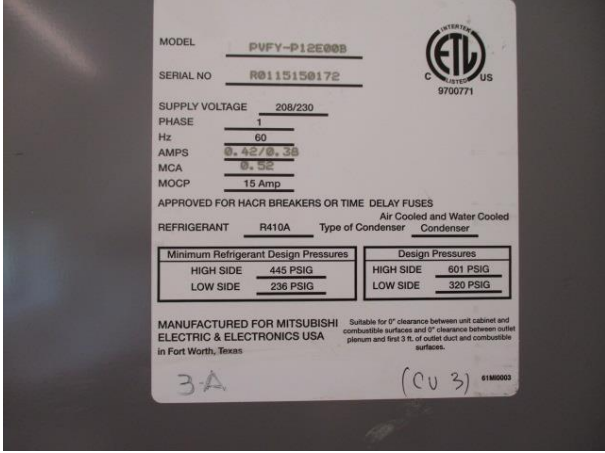
Air Handler Unit 3A (AHU 3A): Mitsubishi | 1 Ton | 2010 (installed in 2015) | The Air Handler is in the second-floor Utility Room

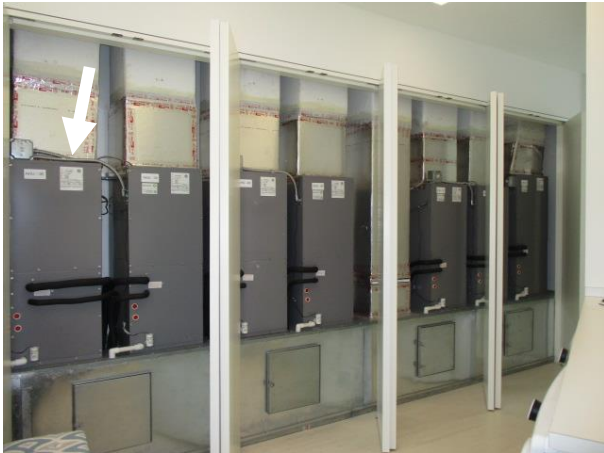
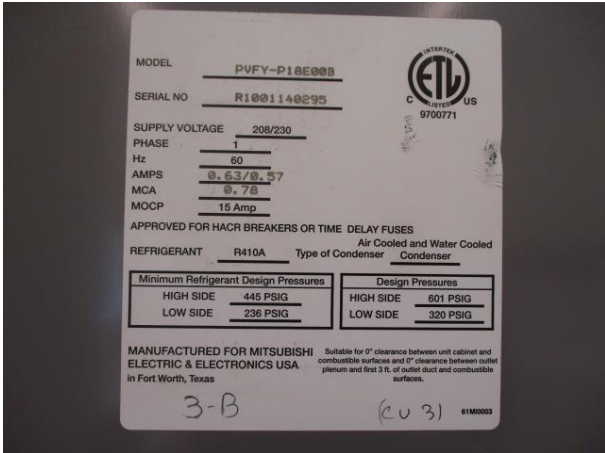
Air Handler Unit 3B (AHU 3B): Mitsubishi | 1.5 Ton | 2011 (installed in 2015) | The Air Handler is in the second-floor Utility Room

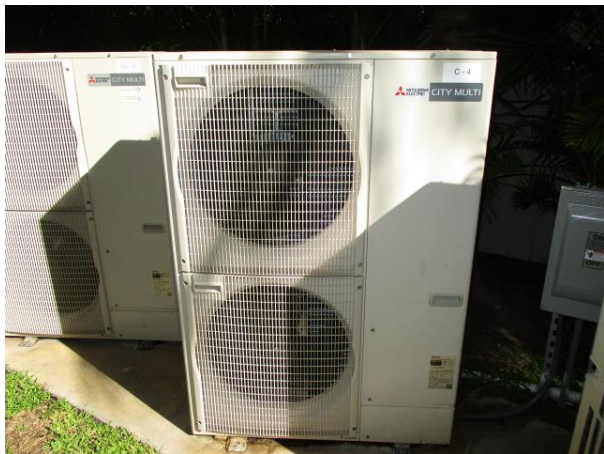
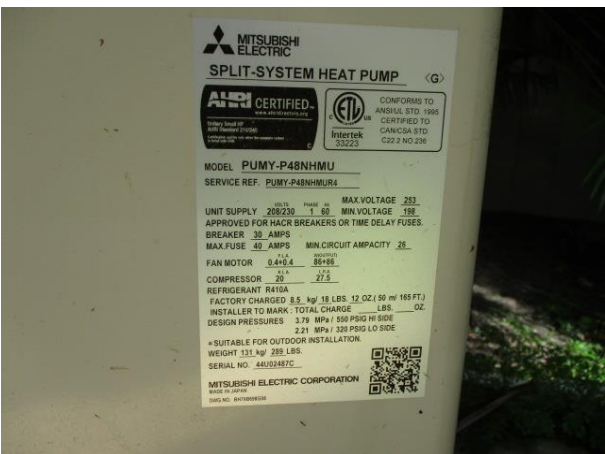
The 4 Ton Mitsubishi Condenser Unit 4 (C 4) is at the North exterior Wall. It was manufactured in 2014 and was installed in 2015. It is paired with the two Air Handlers below.

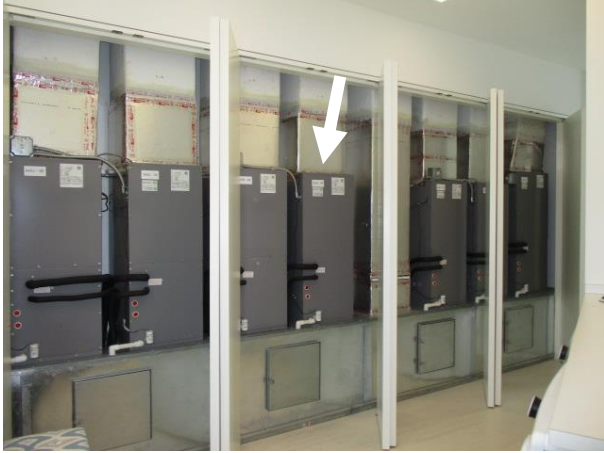
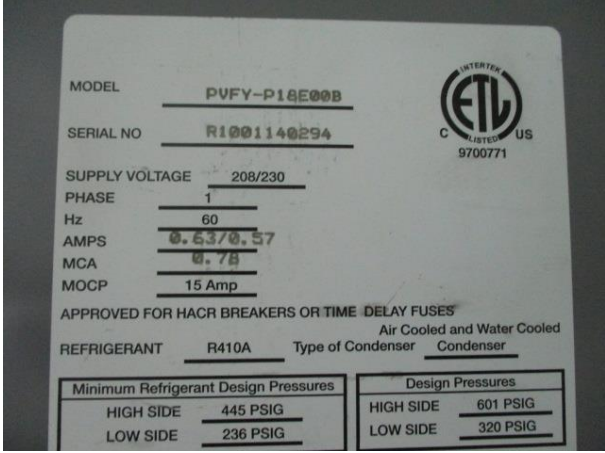
Air Handler Unit 4A (AHU 4A): Mitsubishi | 1.5 Ton | 2011 (installed in 2015) | The Air Handler is in the second-floor Utility Room

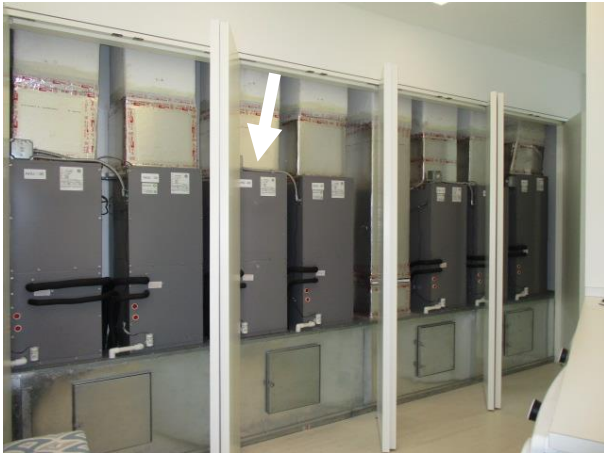
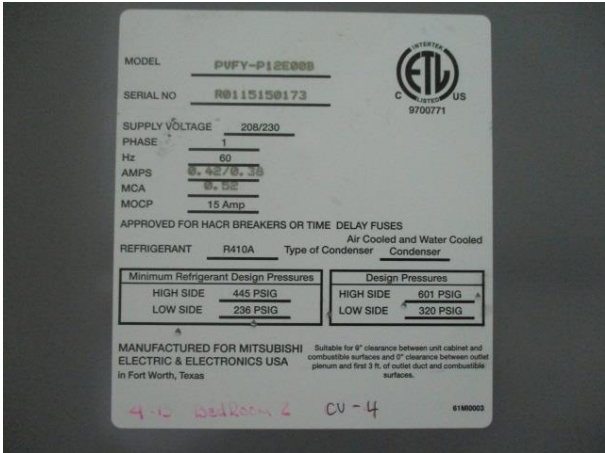
Air Handler Unit 4B (AHU 4B): Mitsubishi | 1 Ton | 2011 (installed in 2015) | The Air Handler is in the second-floor Utility Room

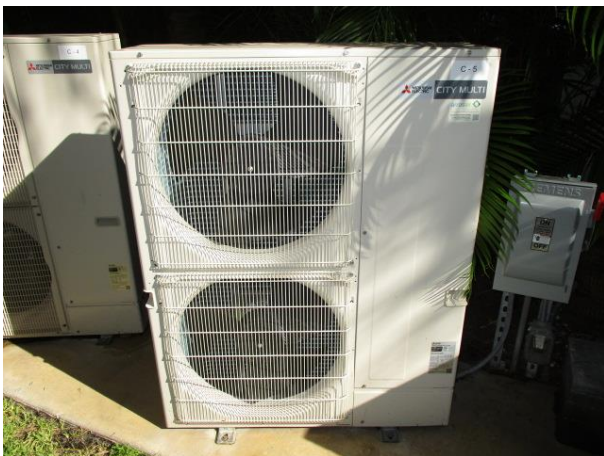
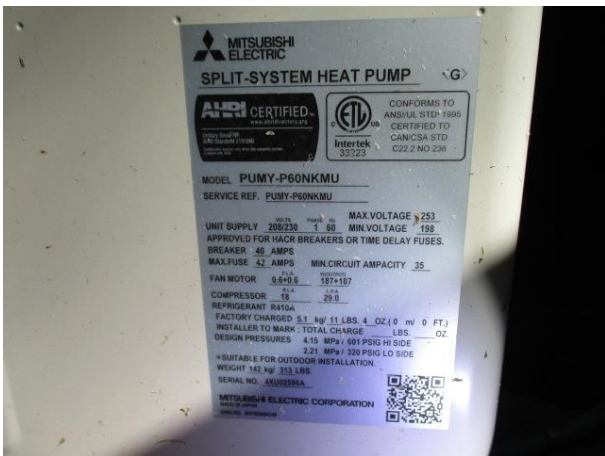
The 5 Ton Mitsubishi Condenser Unit 5 (C 5) is at the North exterior Wall. It was manufactured in 2014 and was installed in 2015. It is paired with the three Air Handlers below.

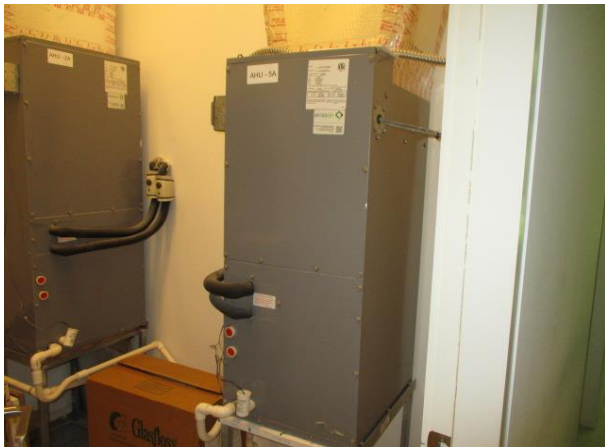
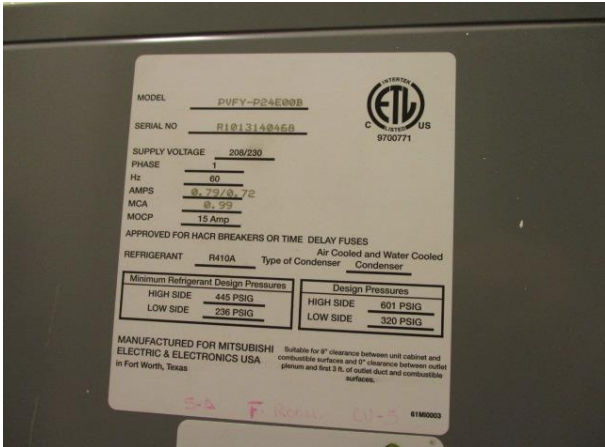
Air Handler Unit 5A (AHU 5A): Mitsubishi | 2 Ton | 2011 (installed in 2015) | *The Air Handler is in the first-floor HVAC Room*

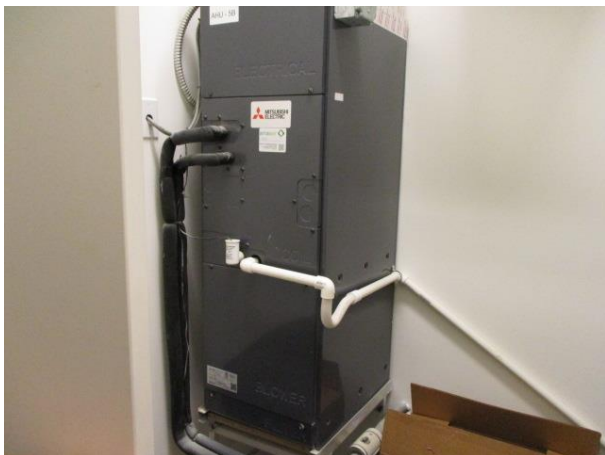
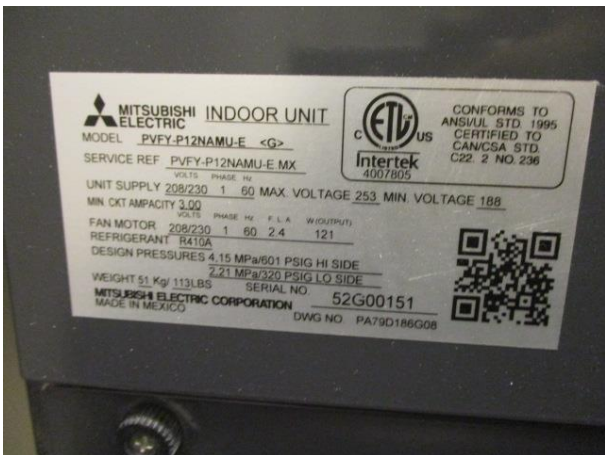
Air Handler Unit 5B (AHU 5B): Mitsubishi | 1 Ton | 2011 (installed in 2015) | *The Air Handler is in the first-floor HVAC Room*

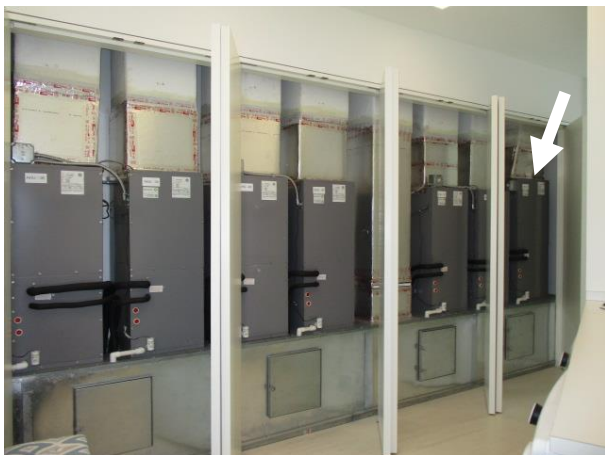
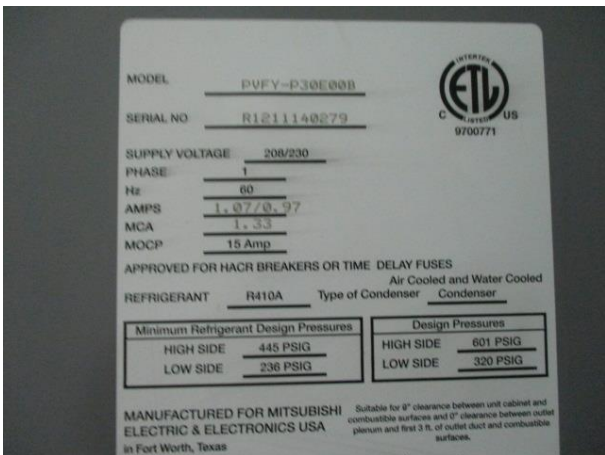
Air Handler Unit 5C (AHU 5C): Mitsubishi | 2.5 Ton | 2011 (installed in 2015) | *The Air Handler is in the second-floor Utility Room*

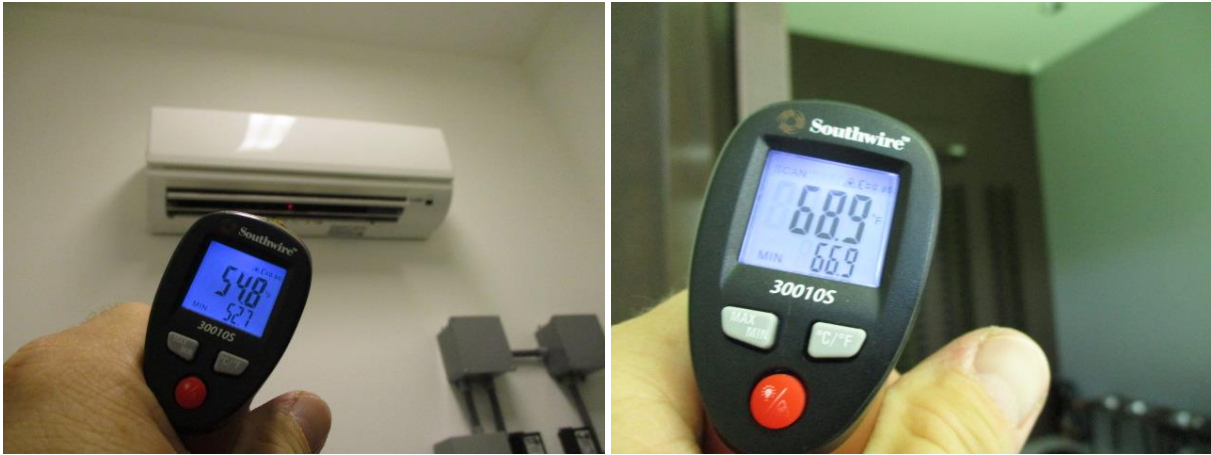
Two Mini Split Ductless Air Conditioners are installed in the Audio-Visual Room and the Pet Room

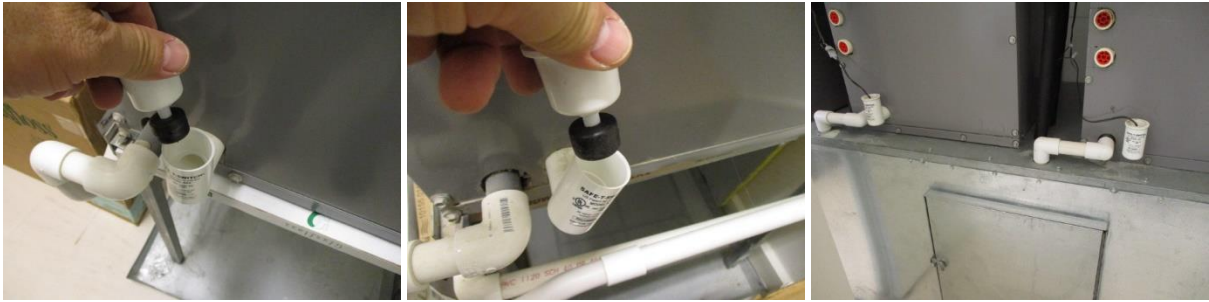
Condensation Float Switches (center) – these devices will shut down the Air Handlers when the condensation lines clog up. De-clogging the lines will allow the units to re-start

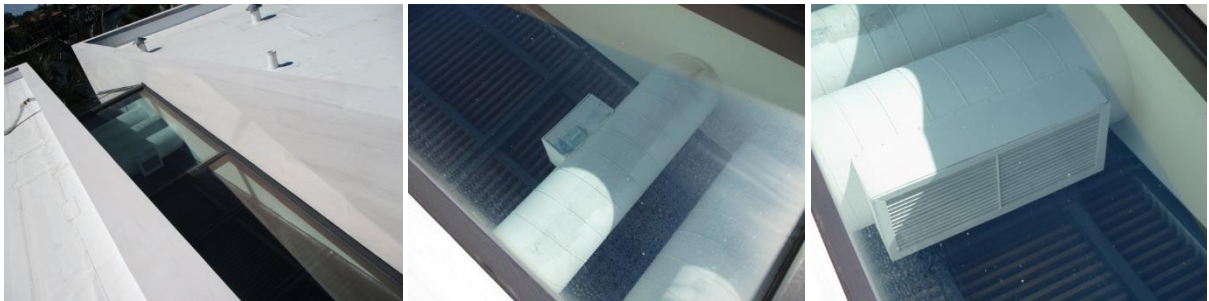
Visible components of the Duct System were observed from the Roof. Most Ducts were boxed-in or concealed above the ceilings

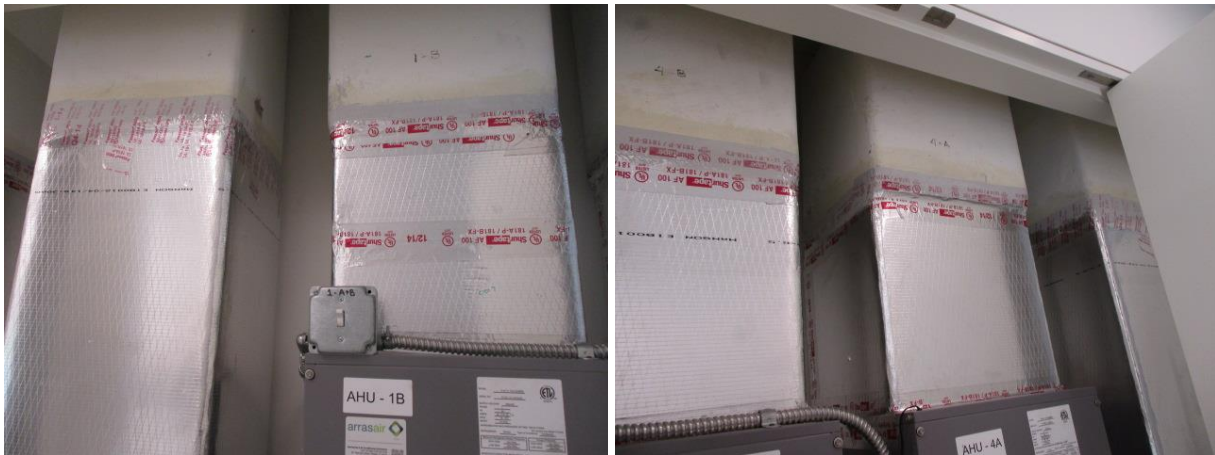
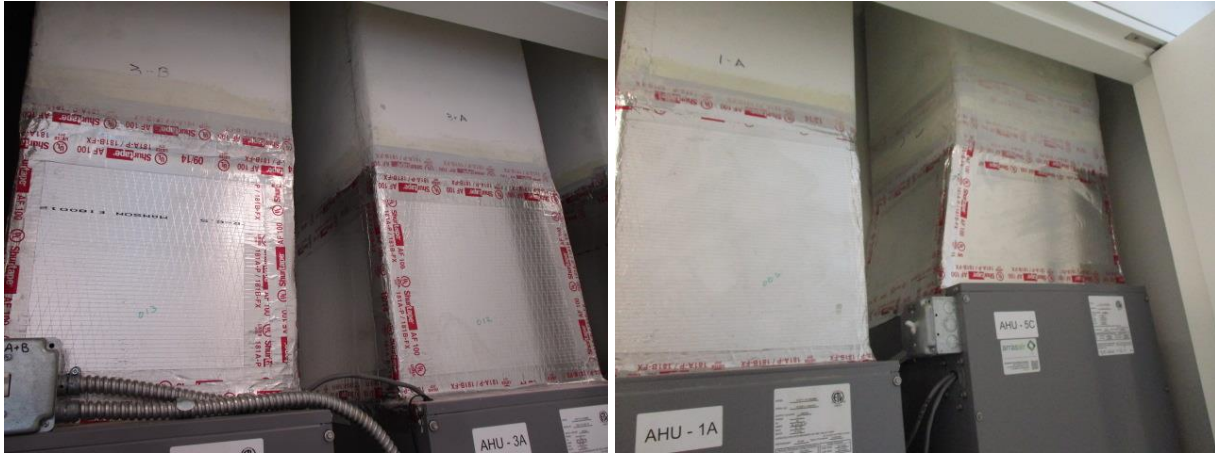
The Plenum Duct System appeared functional and in good condition

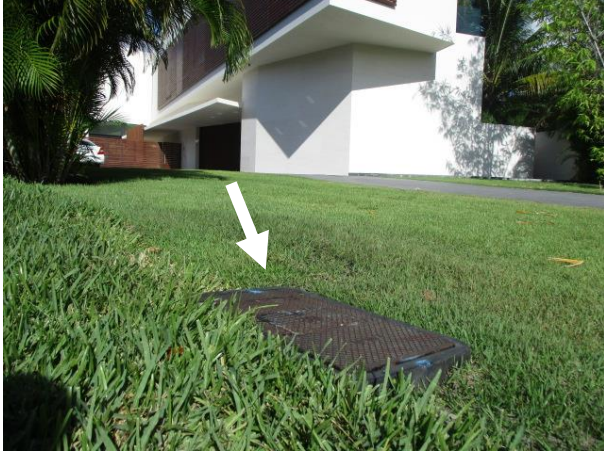
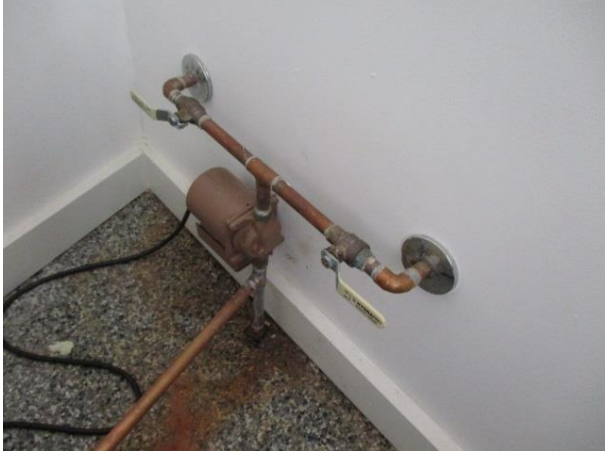
Water Meter Location: SE property corner (left) | **Main Shut off Valve Location:** at the South interior wall of the Garage, next to the Water Heater (right)

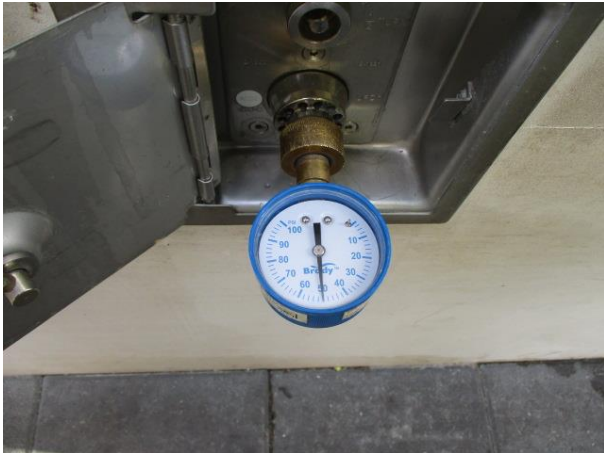
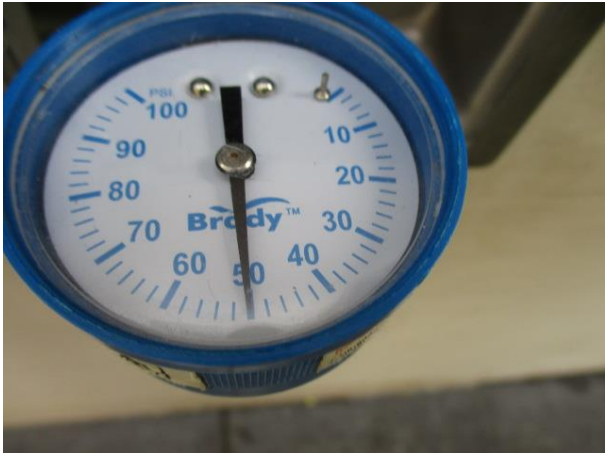
Overall water pressure: 50 PSI | the water pressure appeared to be within Normal Range.

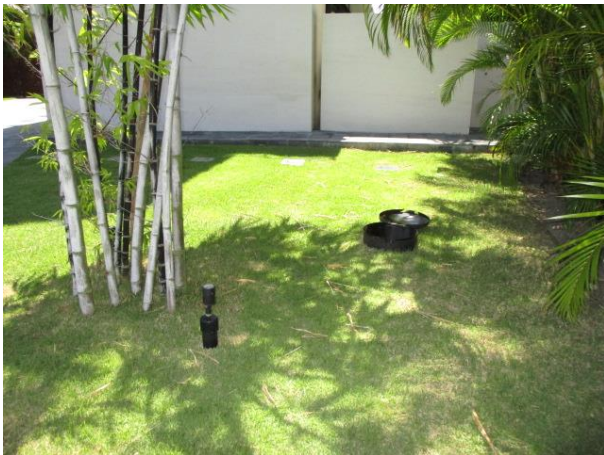
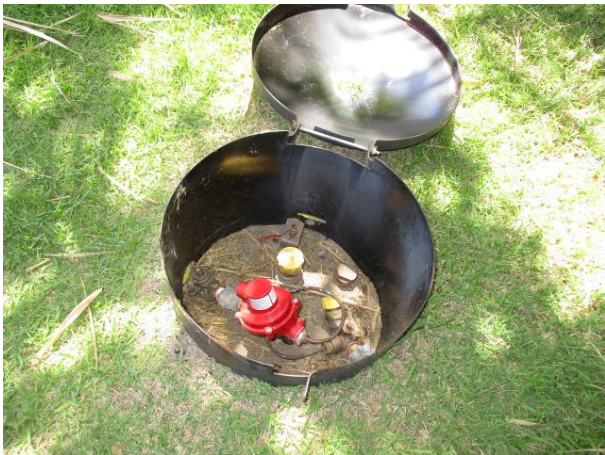
The buried **Propane Tank** is at the NE side of the property

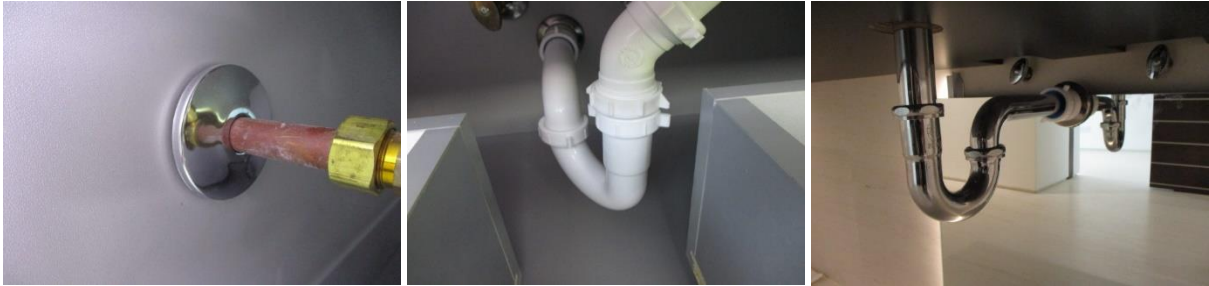
Fixture supply line material: Copper (left) | Fixture drain line material: PVC (center) & Stainless Steel (right)

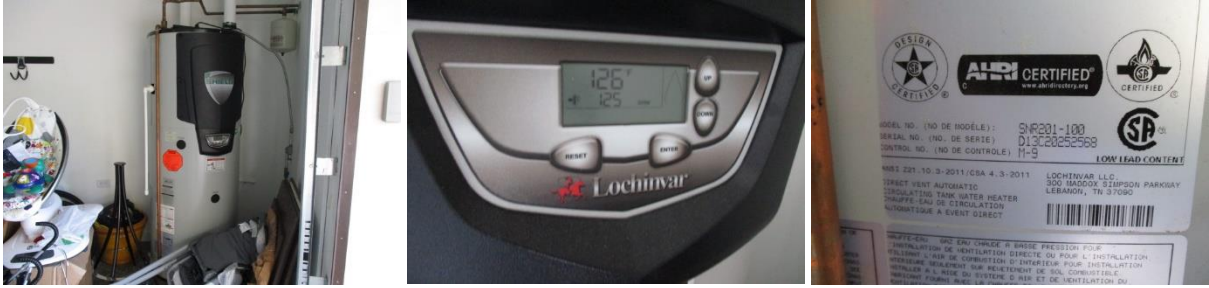
Water Heater: Lochinvar Shield (Commercial Grade) | 100 Gallon | Propane Gas | 2013 (installed in 2015)

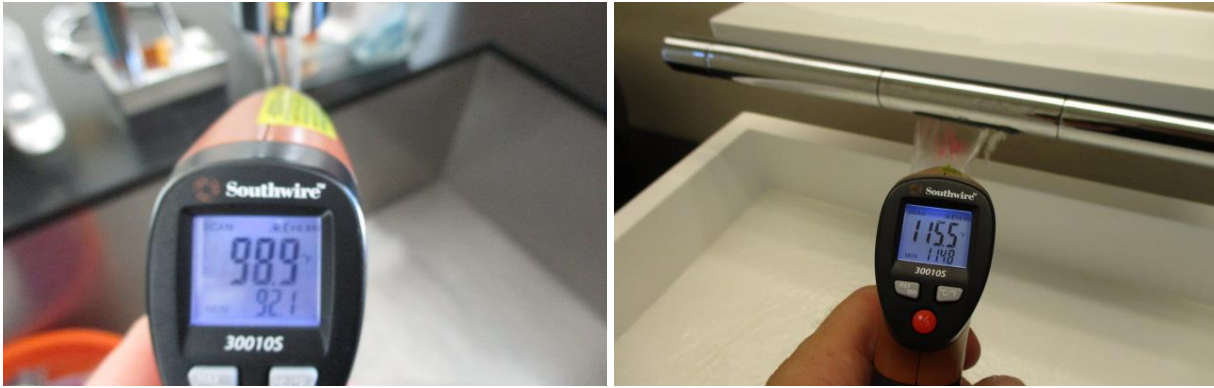
The Water Heater appeared functional and in fair condition as it provided hot water to the Kitchen and Bathrooms during the Home Inspection | Based on the average Life Expectancy of a standard Water Heater, the unit may have an estimated 12 – 15 years remaining life with proper maintenance and professional annual service.

The Water Heater appeared functional and in fair condition as it provided hot water to the Kitchen and Bathrooms during the Home Inspection

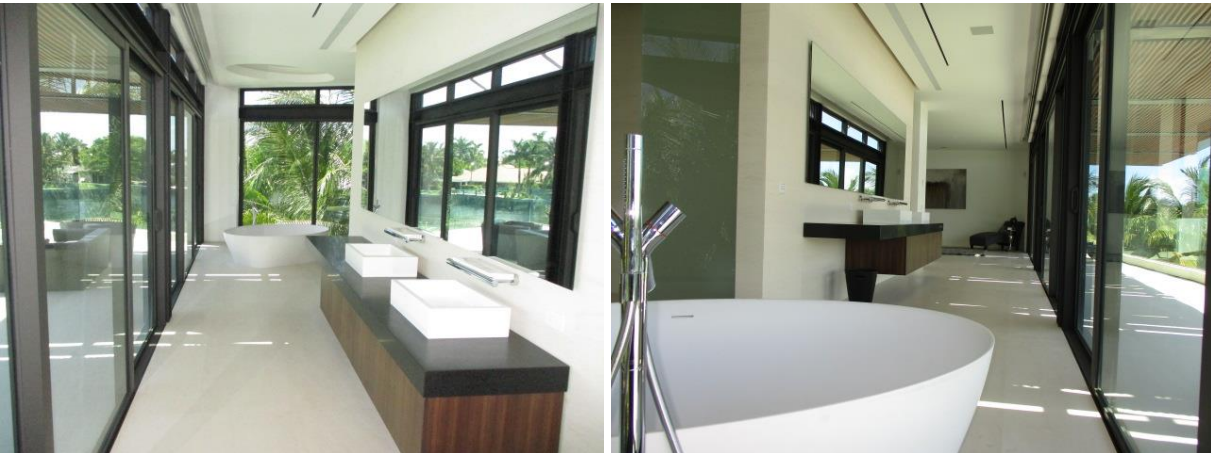
Master Suite (second floor)
