Home Inspection Report

1234 Sample Report
Fort Lauderdale, FL 33308

Inspection Date: January 1, 2017 | 9:00 AM

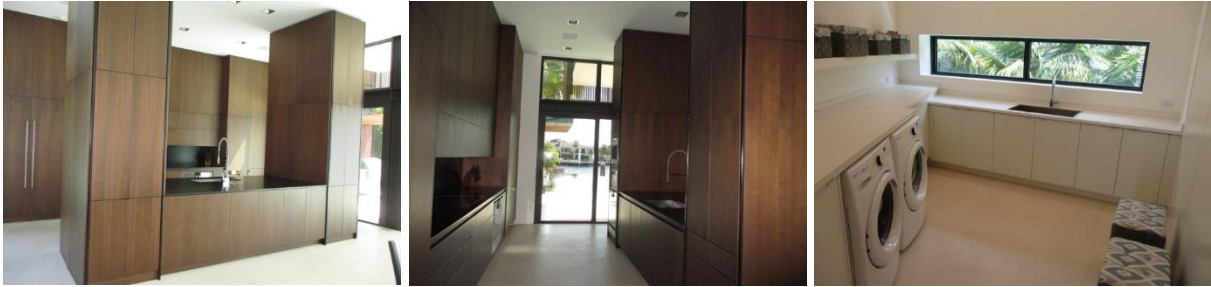
- Induction Stove Top:** Good | Functional
- Hood Vent Fan:** Good | Functional
- Hood Light:** Good | Functional
- Dishwasher:** Good | Functional
- Food Disposal:** Good | Functional
- Built-in Microwave Oven:** Good | Functional
- Two Built-in Ovens:** Good | Functional
- Sub-Zero Refrigerator:** Good | Functional
- Wine Cooler:** Good | Functional
- Clothes Washer:** Good | Functional
- Clothes Dryer:** Good | Functional

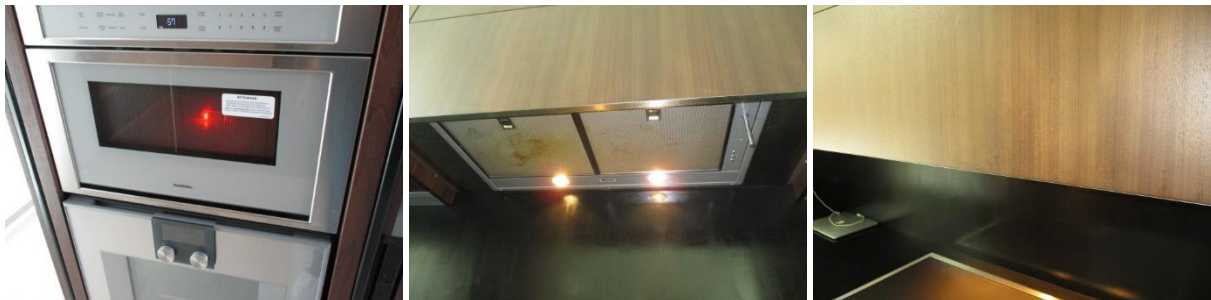
The **Microwave Oven** was checked with a Microwave Testing Device that illuminates when Microwaves are present in the Microwave Oven | The **Hood Vent Fan and Light** were functional

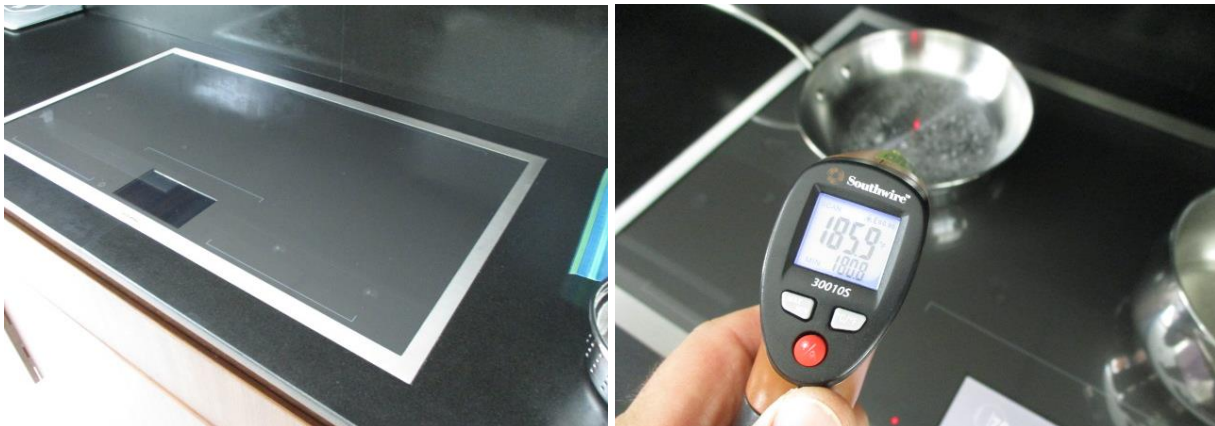
The electric **Induction Stove Top**, was functional.

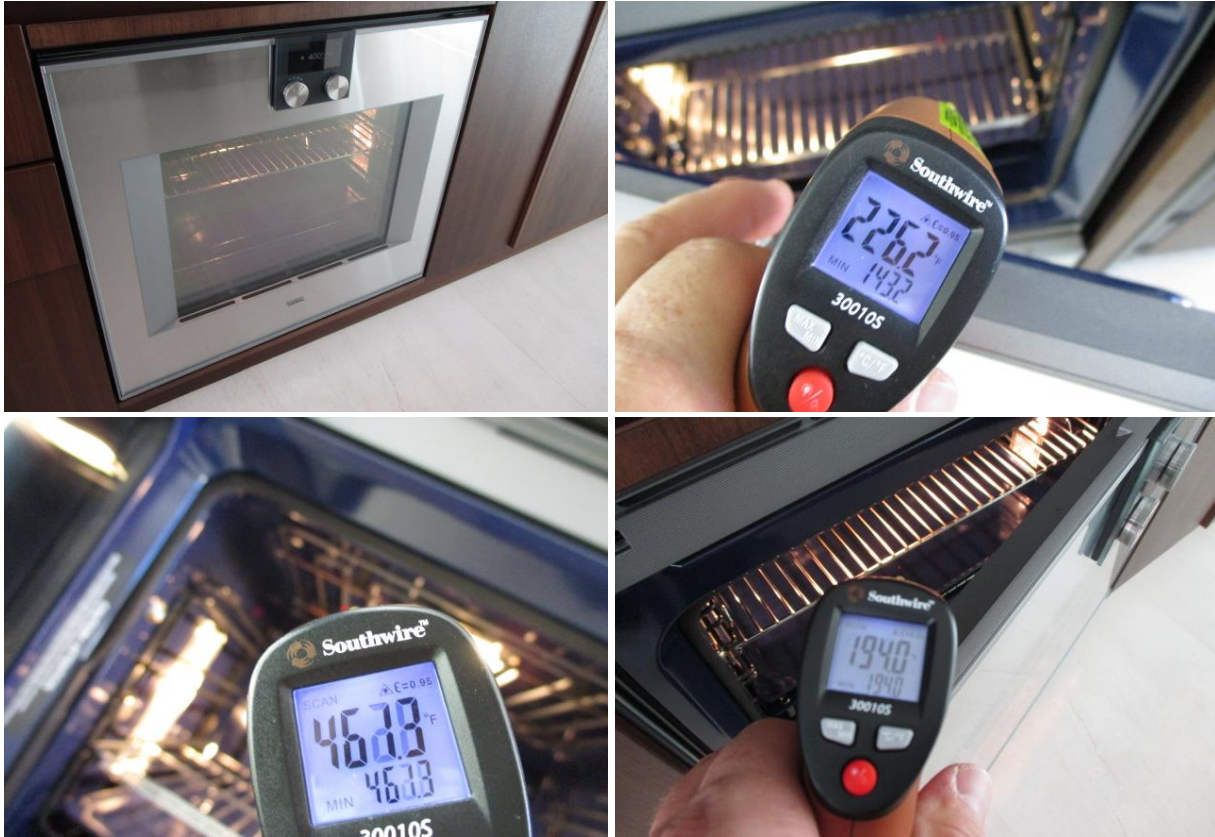
The Two **Built-in Ovens** including the **Broiler** functions: Good | Functional

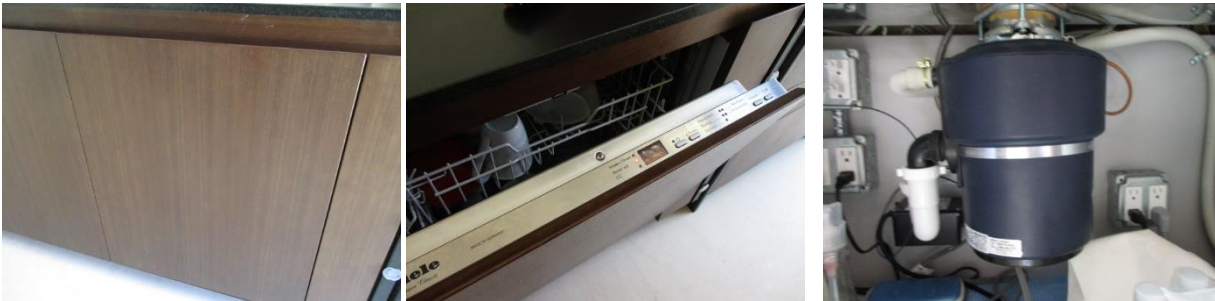
The **Dishwasher** ran an abbreviated cycle | the **Food Disposal** was functional

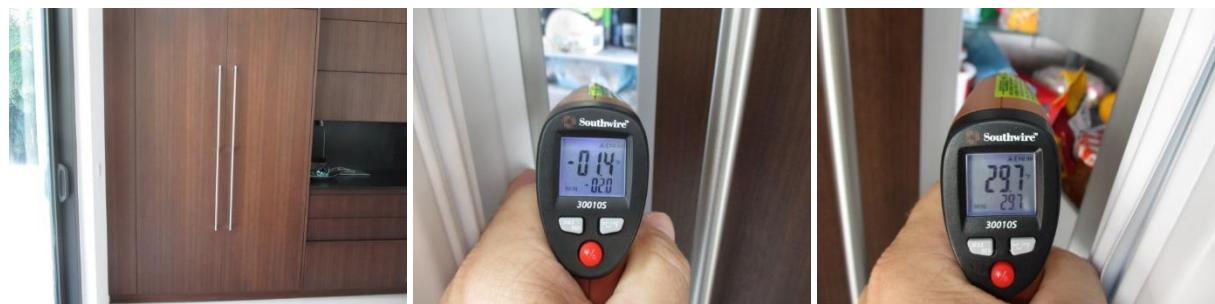
The **Sub-Zero Refrigerator** was checked with an Infrared Thermometer to confirm function.

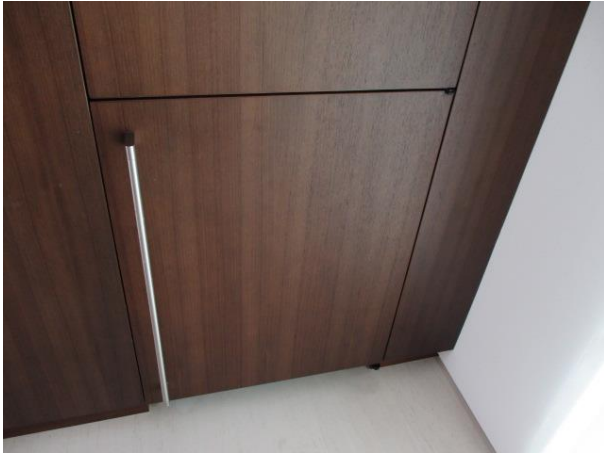
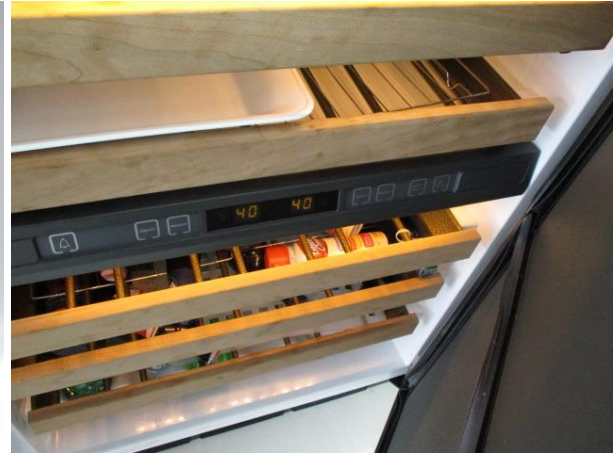
The Wine Cooler was functional

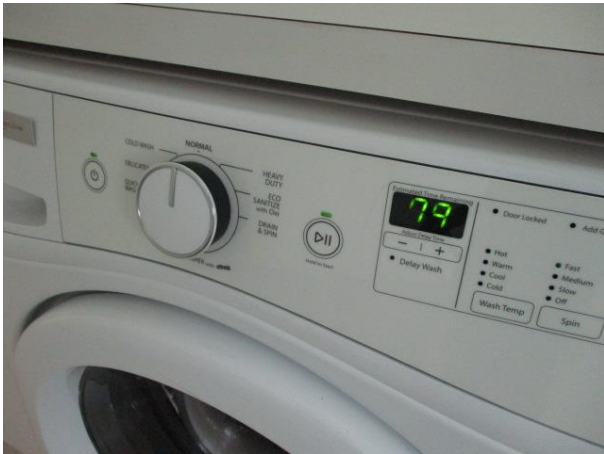
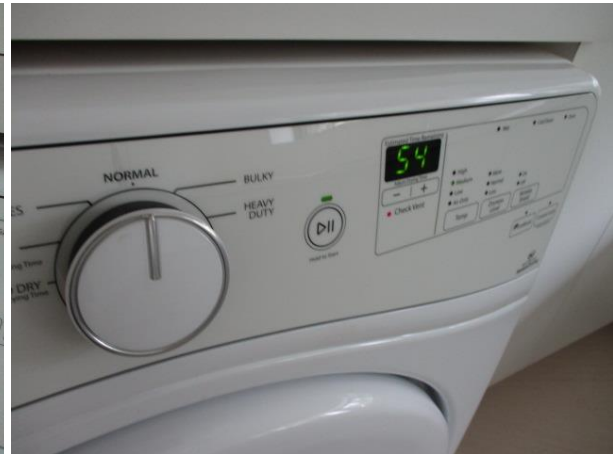
The Washer & Dryer were functional
