Home Inspections By PJM, Inc.

Confidential - Property Inspection Report - Confidential

Sample Report, FL
Inspection prepared for: Sample Report
Date of Inspection: 11/24/2018
Age of Home: 3 years Size: 7,321 SqFt

Inspector: Luis D. Nigaglioni
Sub Contractor for Home Inspections by PJM Inc. License #HI-2100
11621 Thurston Way, Orlando, FL 32837

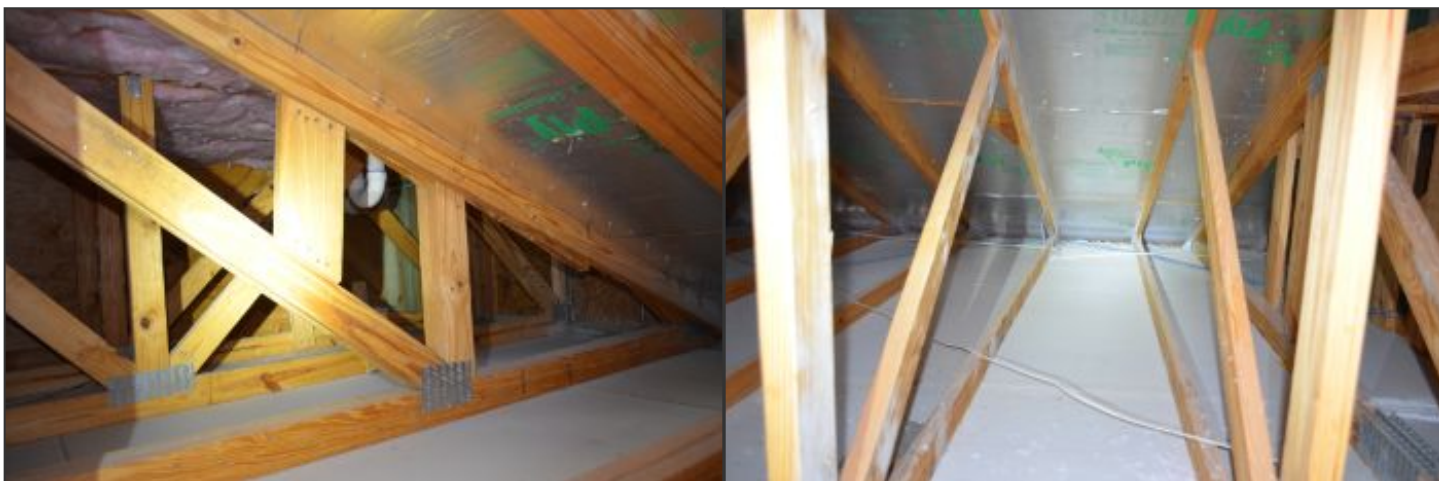
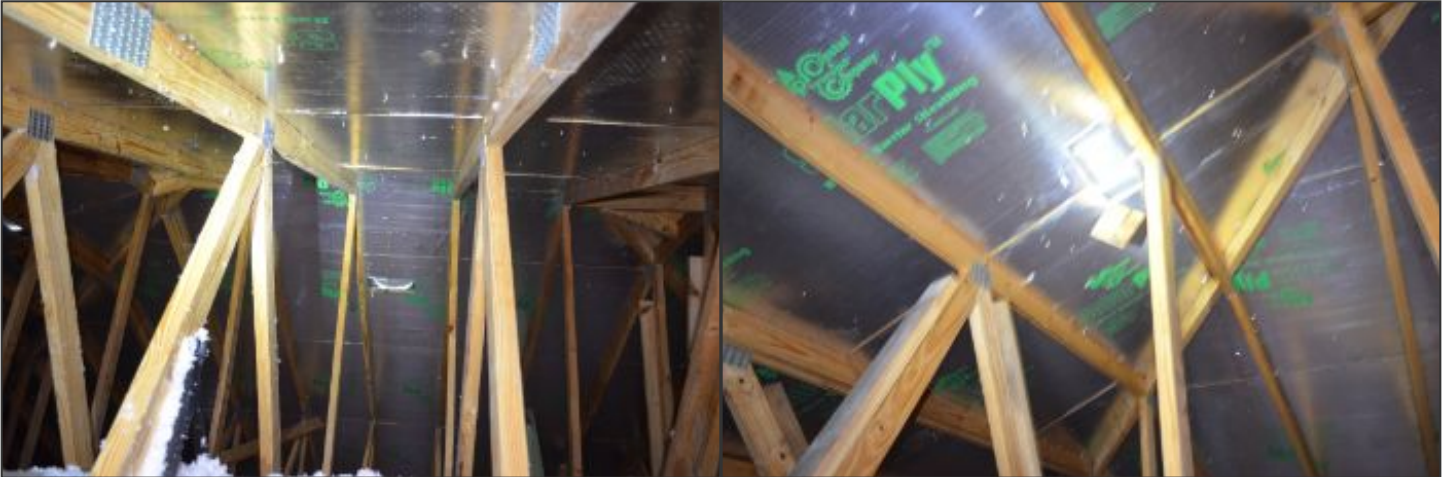
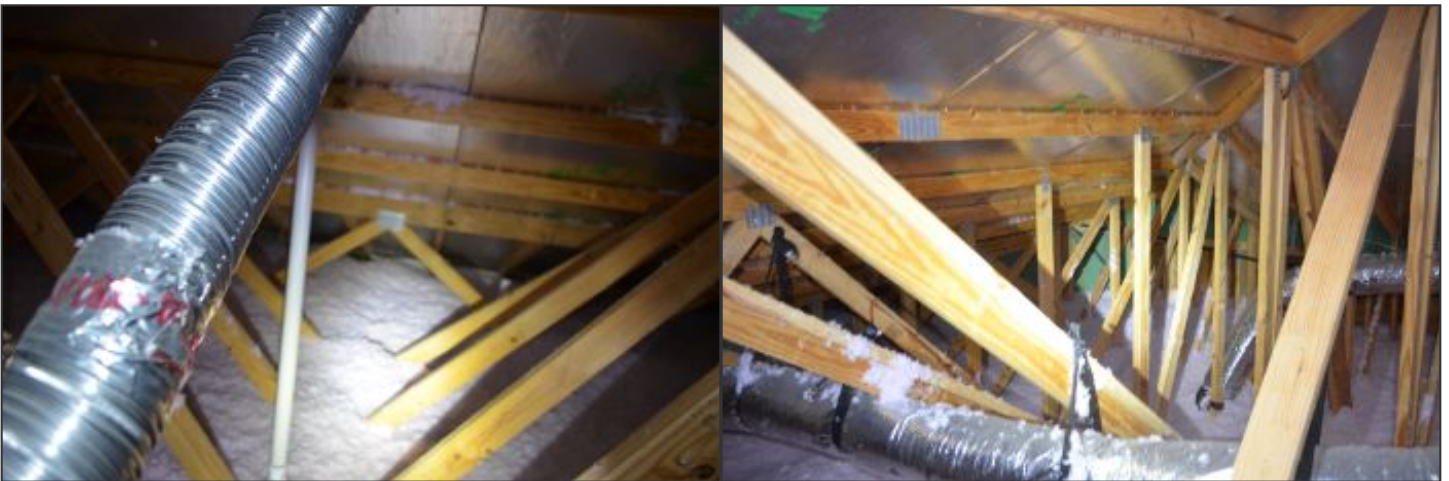
5.1. No major defects were observed in the accessible structural components of the roof. No repair to structural components is necessary at this time.

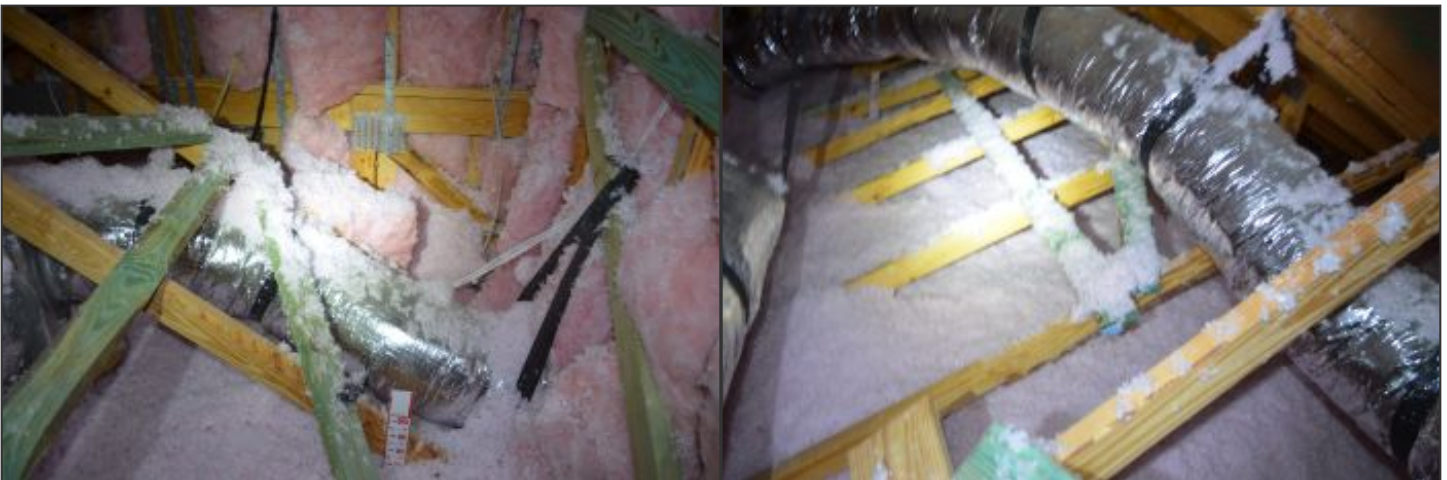
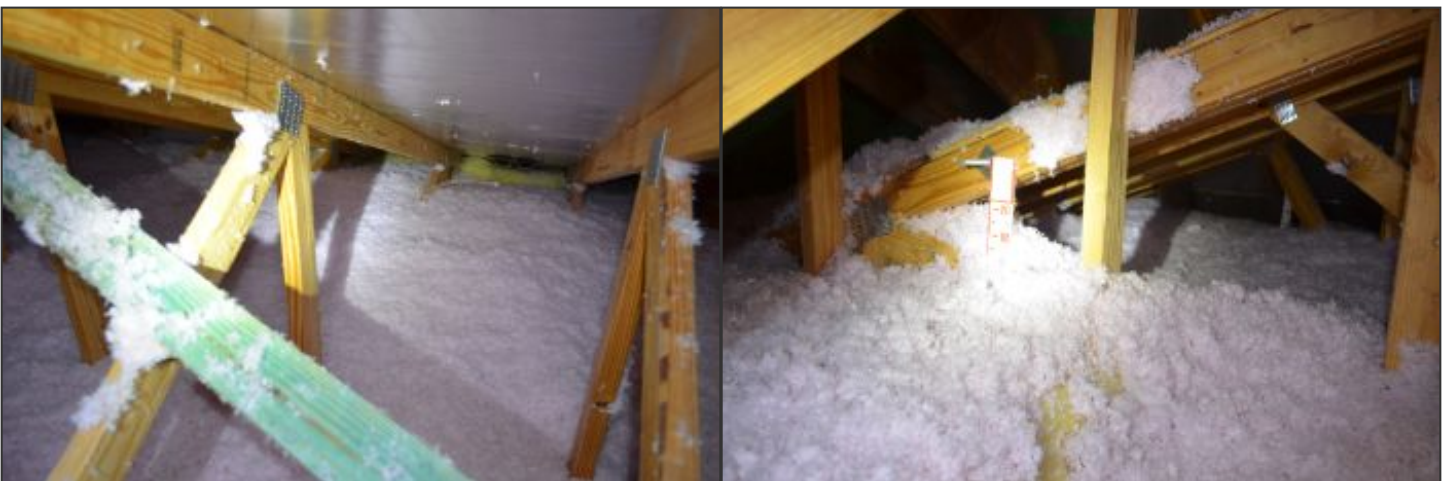
- 2.1. Attic insulation thickness was approximately 13 to 15 inches. The attic insulation was properly installed and in good condition.

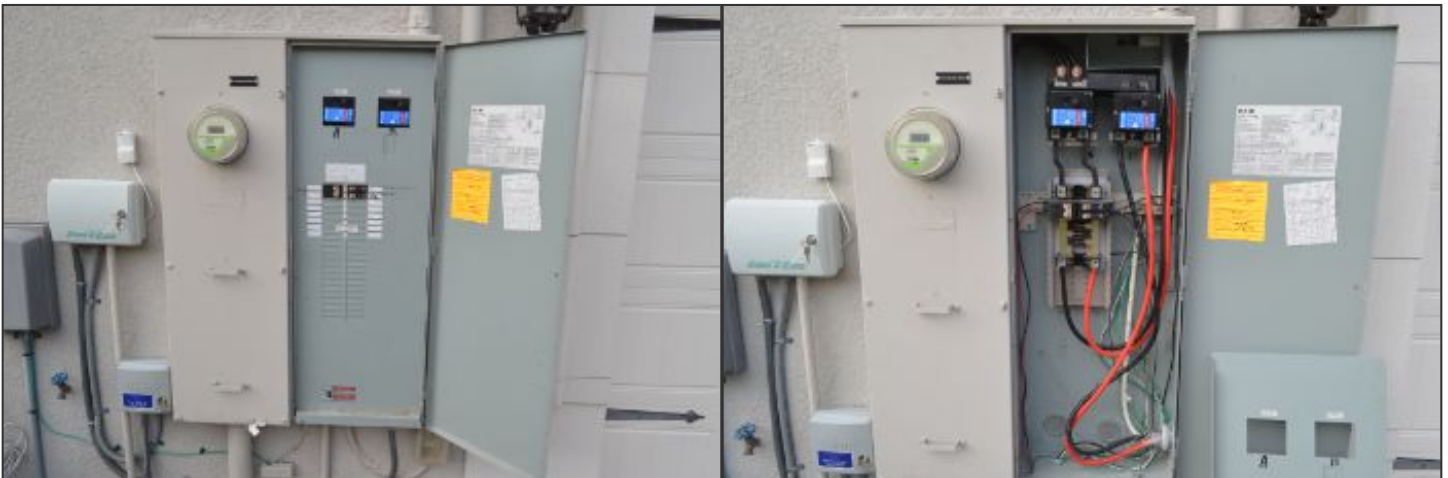
4.1. The main electrical service panel appeared to be in satisfactory condition at the time of the inspection. Inspection of the main service panel typically includes examination of the following: Panel interior and exterior condition, Panel amperage rating, Label information present, Service and equipment grounding, and bonding of service equipment.

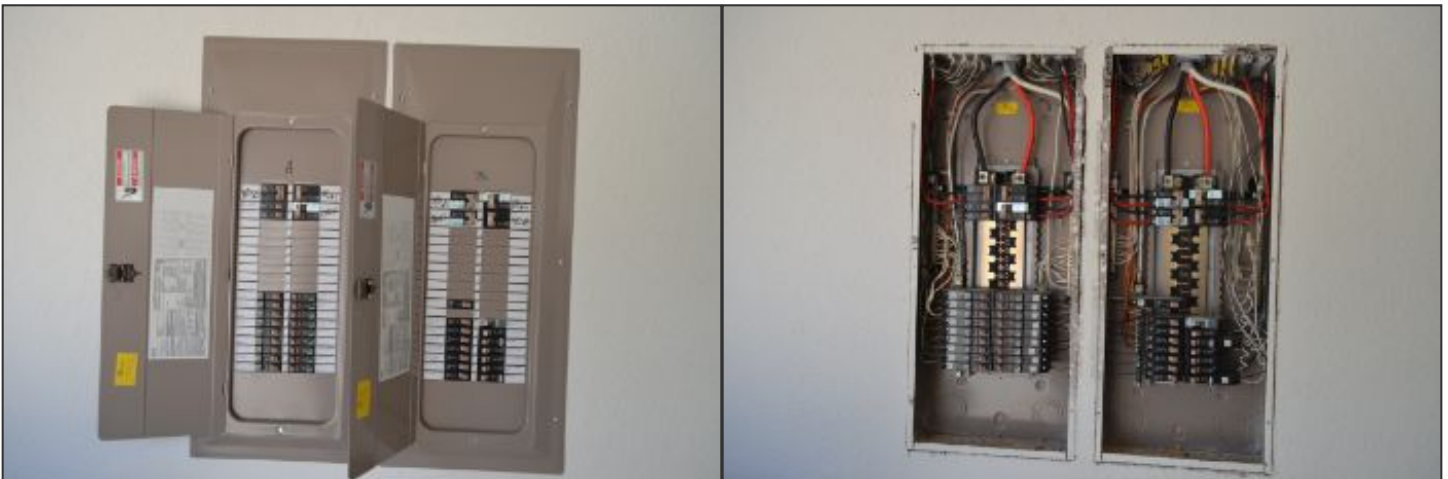
8.1. All components visible in the sub-panel appeared to be in satisfactory condition at the time of the inspection. Inspection of the sub-panel typically includes examination of the following: Panel interior and exterior condition, Panel amperage rating, Main disconnect amperage rating and condition, Main conductor amperage ratings, Branch conductor types, amperage rating and condition, Wiring visible materials, types, condition and connections, Circuit breaker types, amperage ratings and condition, Label information present, Service and equipment grounding, and Bonding of service equipment.

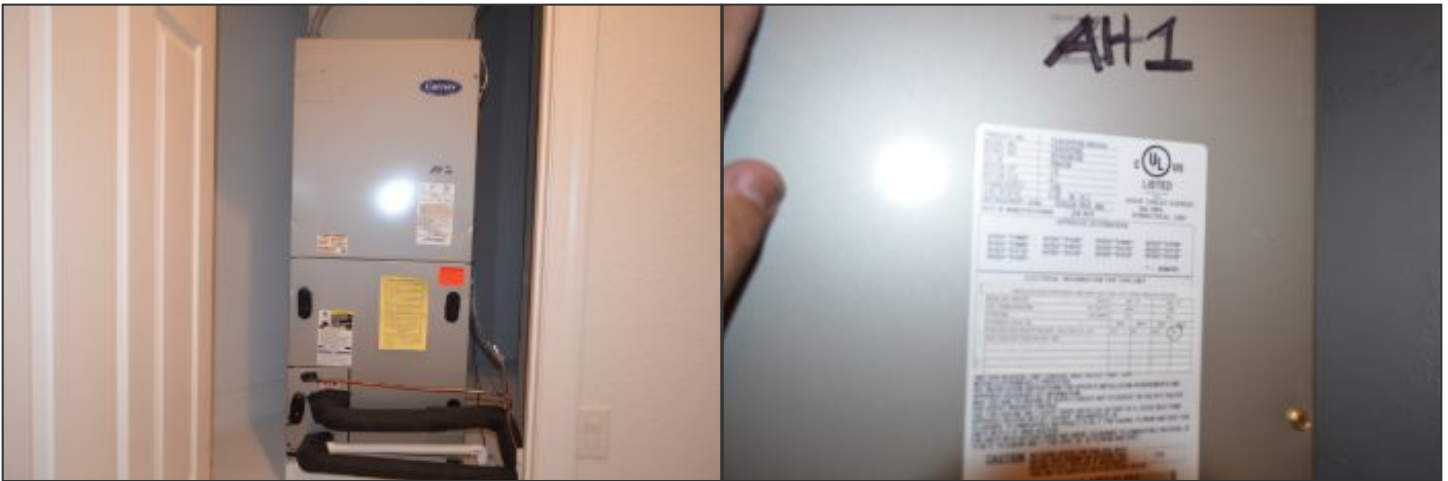
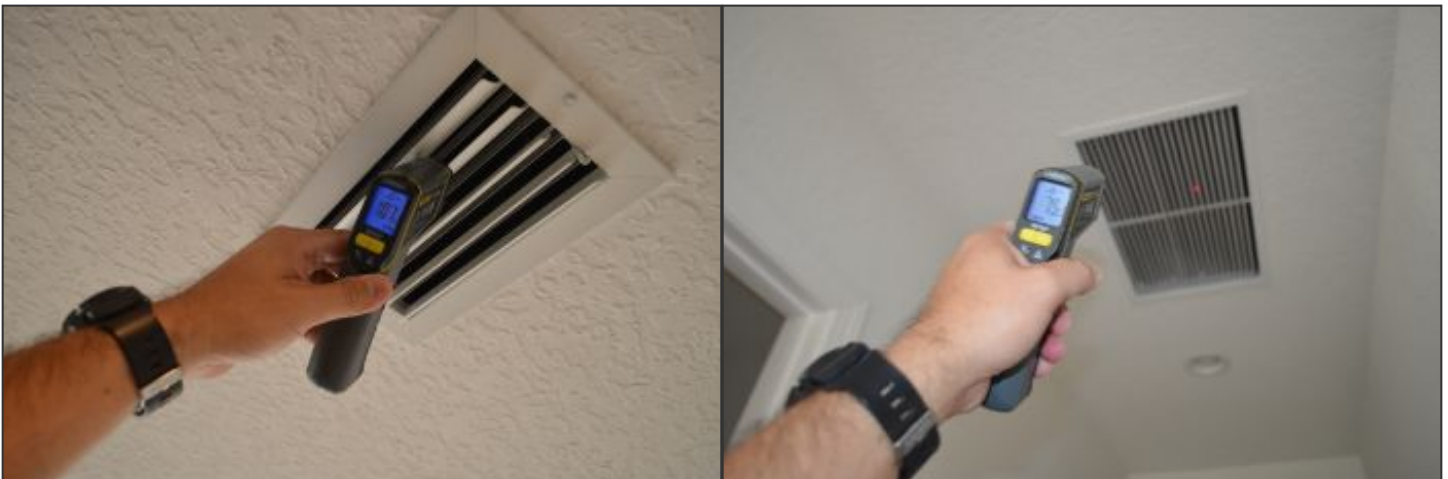
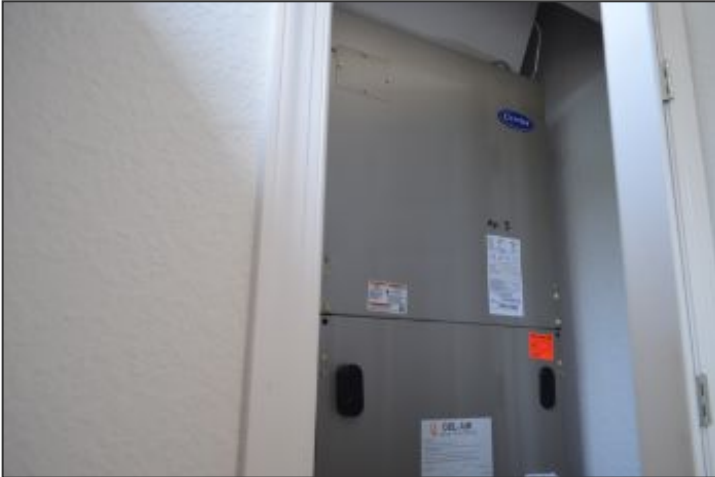
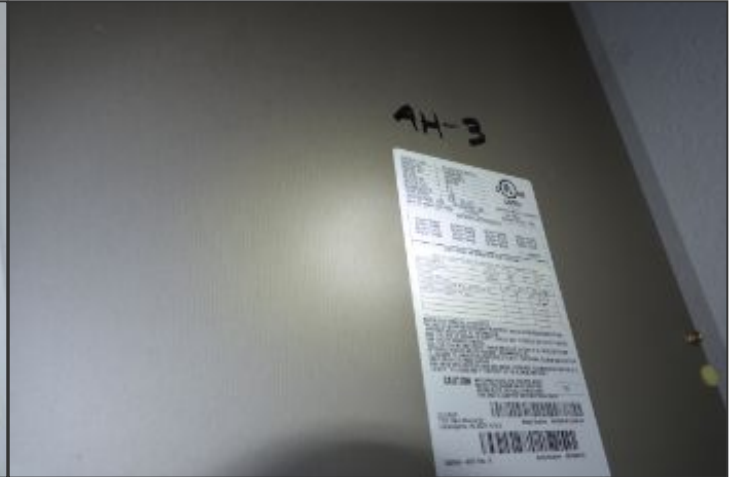
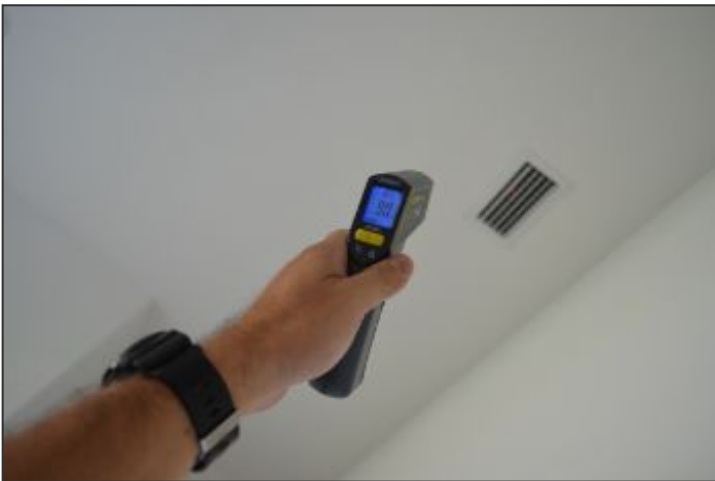
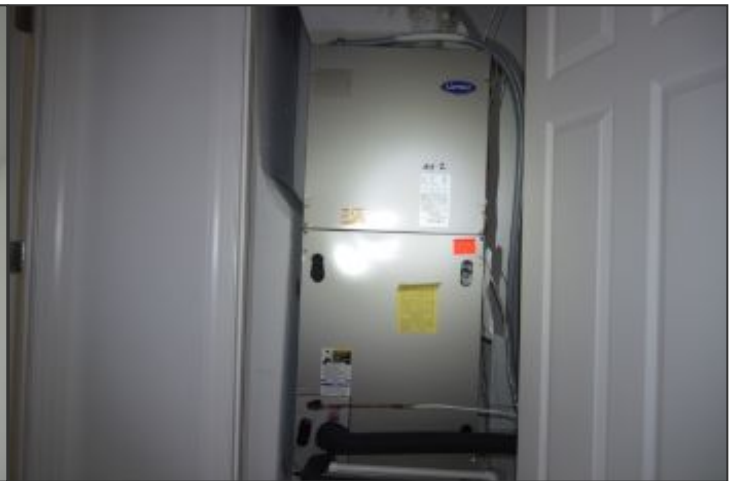
- 1.1. The remaining life expectancy of the units is approx. 13 years. Average life of a forced air system is approx. 16 years.
- 1.2. The heating systems returned air at 100+ degrees which the Inspector measured at the system vents throughout the interior of the home. The heating system appeared to provide heat when operated during the home inspection.
- 1.3. Discoloration at the plenum above the furnace (Unit No. 2 upstairs) should be removed as it appears to be organic growth which is common at this location but should be kept under control because if neglected it may affect indoor air quality.

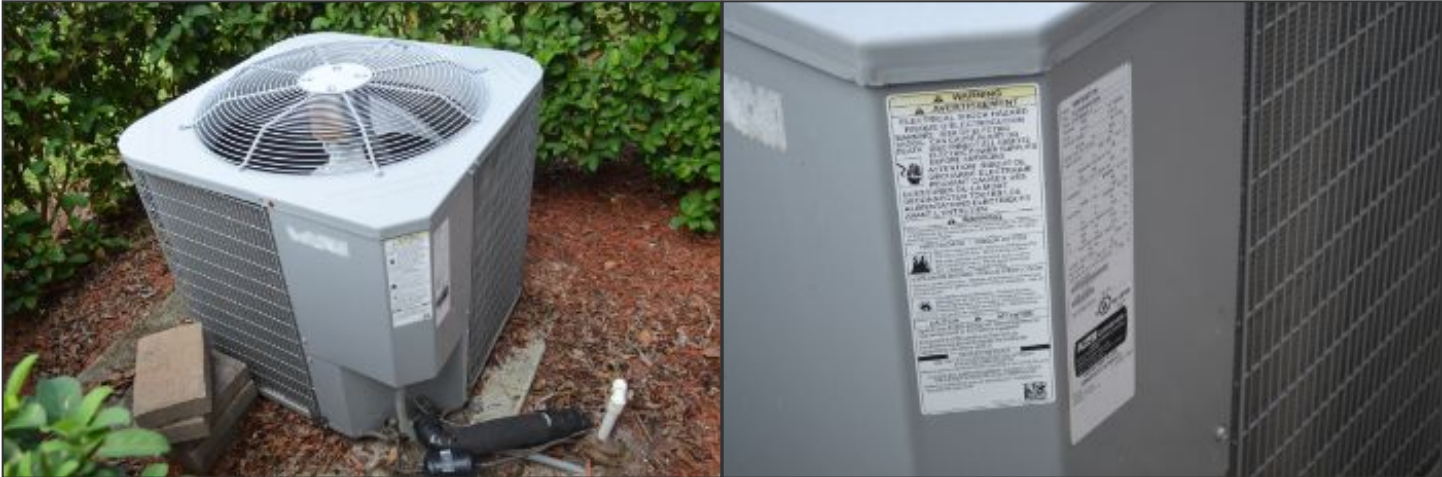
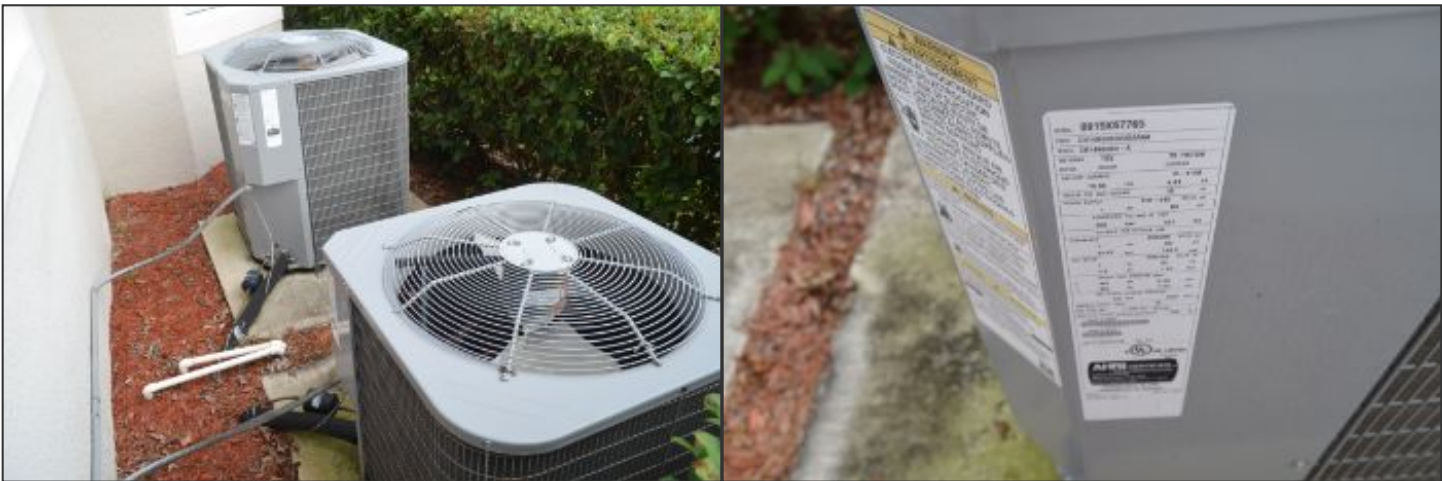
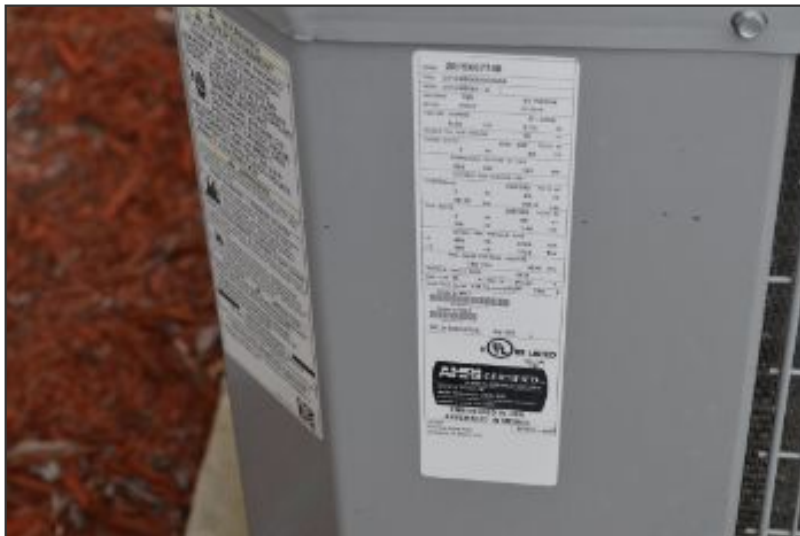
- 4.1. The air-conditioning systems responded to the controls and appeared to operate in a satisfactory manner. All visible components of the air-conditioning system appeared to be in serviceable condition at the time of the inspection. Inspection of the air-conditioning system typically includes examination of the following: Compressor housing exterior and mounting condition, refrigerant line condition, proper disconnect (line of sight), proper operation (outside temperature permitting), and proper condensate discharge. The system should be serviced at the beginning of every cooling season.
- 4.2. The remaining life expectancy of the unit is approx. 12 years. Average life of an outside A/C compressor/condenser is approx. 10-15 years.

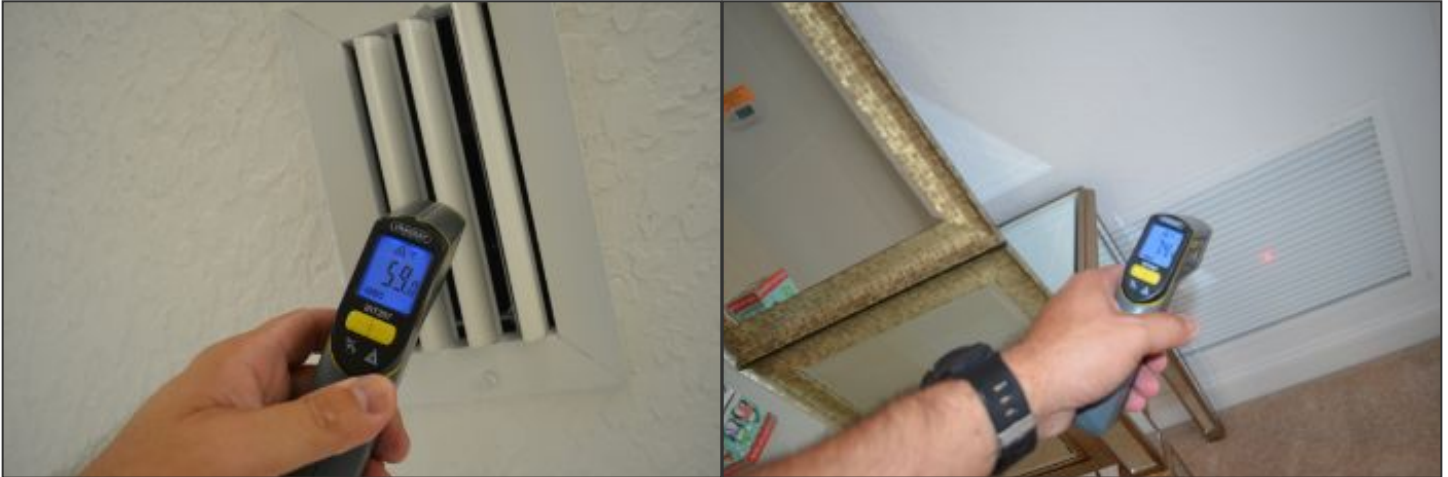
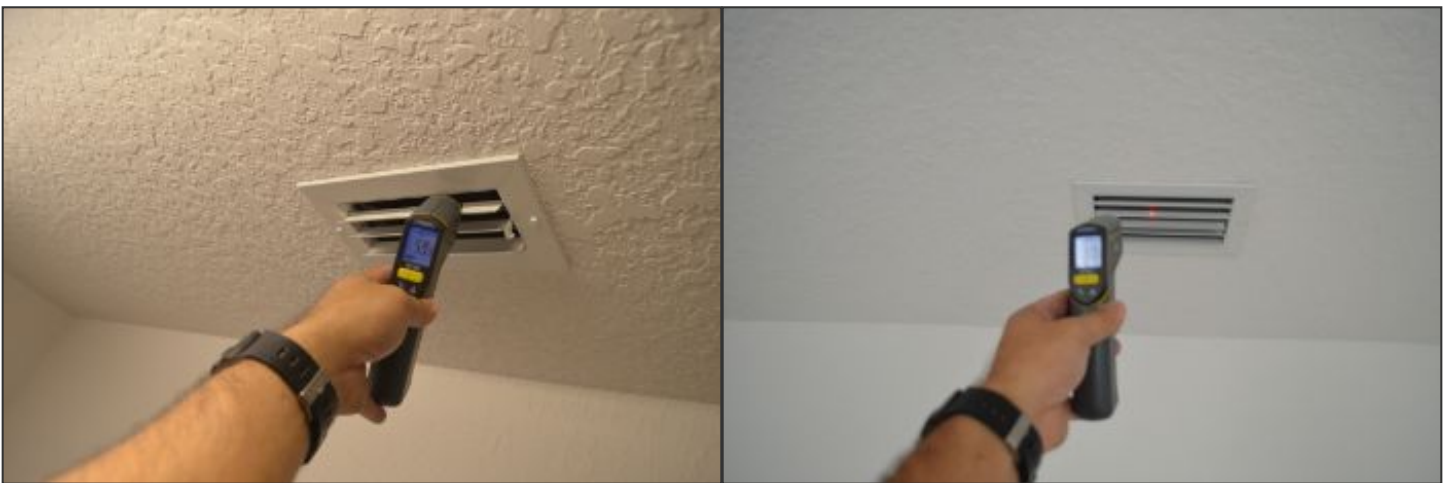
5.1. The differences in air temperature measured at supply and return registers fell within the acceptable range of between 14 and 22 degrees F. This indicates the unit were cooling as intended.

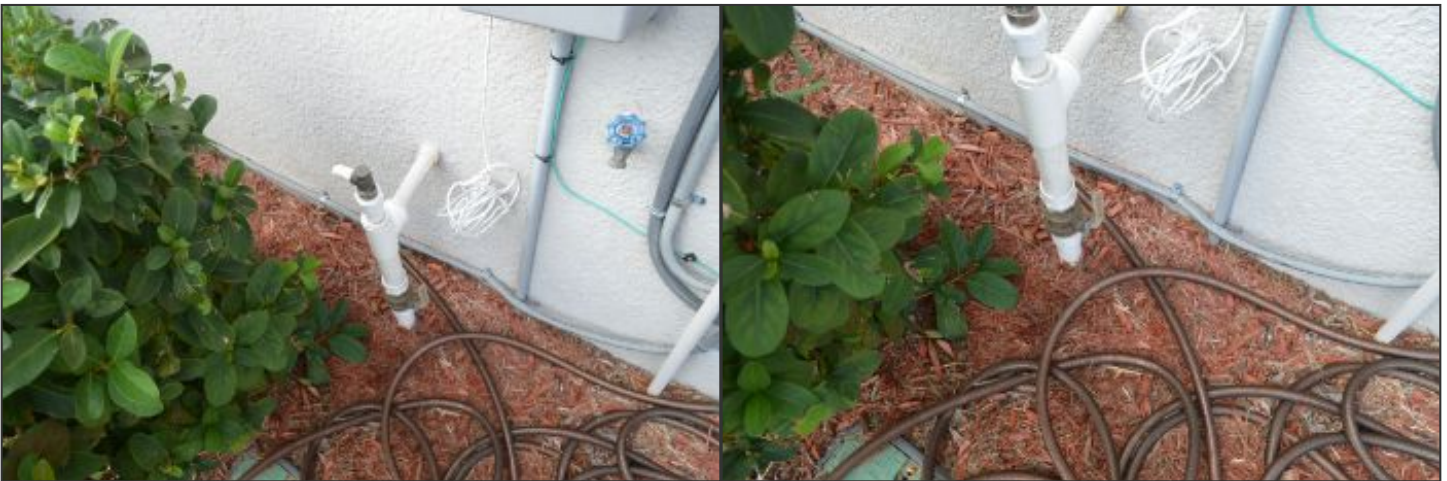
3.1. Although the main water supply shut-off valve was not operated at the time of the inspection it was visually inspected and appeared to be in satisfactory condition.

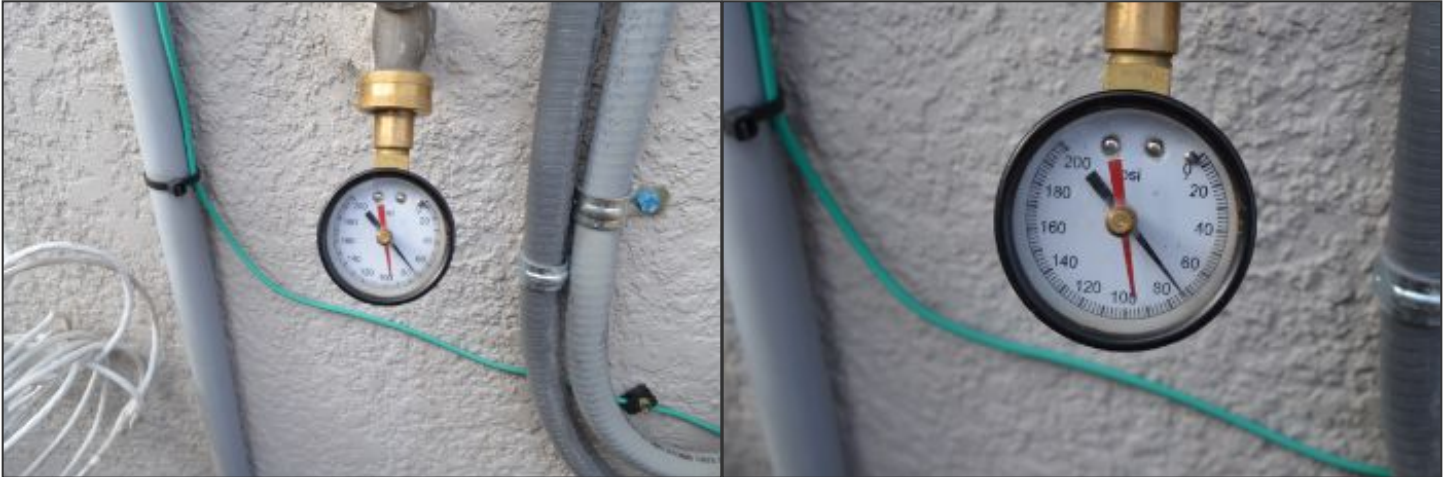
6.1. Home water supply pressure was within the acceptable limits of 40 pounds per square inch (PSI) and 80 PSI at the time of the inspection.

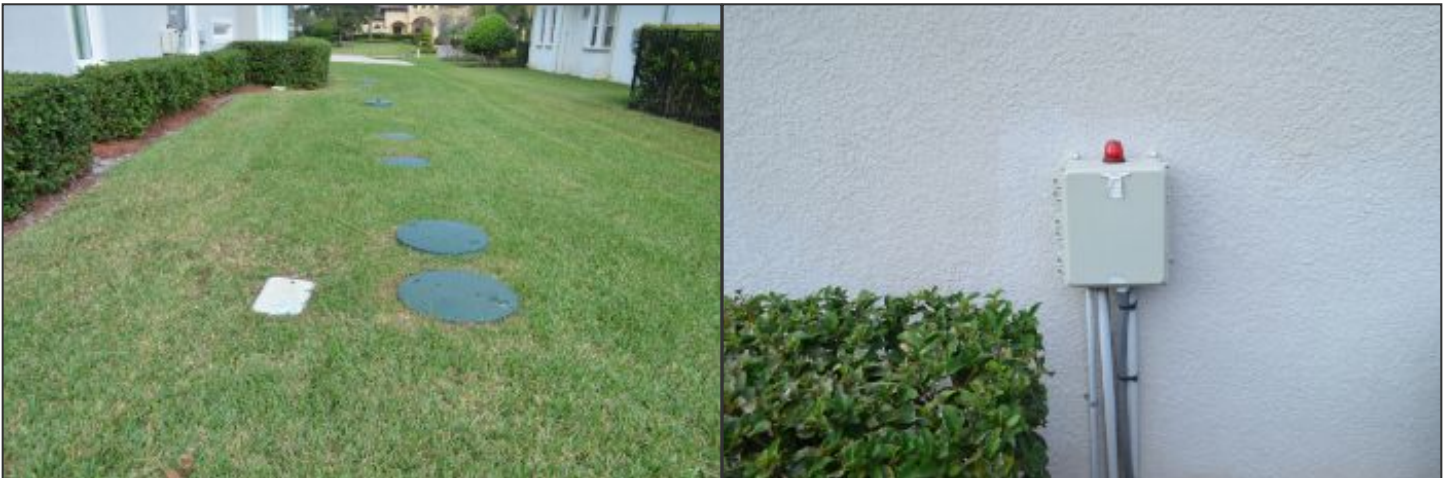
Description: This house is connected to a septic sewer system. We do not inspect these systems. Recommend consulting with the County Health Department for information regarding inspection, certification and maintenance of the septic systems. Seller's agent stated Septic system was in need of maintenance at the time of the inspection.

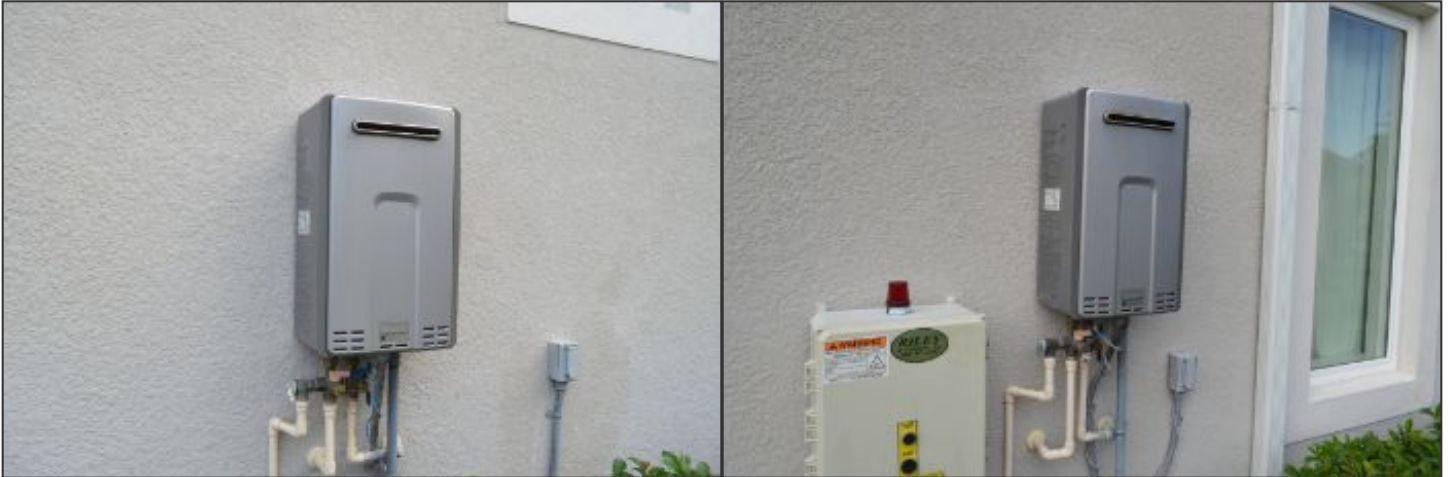
Description: The home was equipped with two tankless gas water heaters. . The water heater brand was Rinnai.

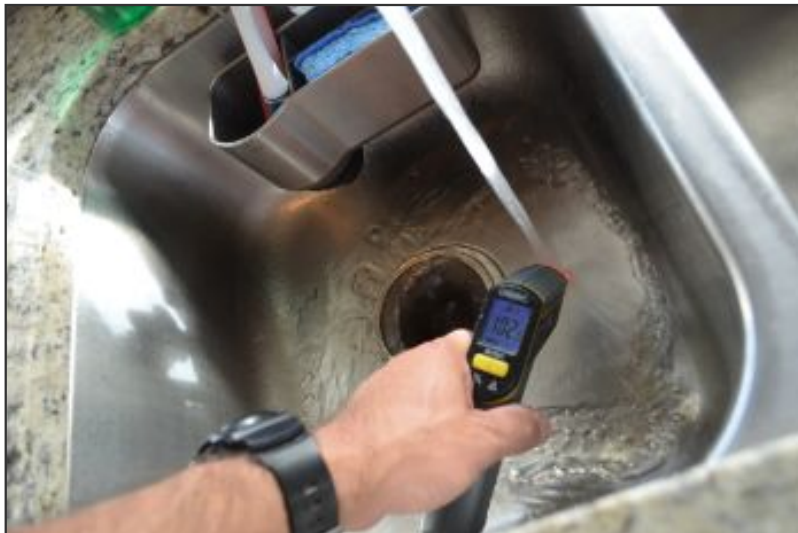
10.1. The water heaters responded to the demand for hot water.

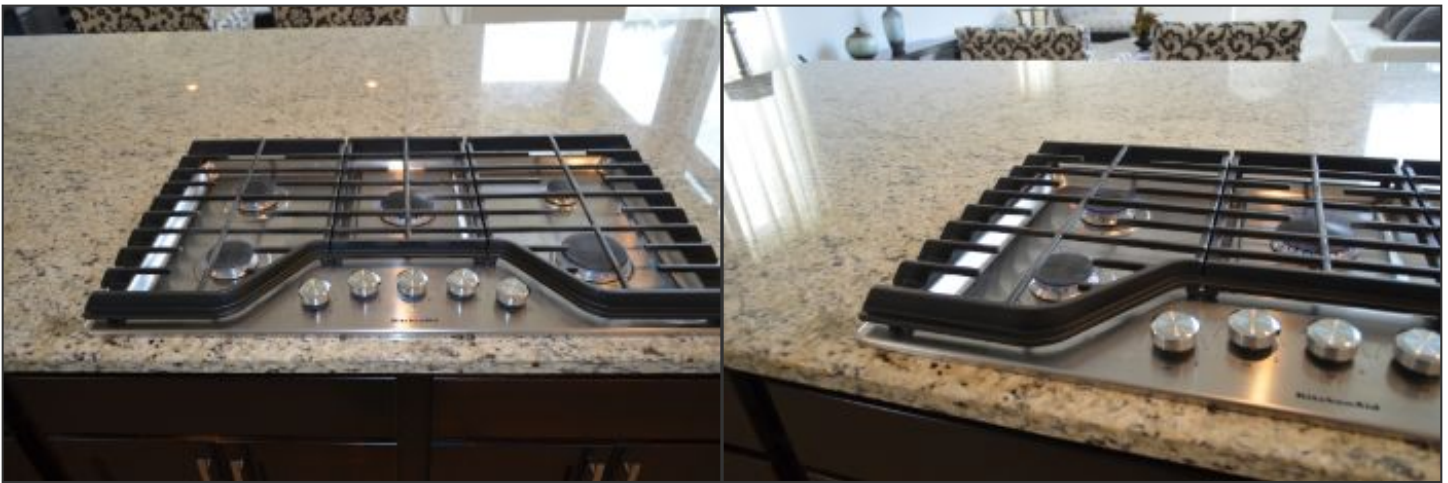
6.1. The home was equipped with a gas-fueled cooktop and separate built-in oven instead of a range. The cooktop indicated to be operating normally and in satisfactory condition at the time of the inspection.

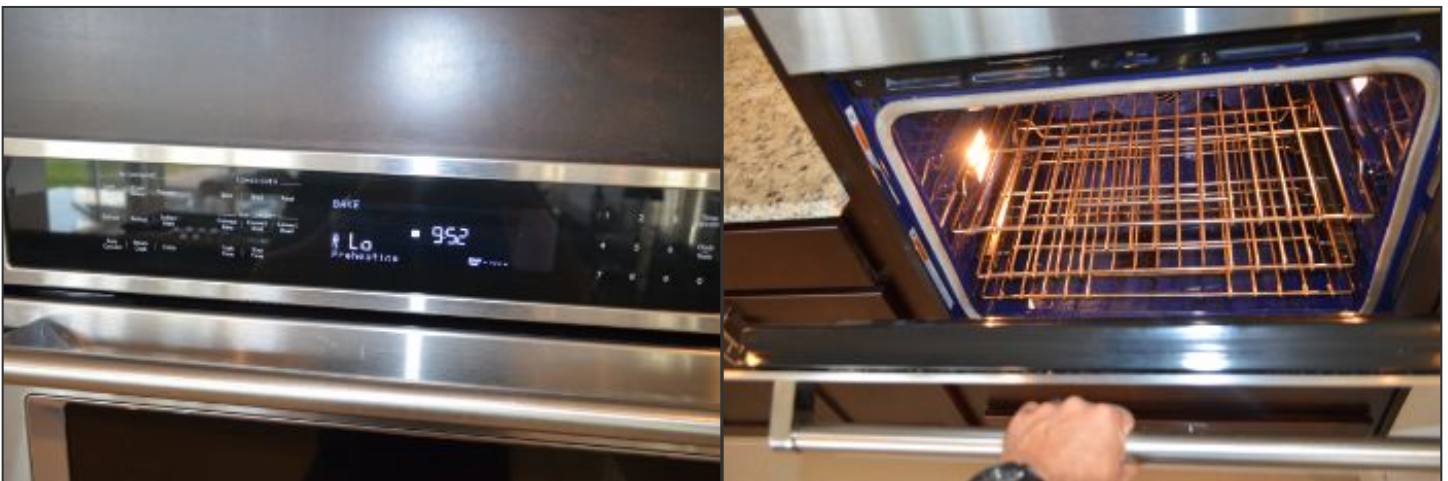
7.1. The electric built-in oven was operated and appeared to be in good working condition at the time of the inspection.

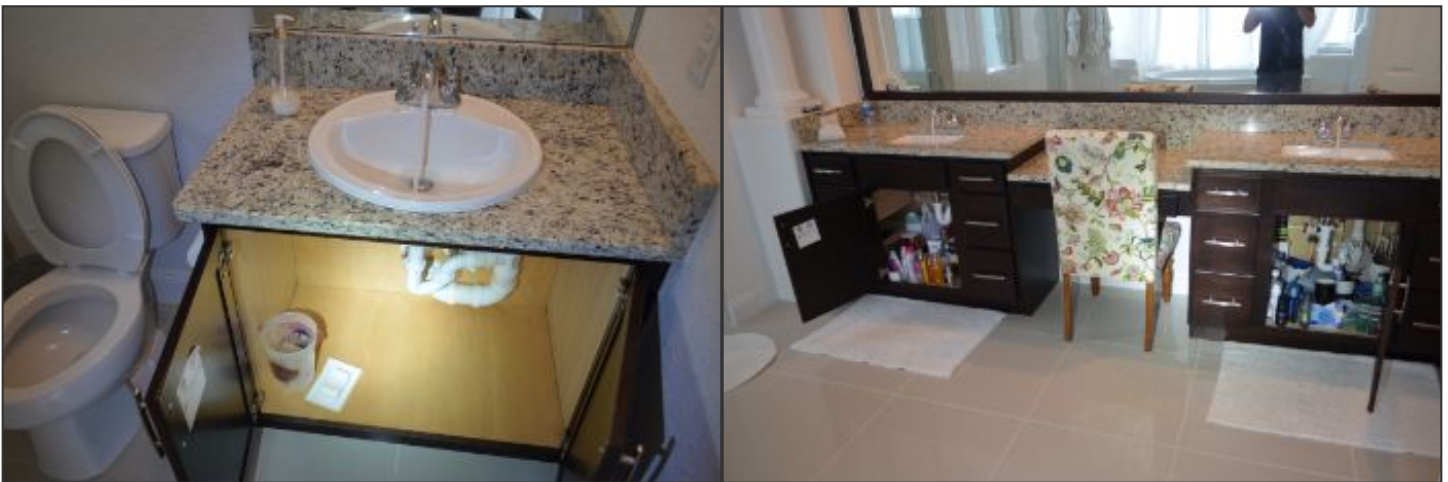
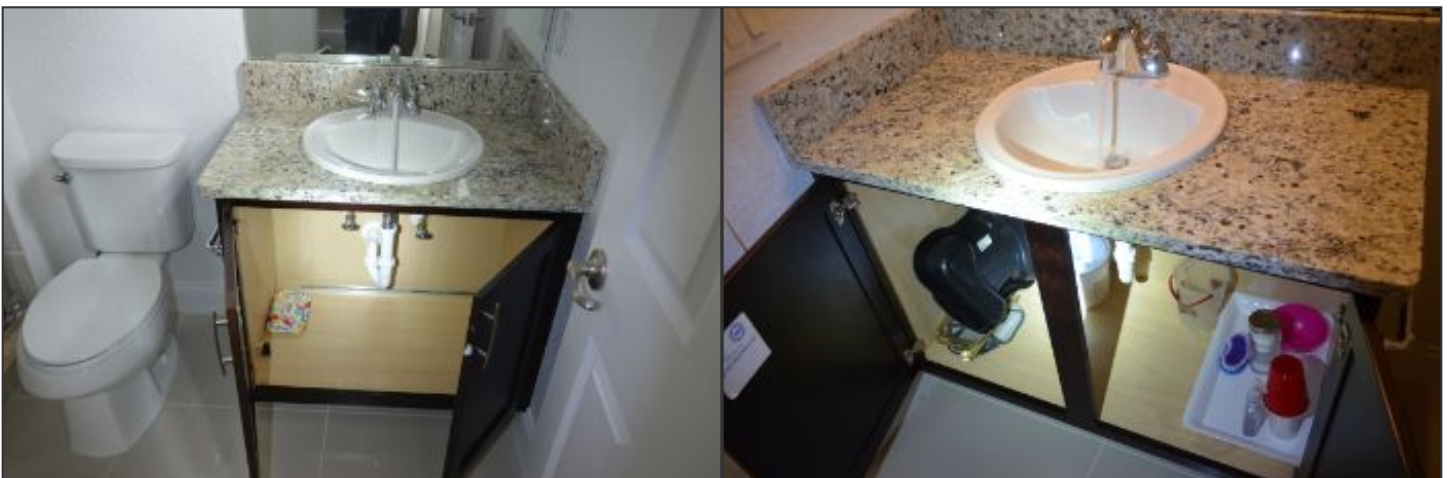
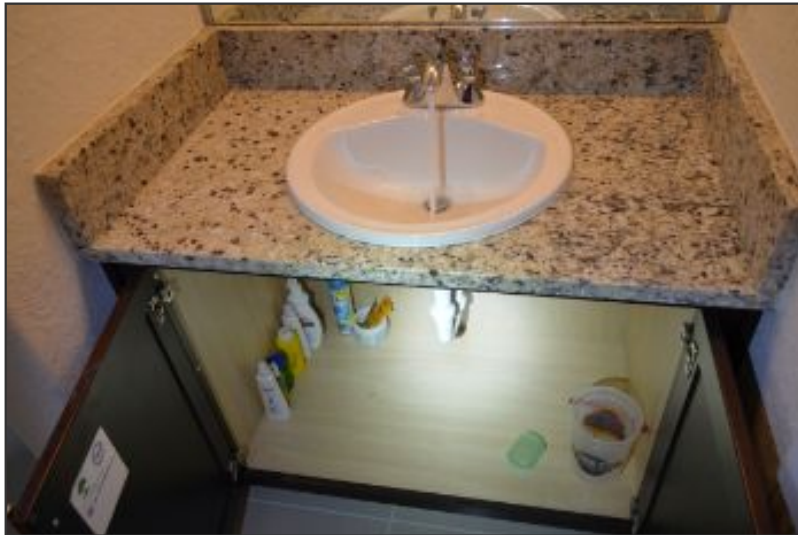
2.1. The cabinets were in good condition overall.

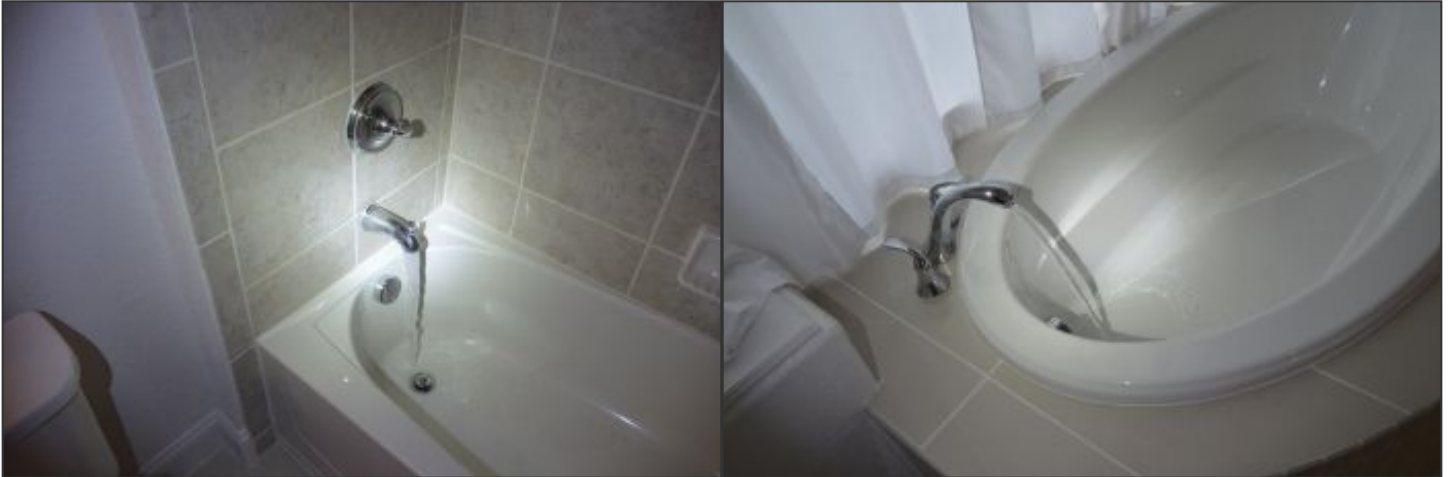
5.1. The bathtubs were in satisfactory condition and they had functional drainage at the time of inspection.

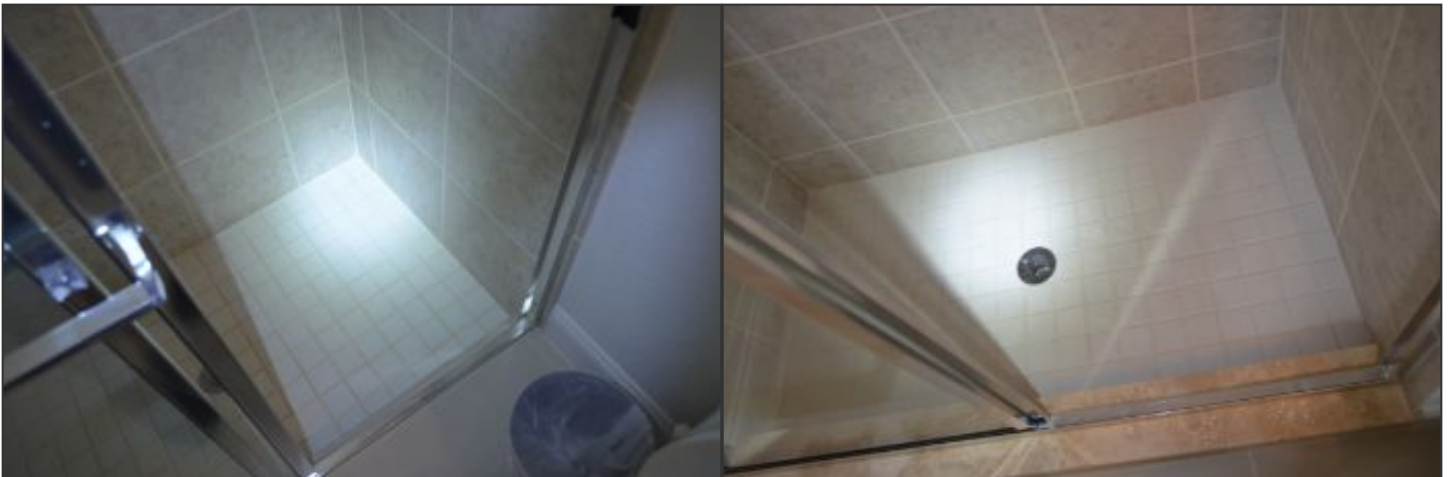
6.1. The bathroom showers were in satisfactory condition. See caulking recommendations below.

9.1. Water intrusion from bathtubs and shower enclosures is a common cause of damage behind walls, sub floors, and ceilings below bathrooms. As such, periodic re-caulking and grouting of tub and shower areas is an ongoing maintenance task which should not be neglected.

9.5. We highly recommend that any caulking issues/deficiencies listed in this inspection report, be addressed and corrected by the client (buyer) and not the seller. The reason is: Old caulk must be removed--the surface meticulously cleaned--Then new caulk should be applied. A seller may not always have the best interest in mind for a thorough job--that will may have to be re-accomplished.
