Home Inspections by PJM, Inc.

Confidential - Property Inspection Report - Confidential

1234 Sample Rd, Kissimmee, FL 34746
Inspection prepared for: Sample Sample
Date of Inspection: 5/9/2017 Time: 2:00 PM
Age of Home: 5 years Size: 3,650 SqFt
Weather: Scattered Clouds/Warm
The utilities were on at the time of the inspection.

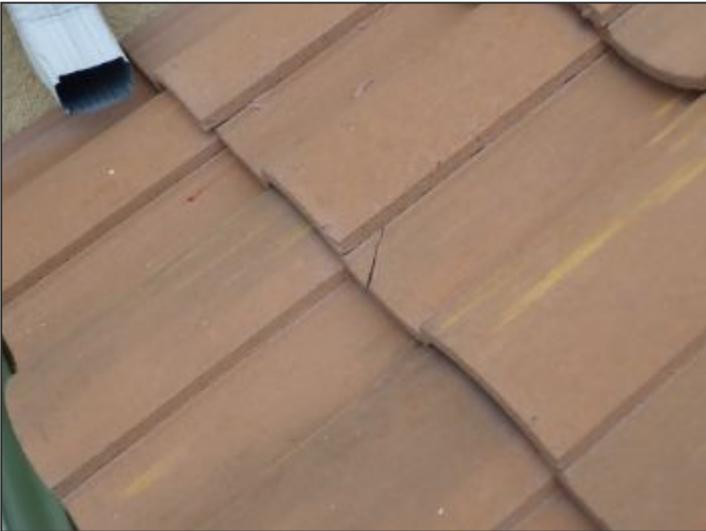
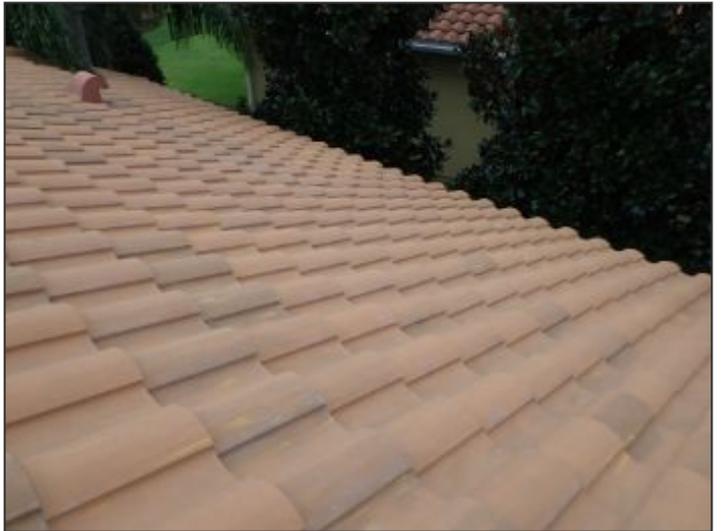
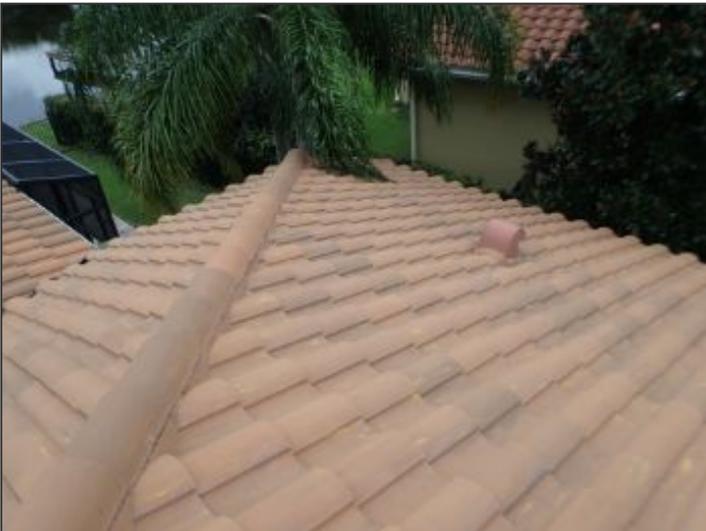
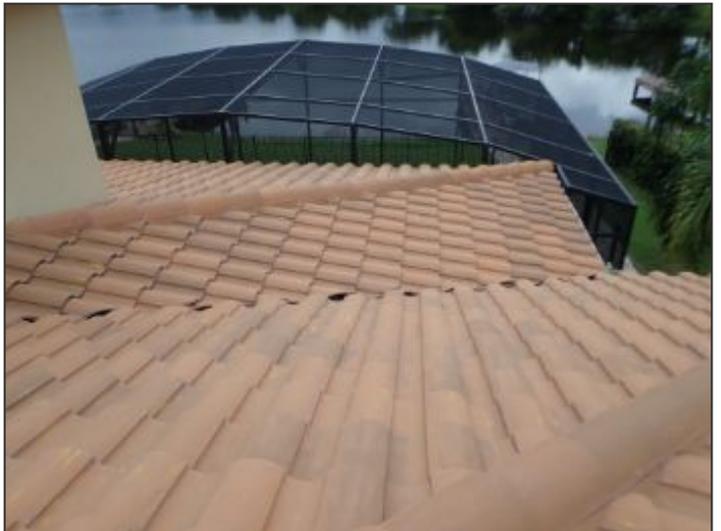
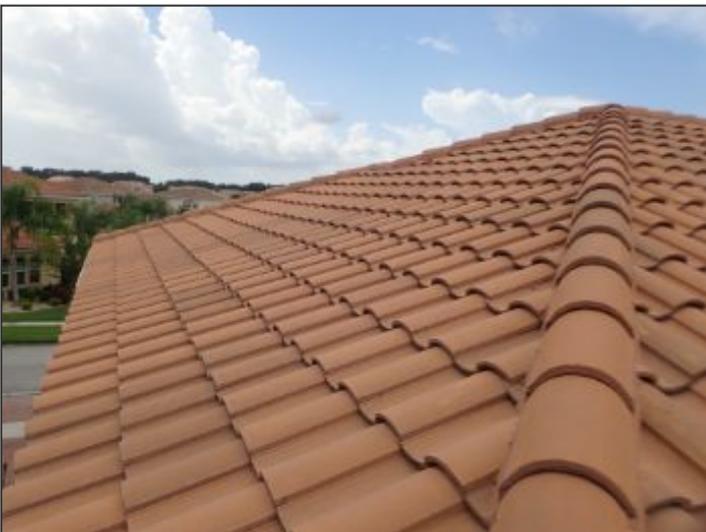
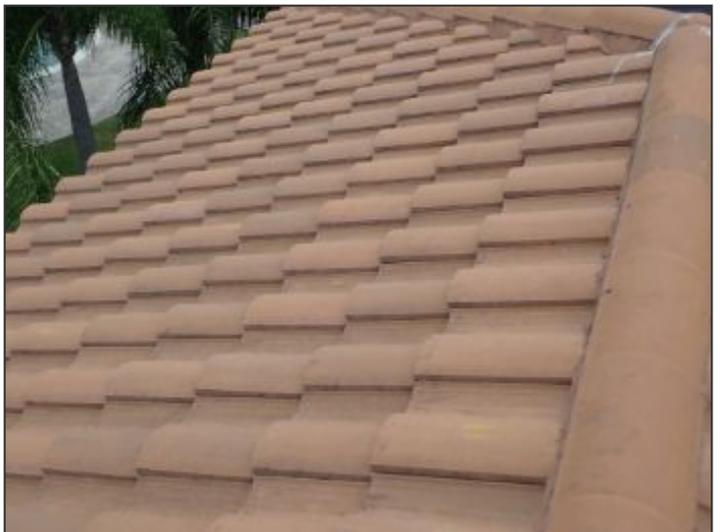
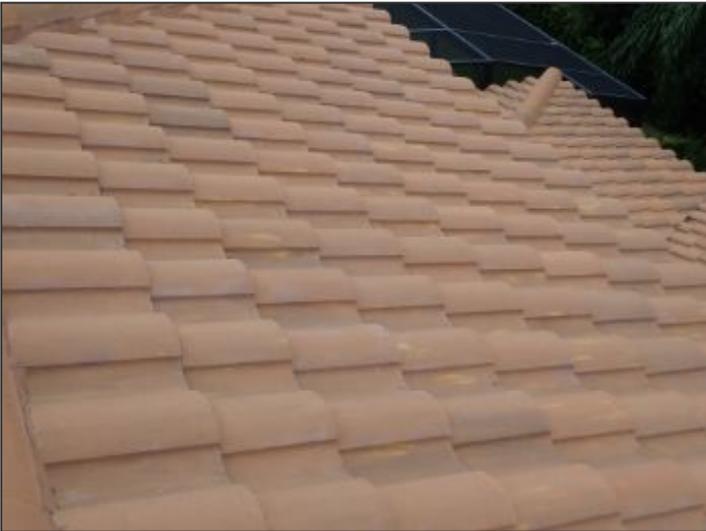
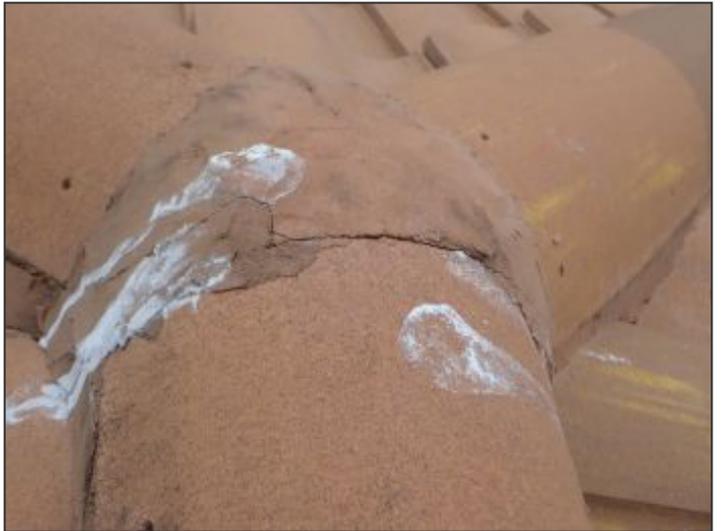
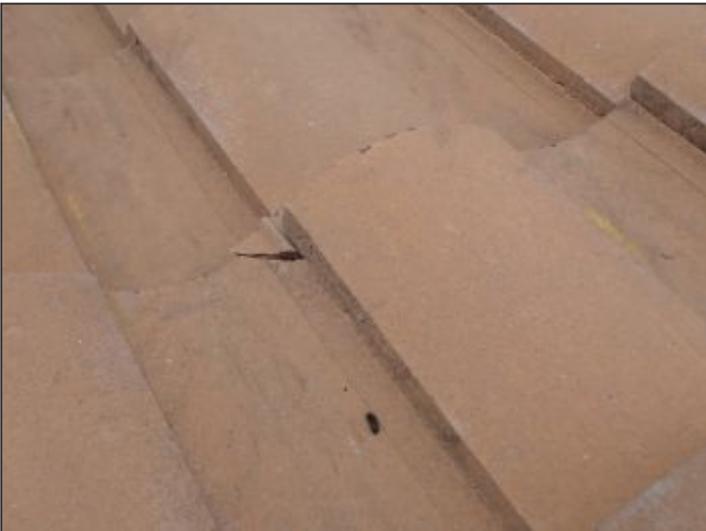
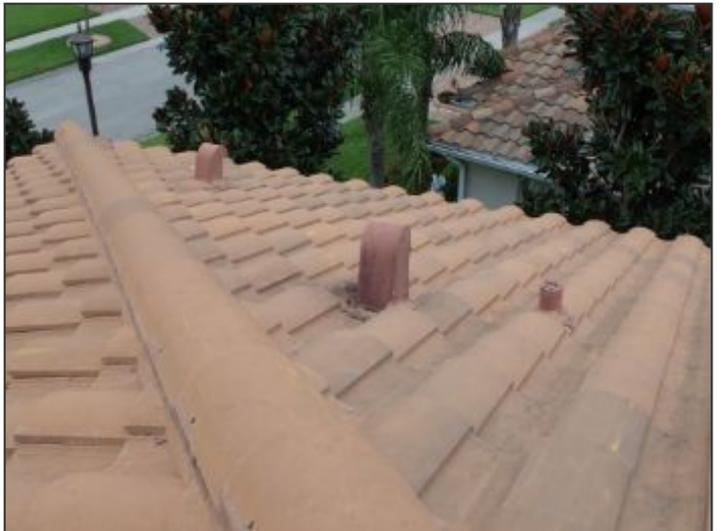
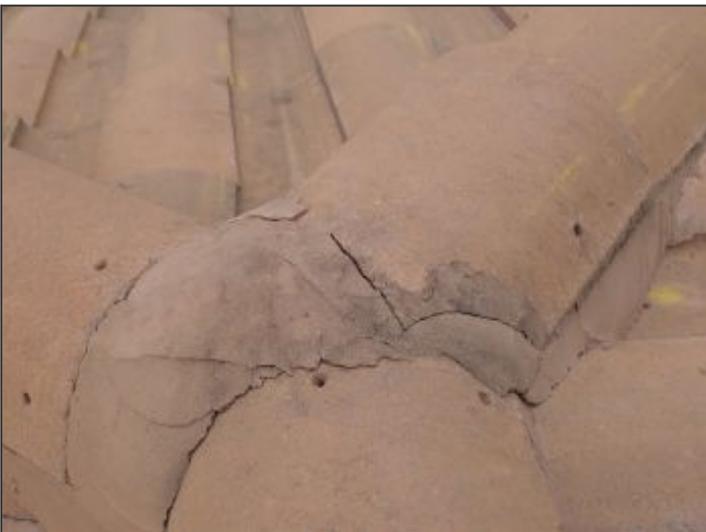
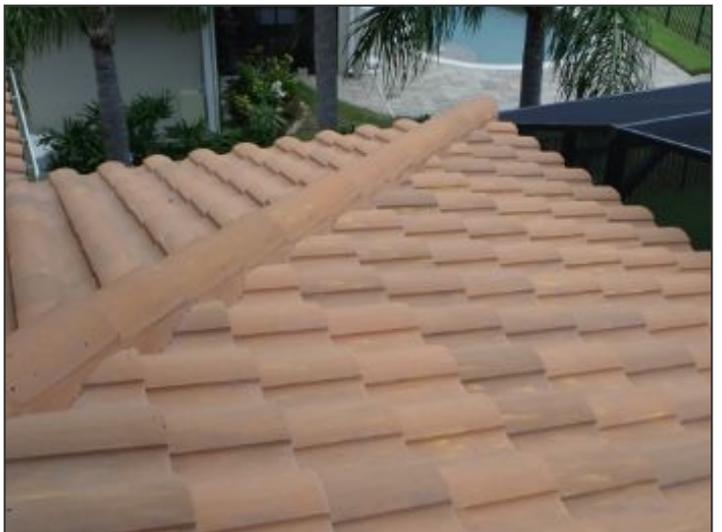
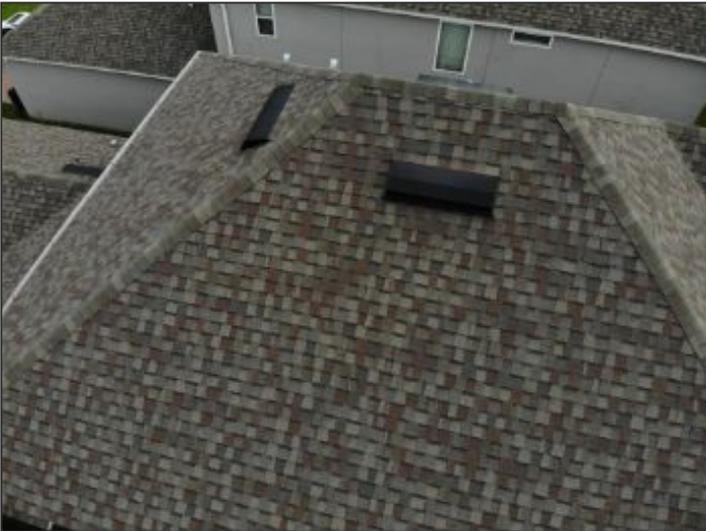
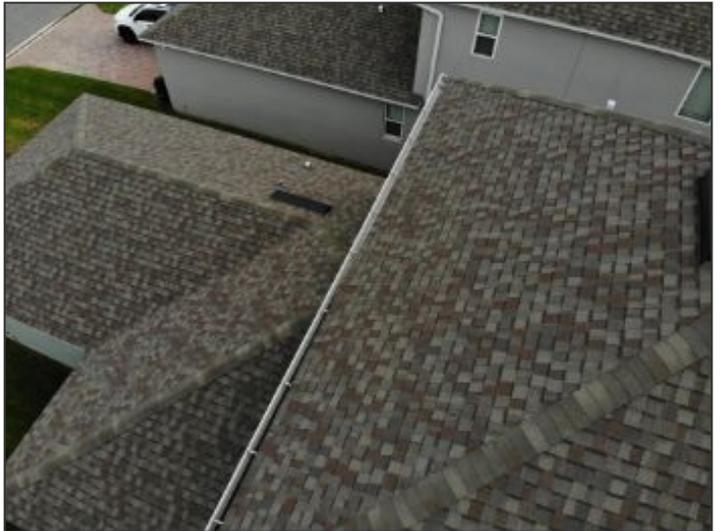
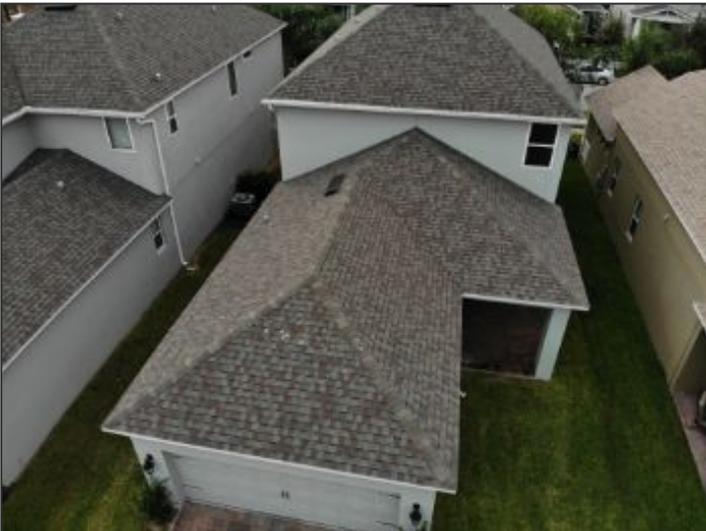
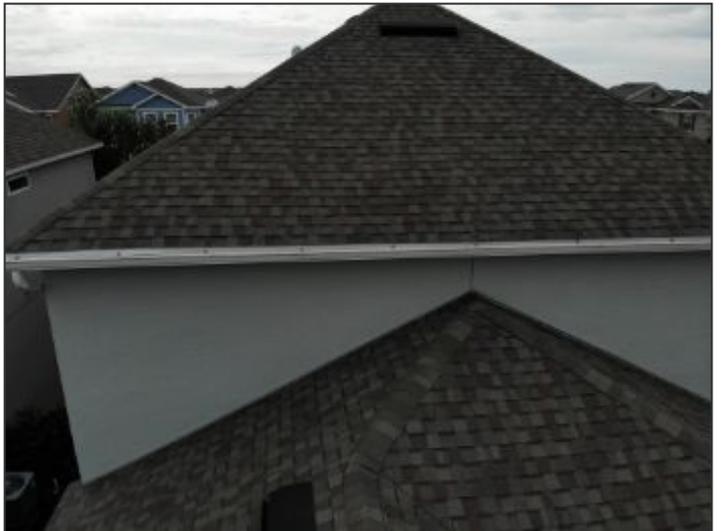
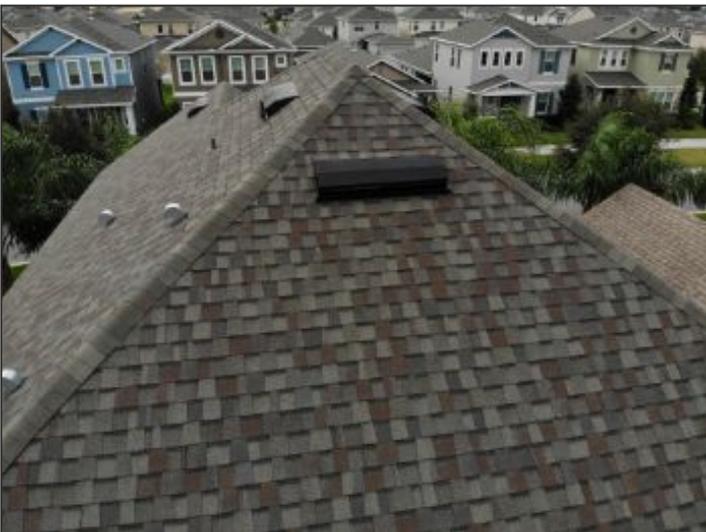
3.2. The inspector noted minor chips and hairline fractures at the roof tiles. This is a common condition for normal wear and age of the roof covering. Consider having someone service as required. Mortar joints at the tiles had minor cracks observed as well, proper maintenance includes sealing as required.

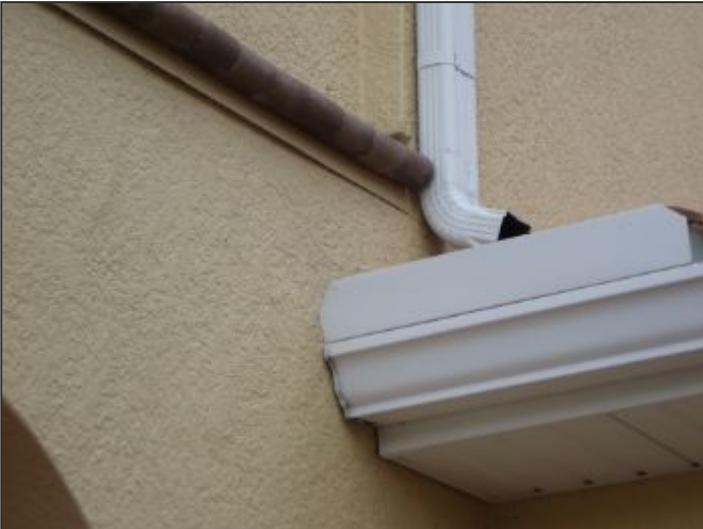
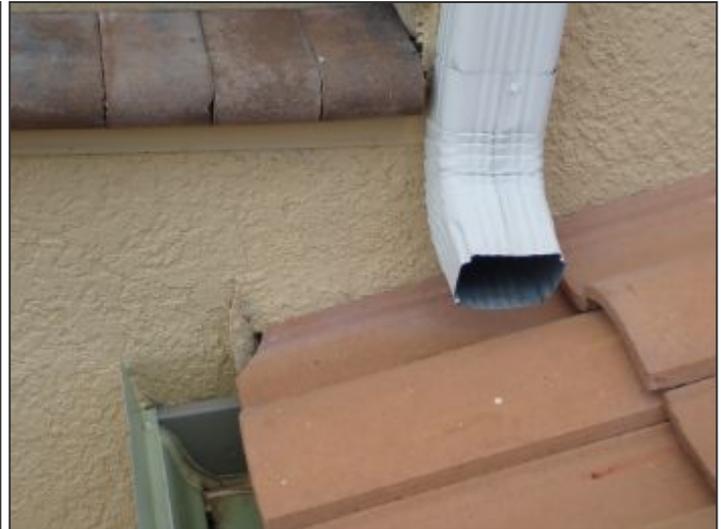
4.1. The inspector recommends having both flashing sections over either garages as leaks were noted at both locations. The inspector noted minor stucco cracking near the flashing as well. The areas were adjacent to the balcony and roof covering, this geometric shape will cause water drainage to impact areas. Ensure to have a qualified roofing contractor review both areas and determine the best possible course of repairs which includes preventative measures to avoid issues from arising again.

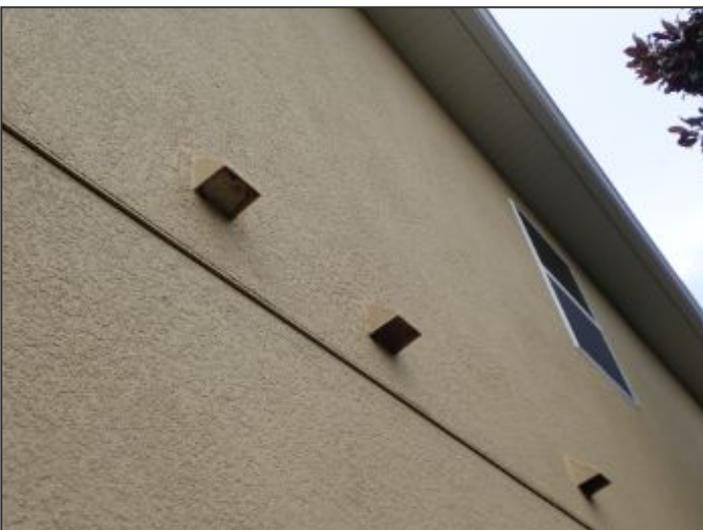
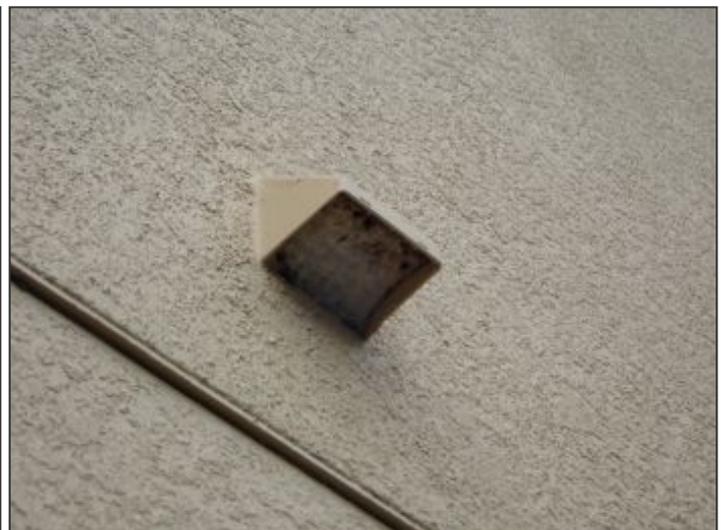
6.1. The inspector noted a vent at the side of the home's exterior wall covering was blocked/clogged at the time of the inspection. Consider servicing to avoid improper ventilation.

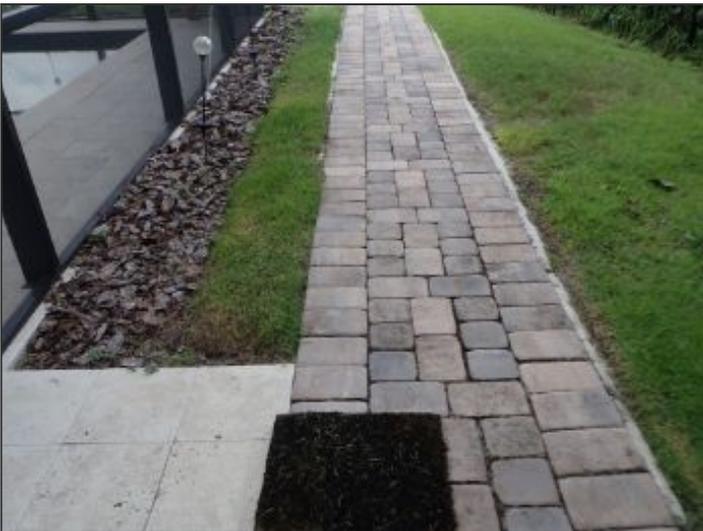
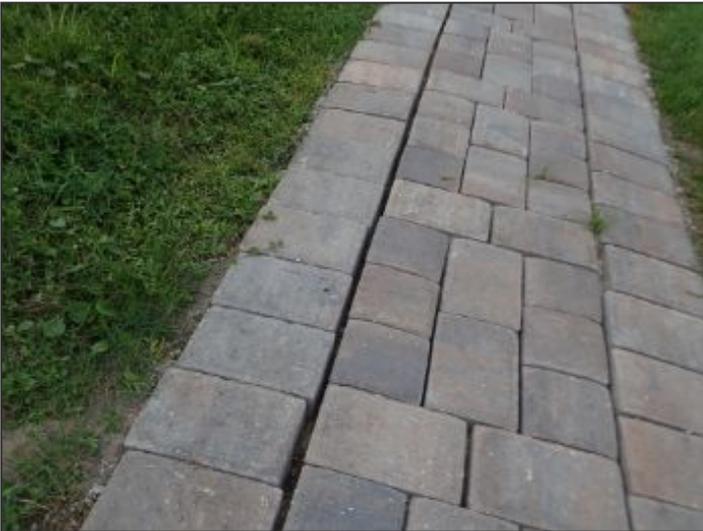
2.1. The inspector noted the pavers leading to the boat dock were loose and appear to require service. Ensure to fasten and seal to avoid pavers becoming a trip hazard or detached.

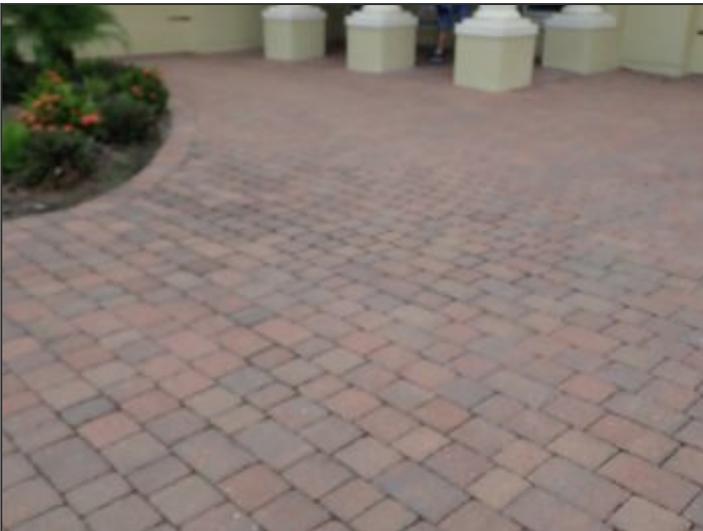
3.1. Driveway in good shape for age and wear. Some of the pavers were loose and should be refastened and serviced.

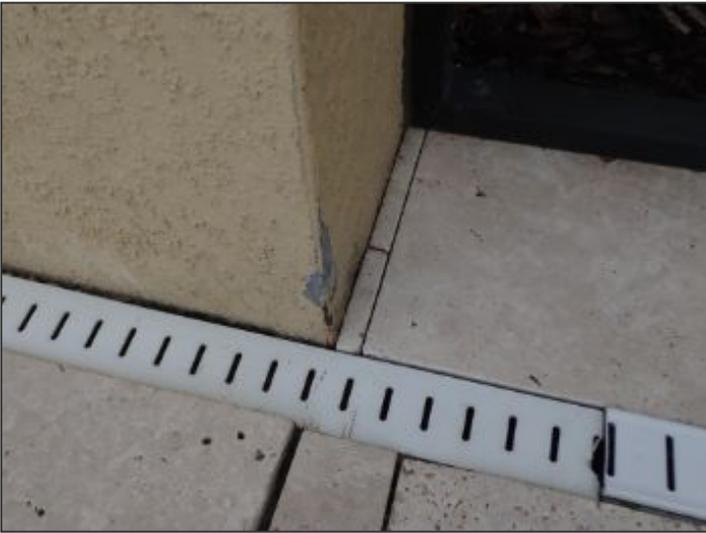
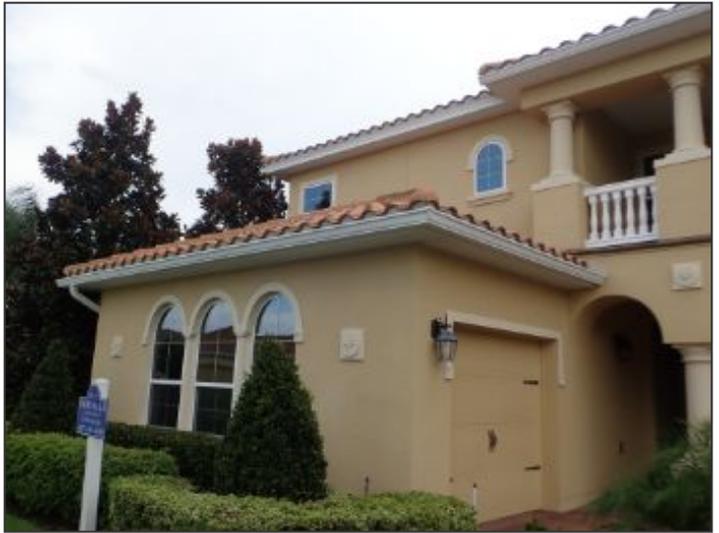
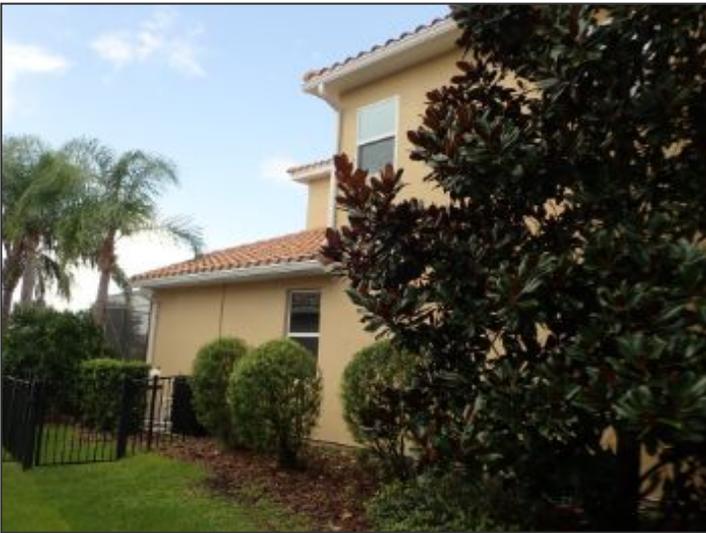
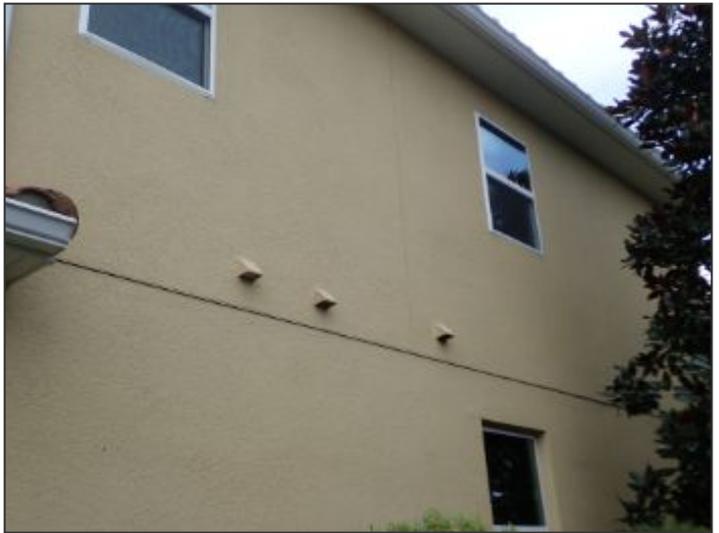
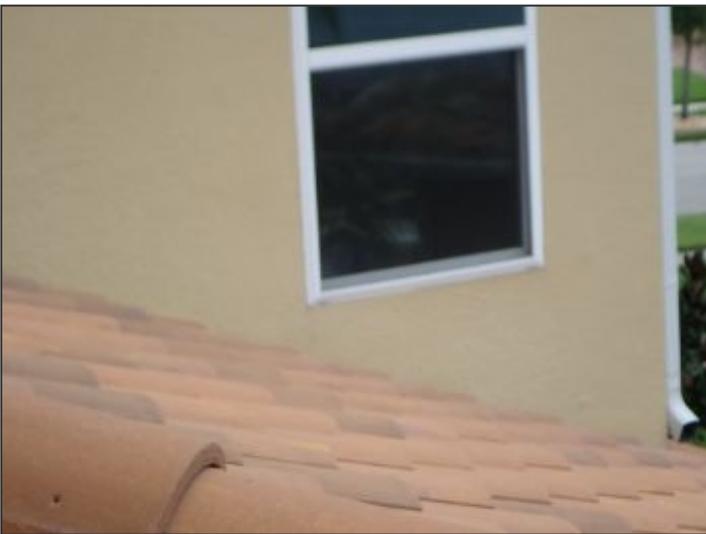
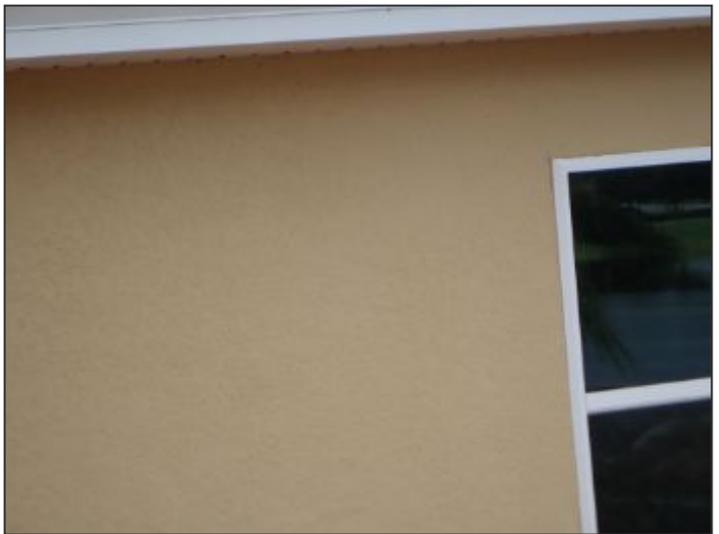
4.1. General minor cracking, not uncommon in stucco covering exterior walls, was visible at the time of the inspection. This condition is typically the result of long-term thermal expansion, contraction and minor settlement. Cracks should be sealed with an appropriate material to help prevent damage from moisture intrusion of the wall assembly.

4.2. Minor stucco cracks were noted at the second floor master bedroom window, consider sealing these cracks. There were other minor cracks, but these appear to require more attention.

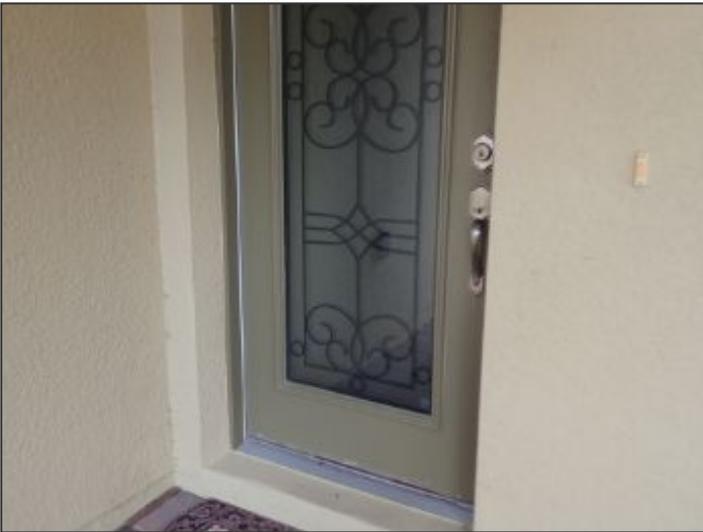
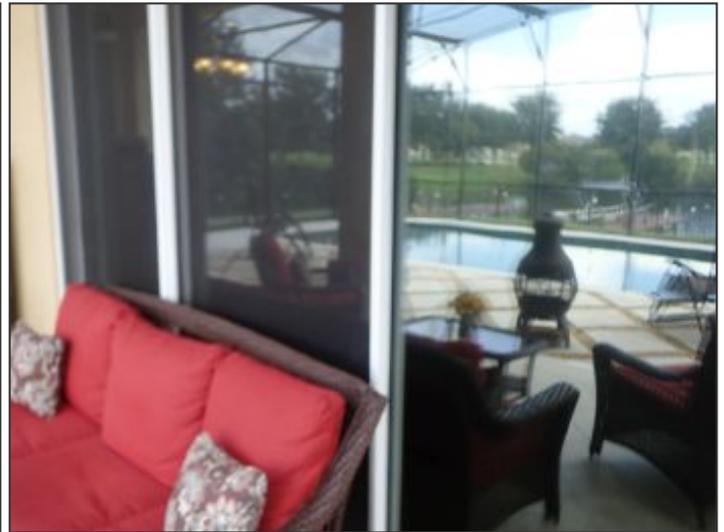
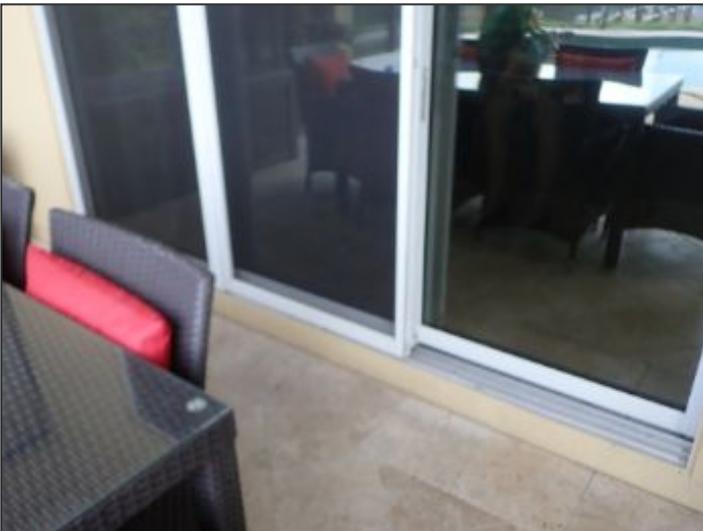
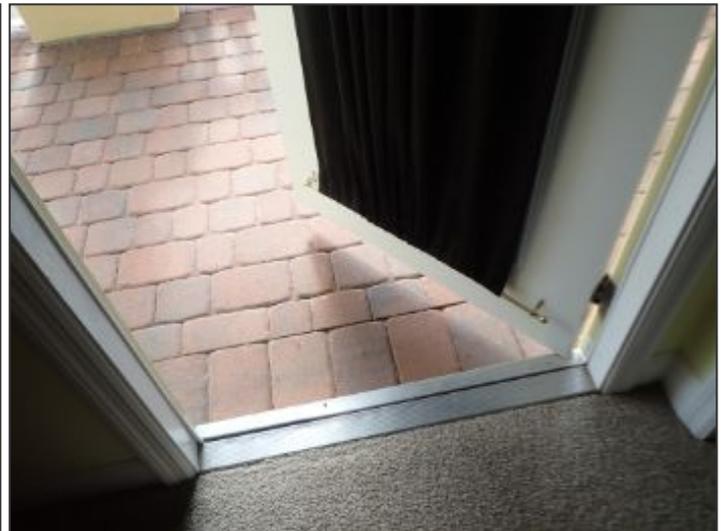
8.1. At the time of the inspection, windows in the home had gaps around the perimeter which should be sealed with an appropriate sealant to help prevent moisture intrusion of the exterior wall assemblies.

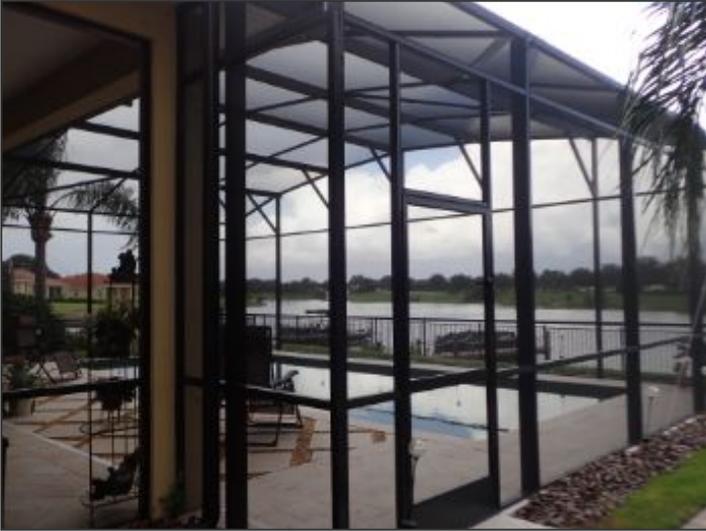
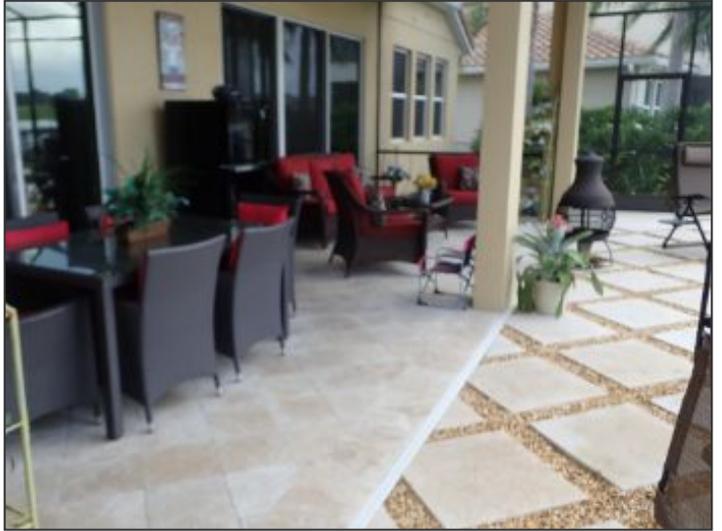
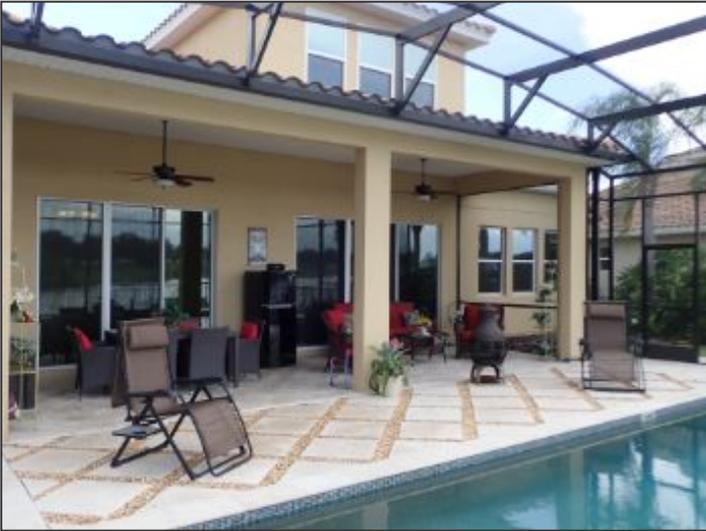
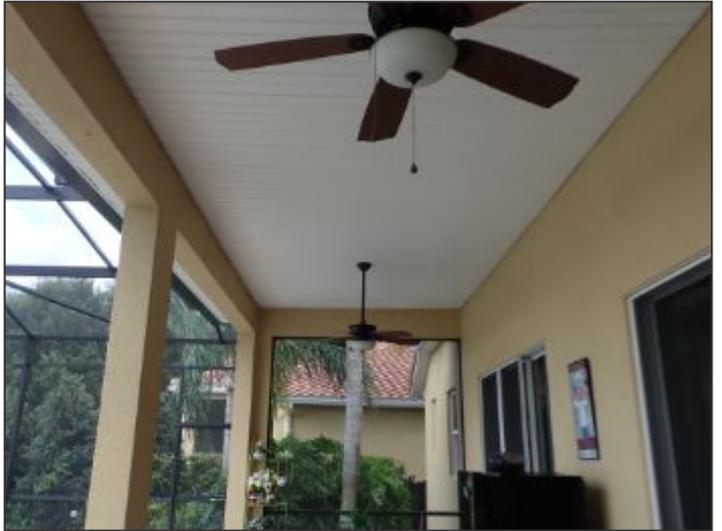
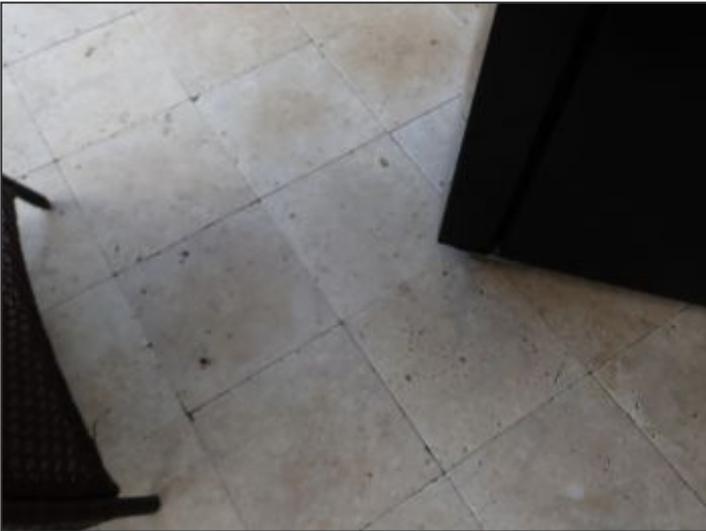
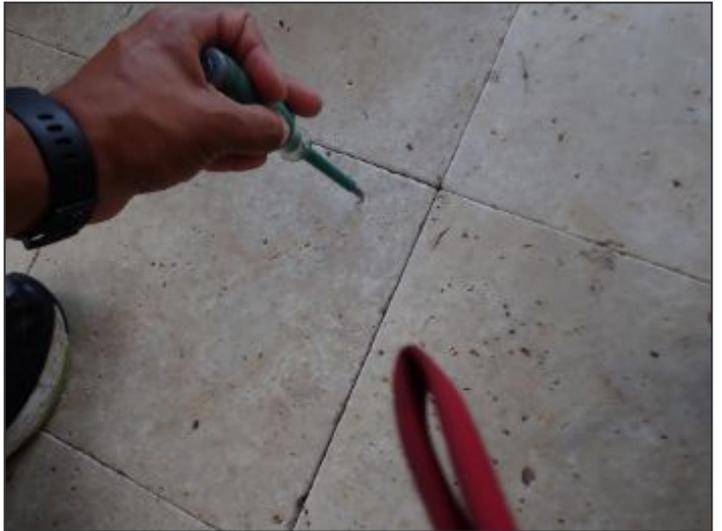
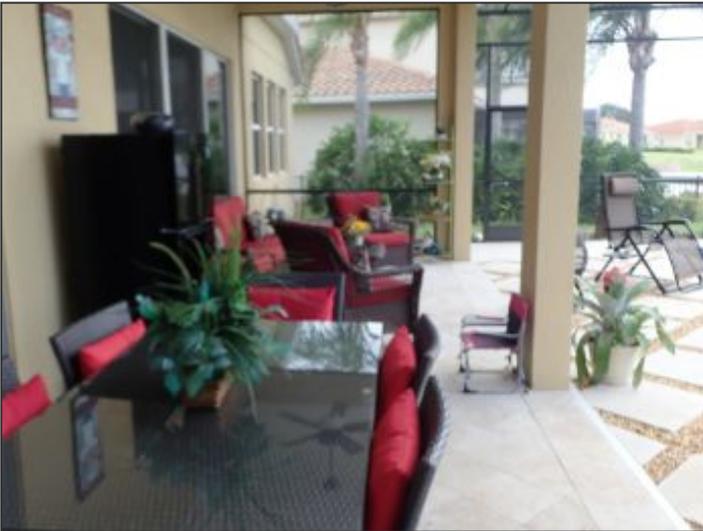
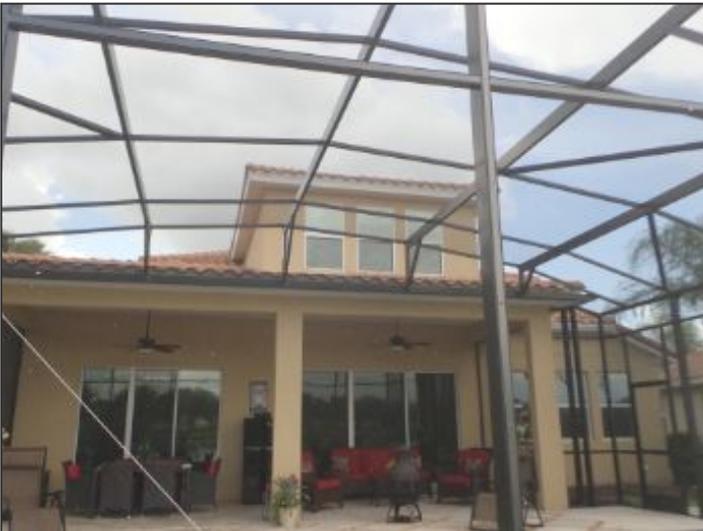
9.2. The pavers at the porch were loose at the time of the inspection. The inspector noted hollow sound from multiple locations tested, which usually signifies poor install of underlying sealant. This can lead to loose pavers which in turn become trip hazard or crack due to movement, consider having the pavers serviced.

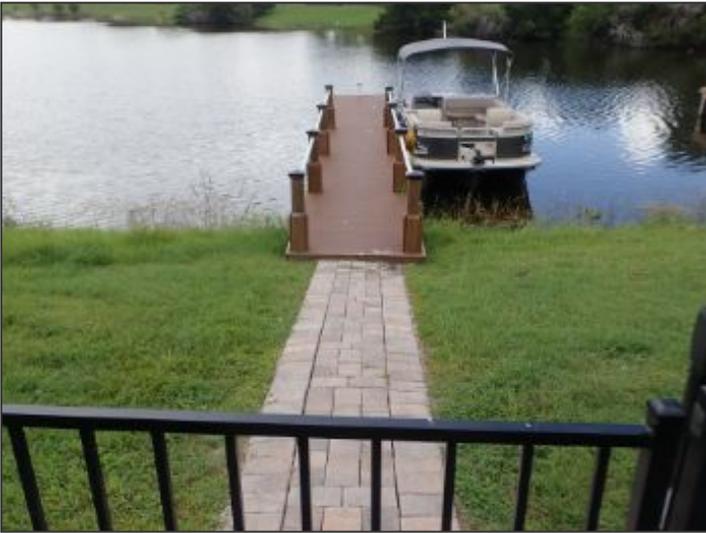
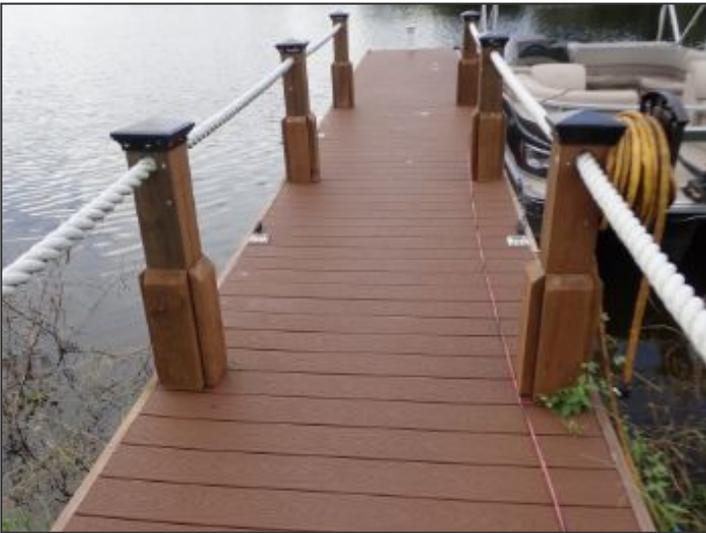
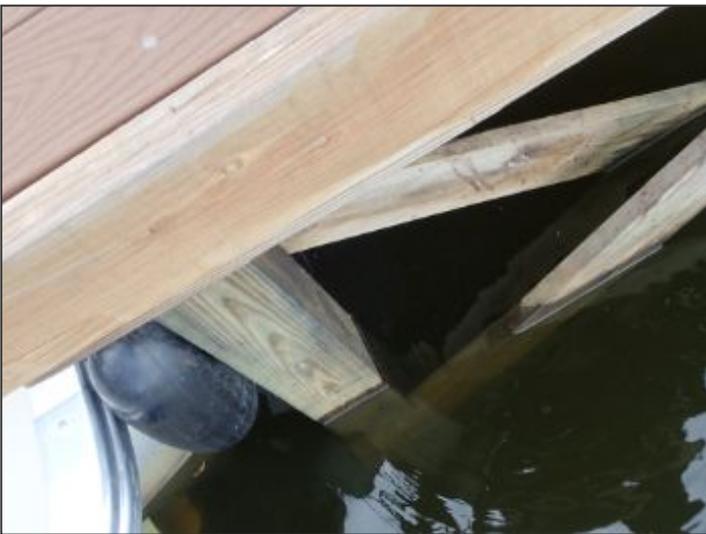
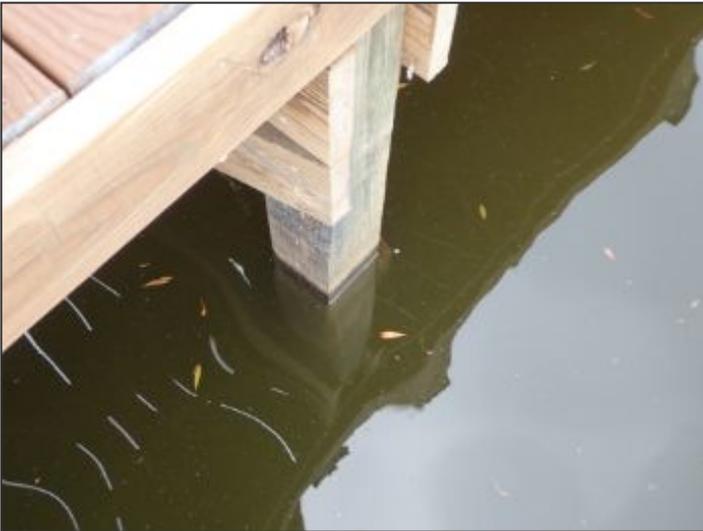
10.1. The inspector observed a boat dock at the rear of the home. There was permit found online for this dock from 2017, which was finalized and closed. The inspector noted the conditions of the dock were in satisfactory condition. The structure was stable and appeared to be in good condition. This inspection was completed under the scope of the general home inspection and evaluated visually.

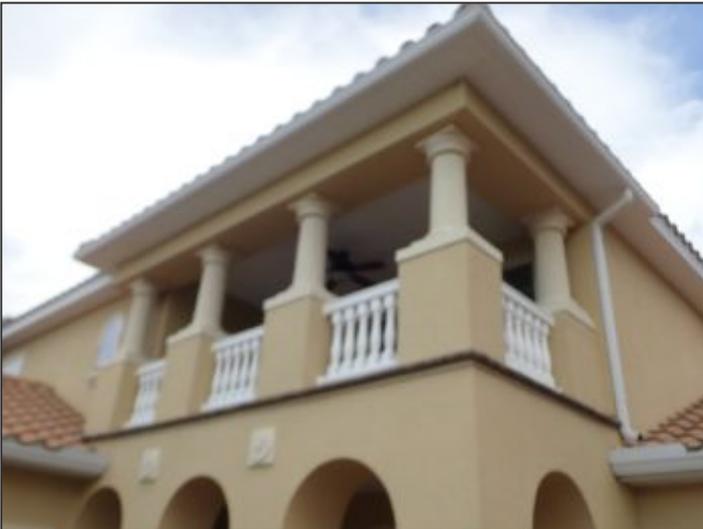
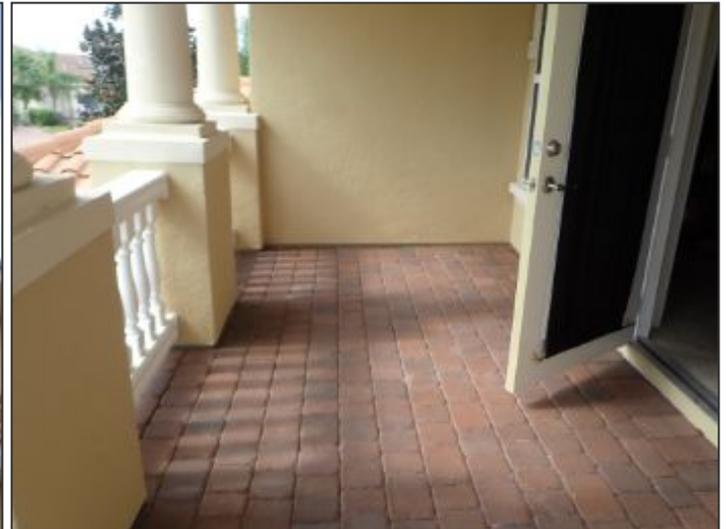
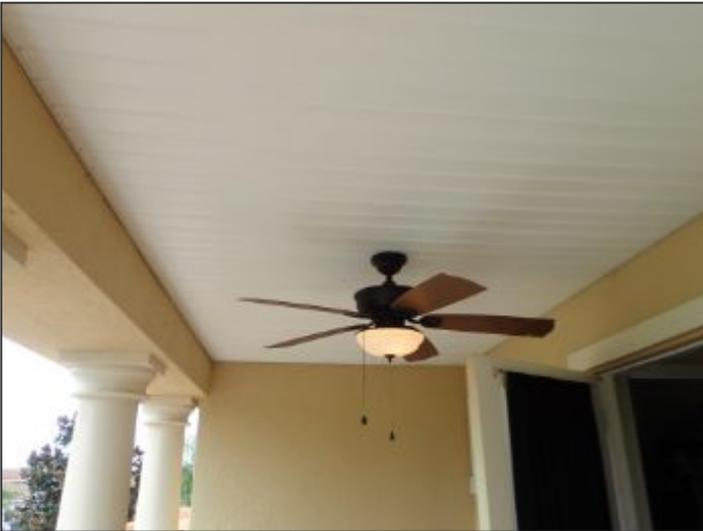
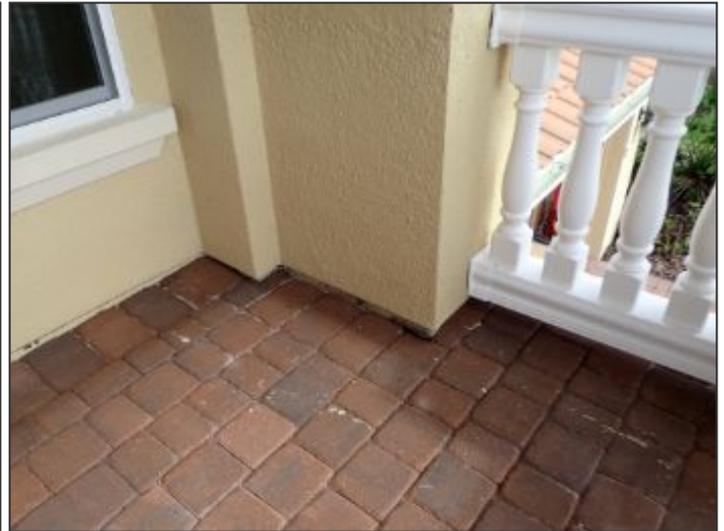
11.1. All balcony components appeared to be in satisfactory condition at the time of the inspection. Inspection of balconies typically includes examination of the following: Attachment to the home (fastening method and flashing), Structural Integrity, Planking (flooring), Guardrails and Finish coatings.

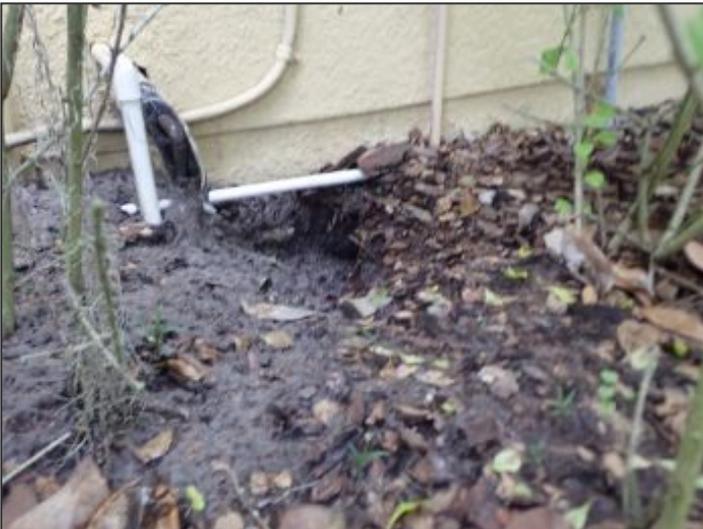
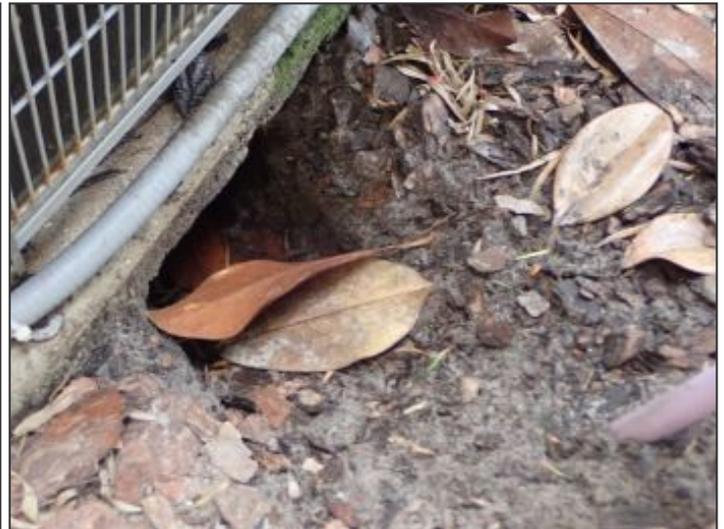
13.1. The inspector noted two areas on either sides of the home with holes dug out near the grading of the home. The inspector suspects an animal created these holes. Both were near the condenser units. Consider having the areas further evaluated and serviced. Ensure to refill erosion to avoid drainage issues and water ponding near these holes.
