Home Inspections by PJM, Inc.

Confidential - Property Inspection Report - Confidential

1234 Sample Rd, Kissimmee, FL 34746
Inspection prepared for: Sample Sample
Date of Inspection: 5/9/2017 Time: 2:00 PM
Age of Home: 5 years Size: 3,650 SqFt
Weather: Scattered Clouds/Warm
The utilities were on at the time of the inspection.

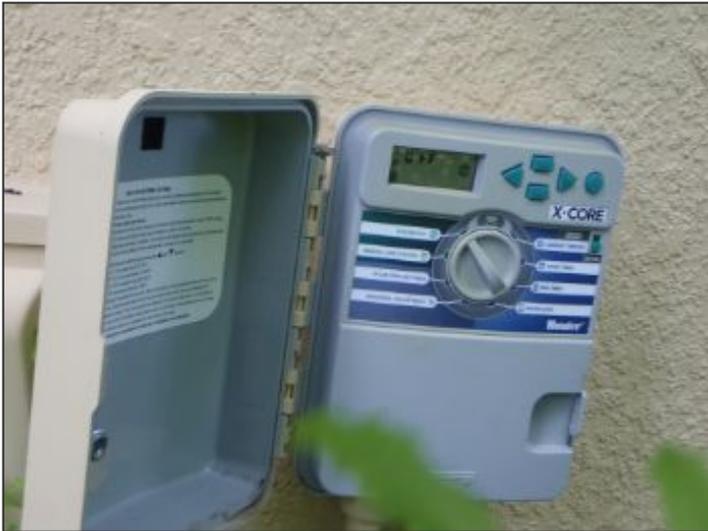
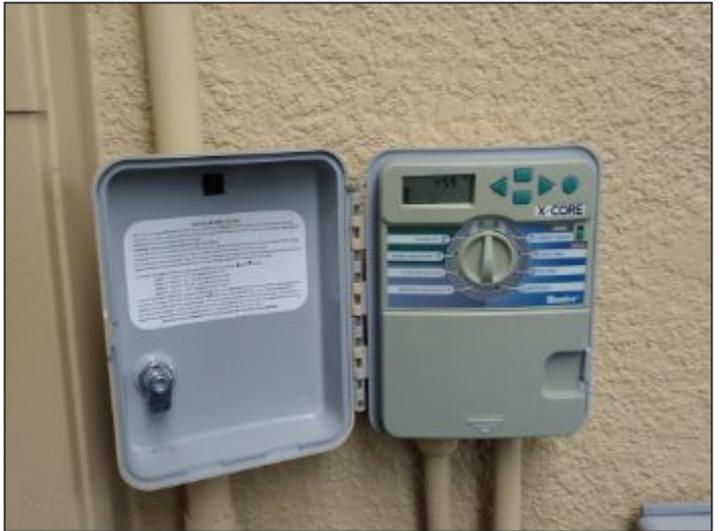
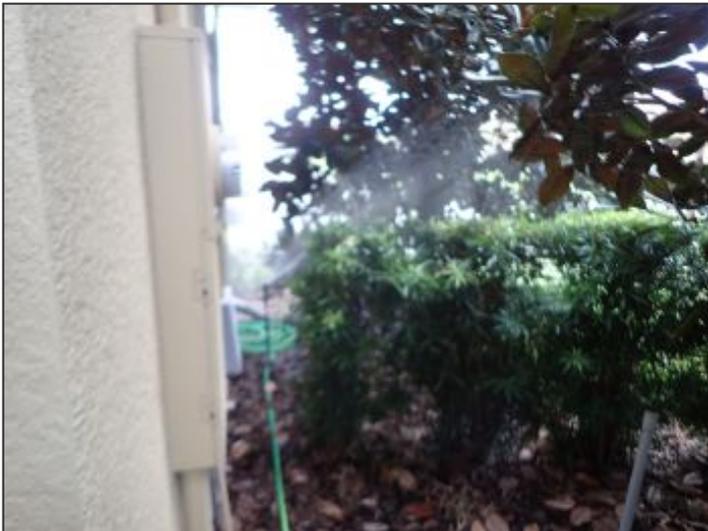
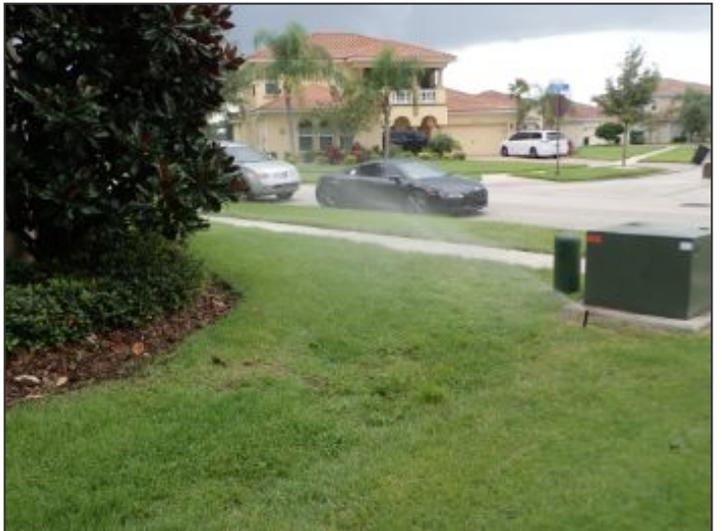
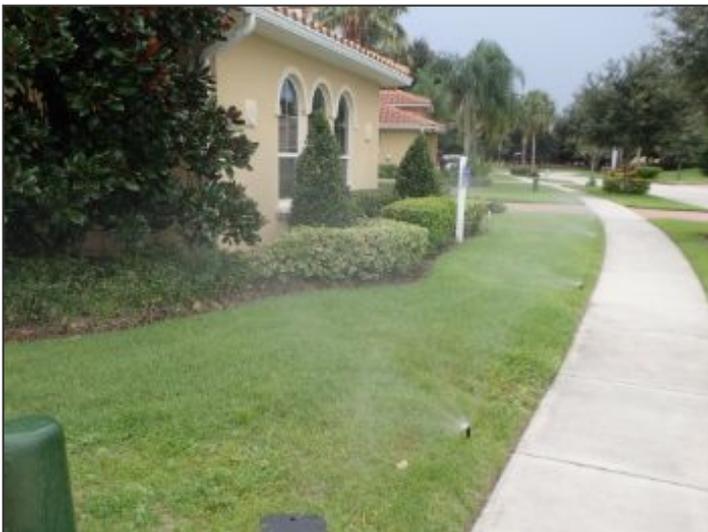
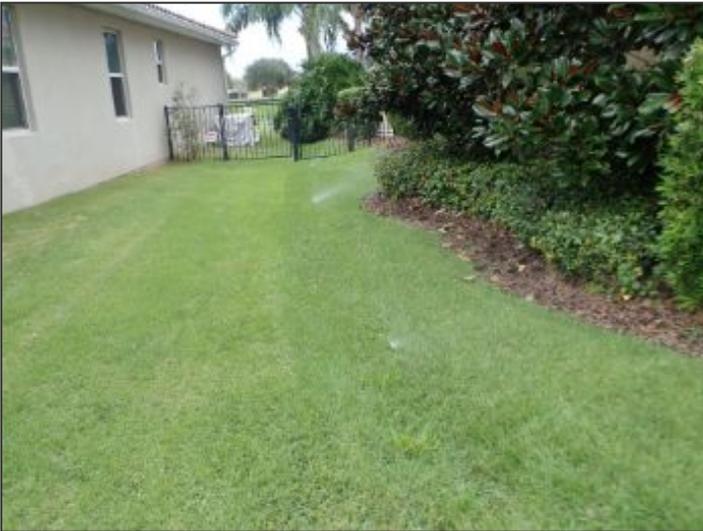
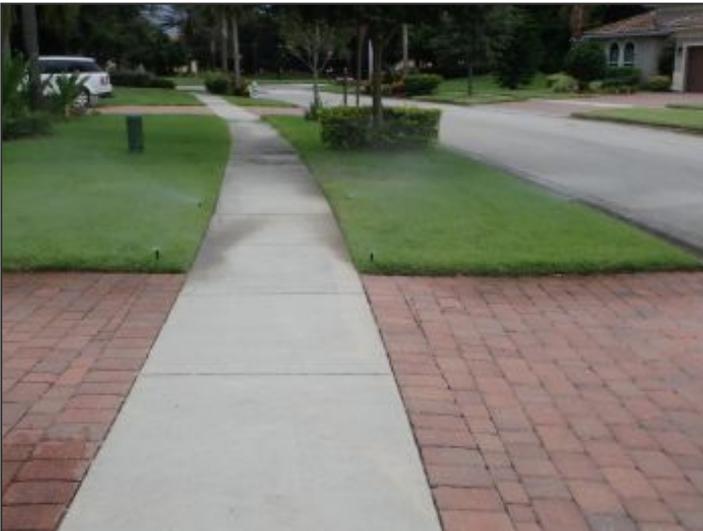
14.1. The inspector noted there was an additional sprinkler control panel located near air condenser unit 1, but it did not operate. The inspector could not determine if this unit is no longer in use or its damaged. The inspector also noted a damaged/leaking sprinkler head at the front of the home. Further evaluation and repairs will be required by a qualified person.

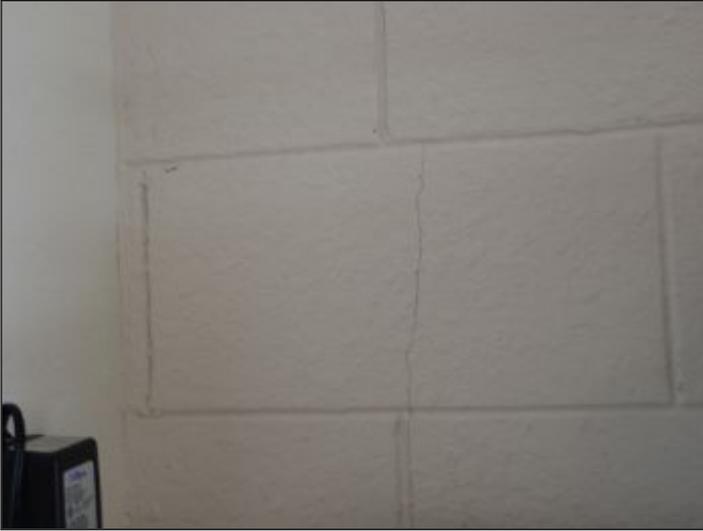
5.1. Minor stepped cracking was noted at the garage walls at various locations. Ensure to service and seal to avoid these areas becoming points of moisture intrusion.

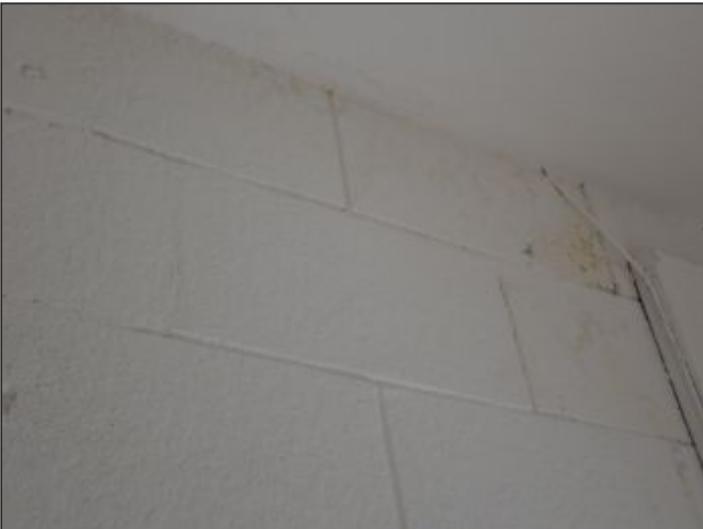
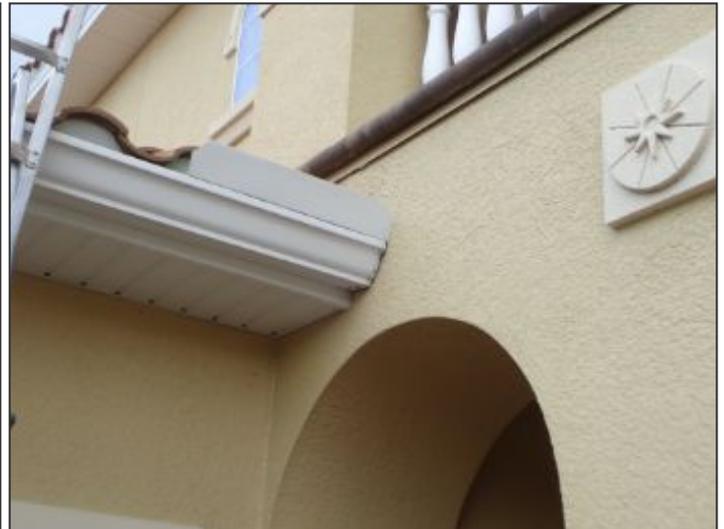
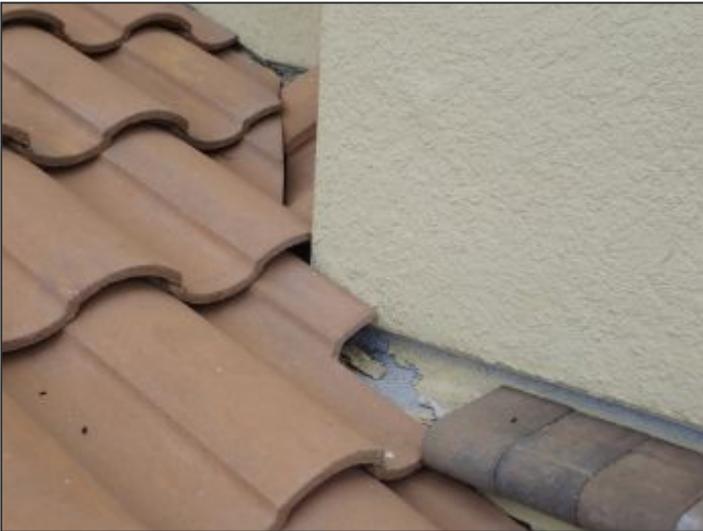
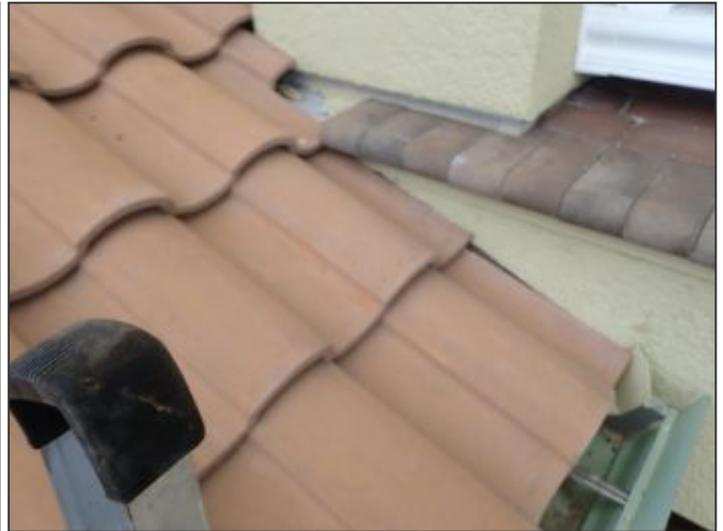
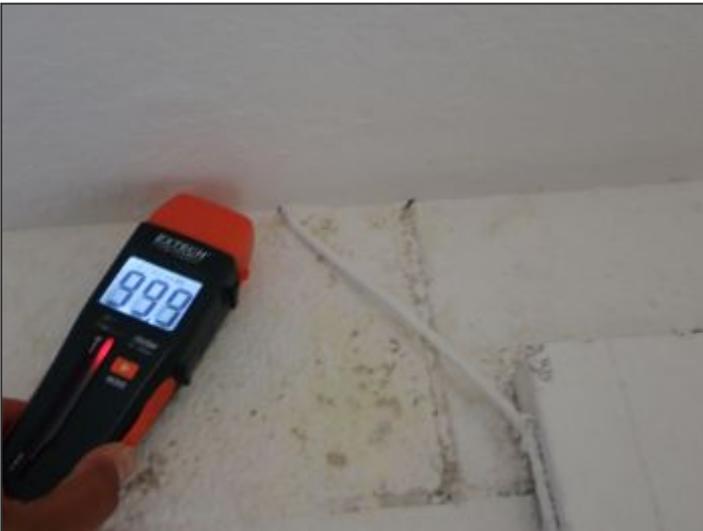
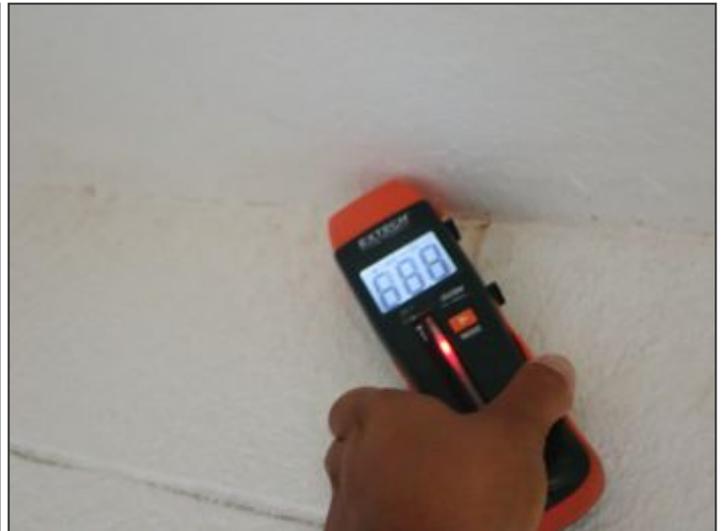
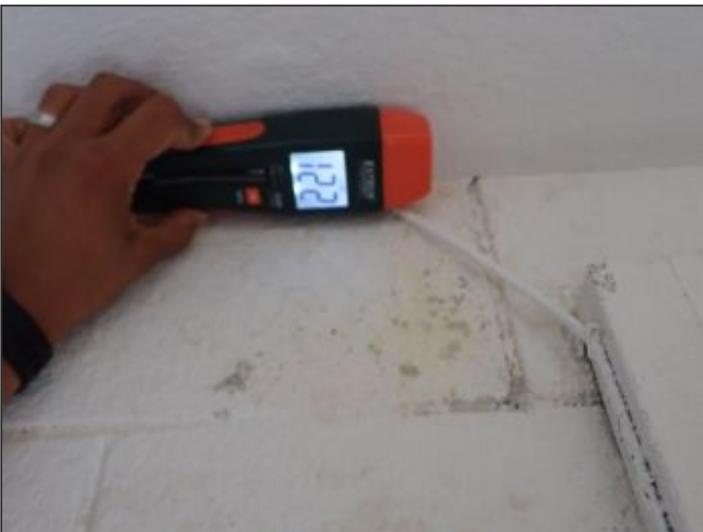
6.1. Moisture intrusion and damage was noted at the single car garage ceiling. The area had staining and organic growth (mold like appearance). The inspector noted the area registered with active moisture when tested with a moisture meter. The inspector could not determine the extent of the damage due to lack of attic access at this area. Further evaluation and repairs will be required.

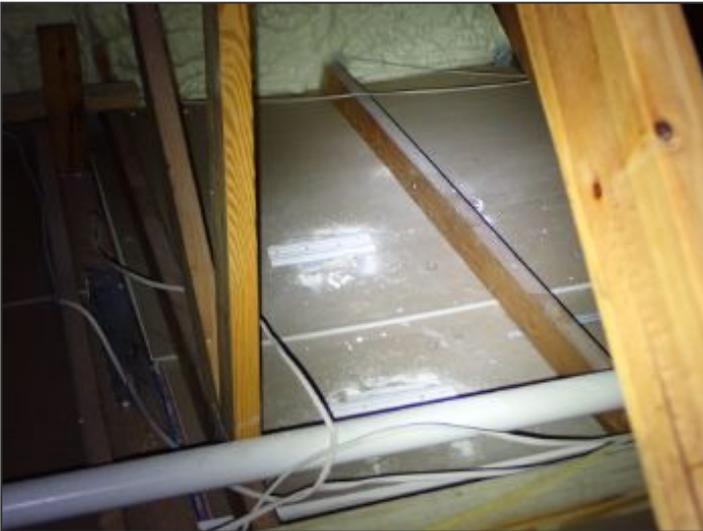
4.1. The inspector noted a repair at the attic space ceiling panel in the second floor. The inspector recommends having this repair reviewed by a qualified person, substandard repair was observed. Consider servicing this area as required.

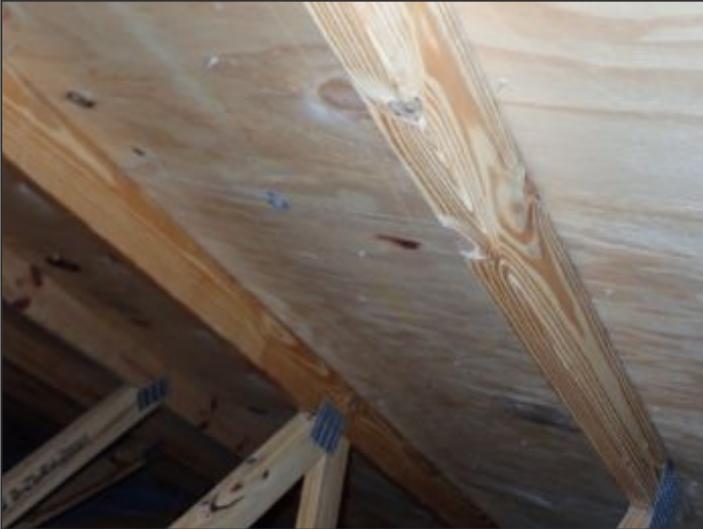
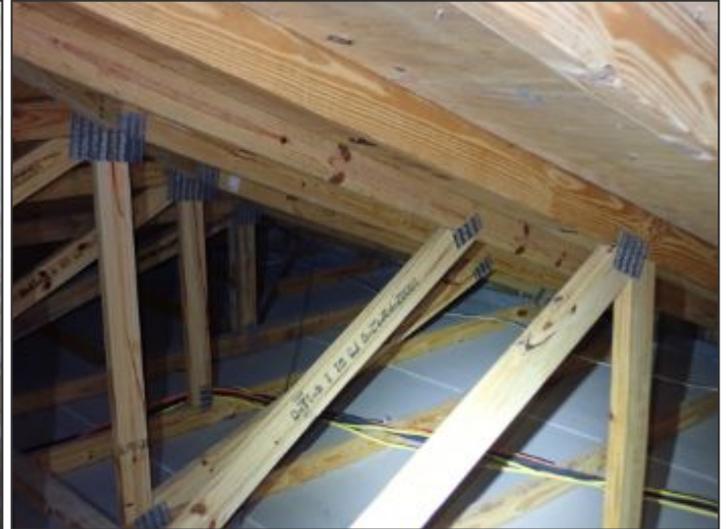
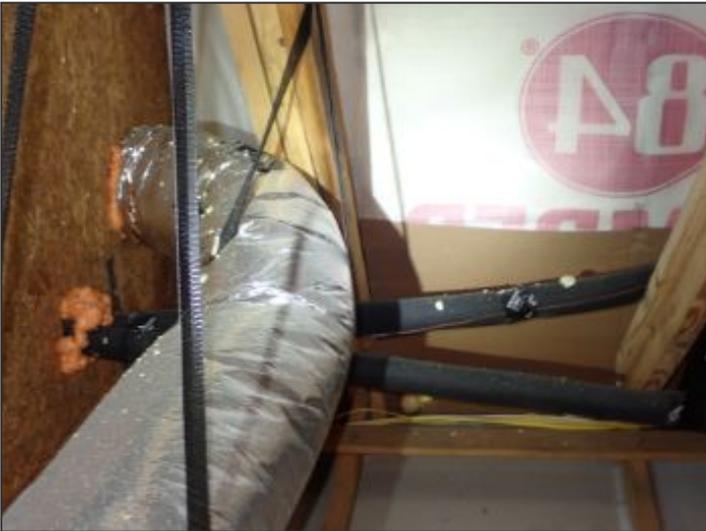
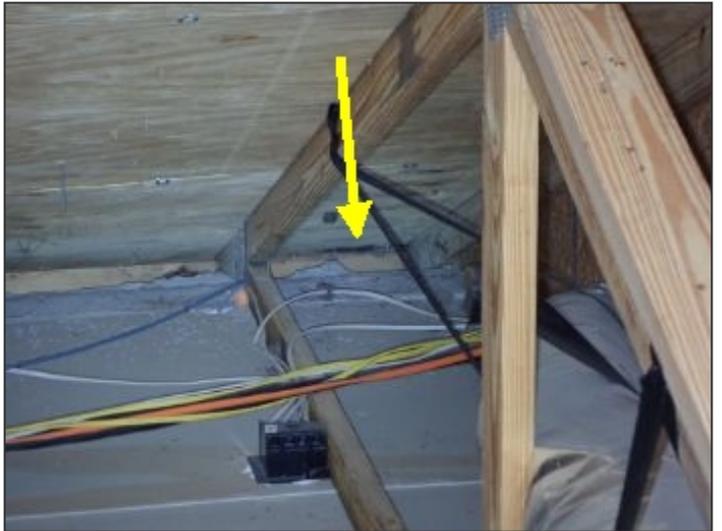
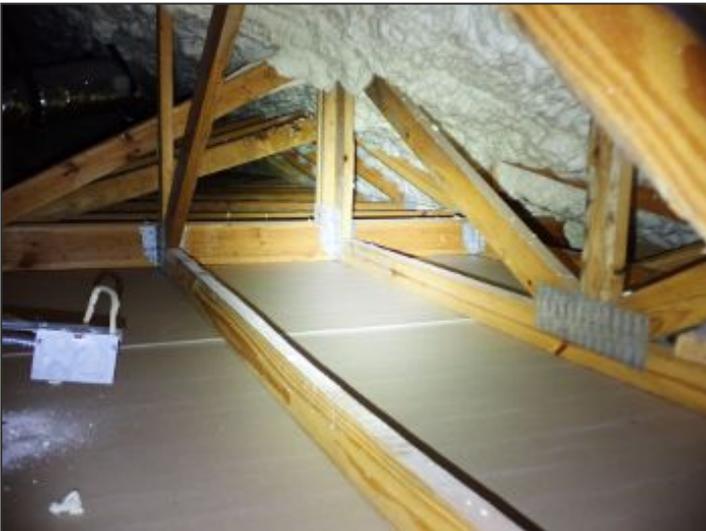
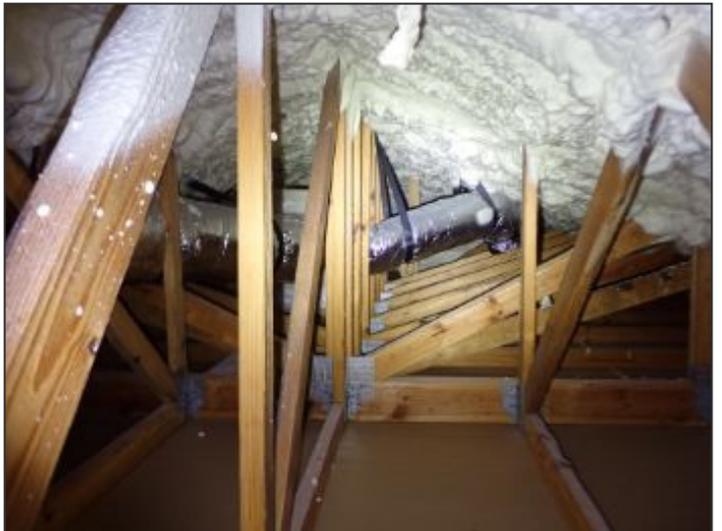
5.2. The inspector noted moisture intrusion at the roof structure at the garage attic space. The moisture intrusion has caused staining and damage at the fascia board and sheathing board. This area was one of two leaks noted at the garage areas. Further evaluation is required by a qualified roofing contractor. This area appears to be impacting the interior ceiling of the (front) family room adjacent to the garage and front entrance.

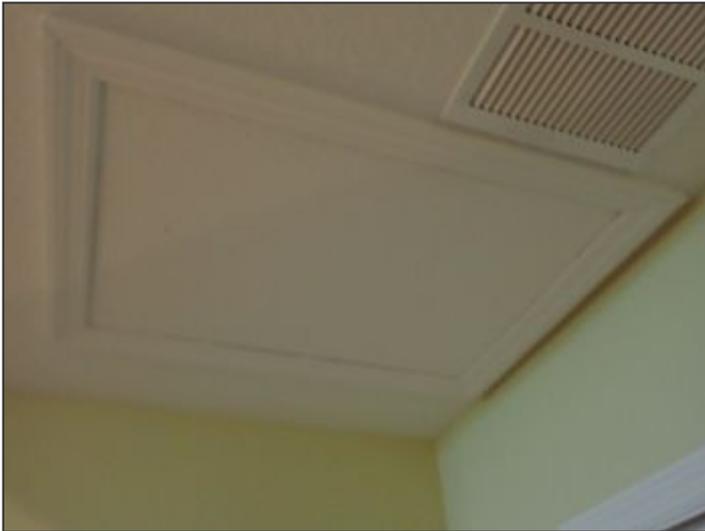
1.1. Appeared functional - We recommend to install a pull-down ladder for easy access.

1.2. Consider installing an additional attic hatch(s) which can help view more of the roof structure to ensure physical access if issues arise.

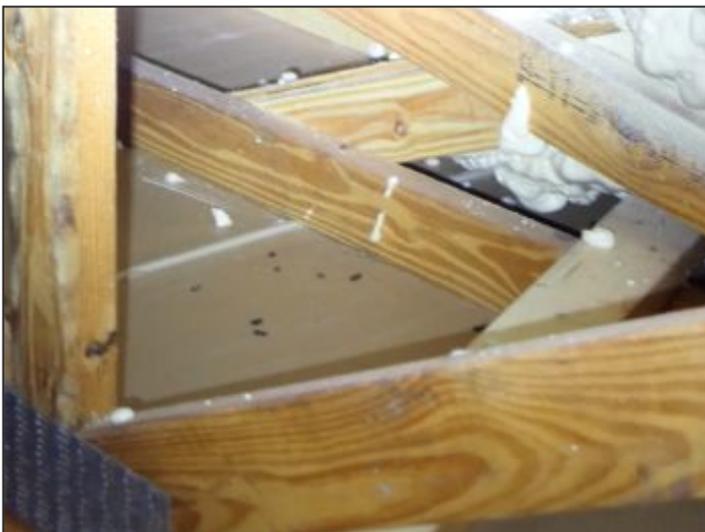
2.2. The attic had minor amounts of rodent feces visible. You should consider setting traps for mice and closing off avenues of entry. The inspector cannot determine the recency of the feces.

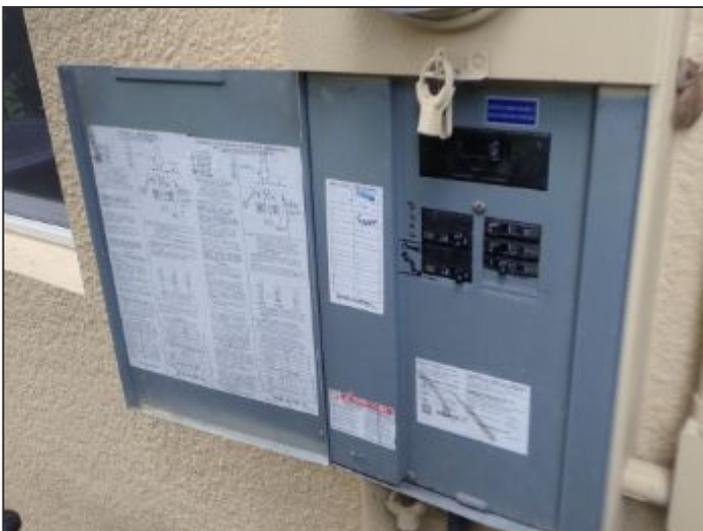
- 4.4. The main panel had visible corrosion near the bottom panel. The inspector recommends ensuring panel is properly secured and covered to avoid moisture damage. There was a nearby sprinkler head which sprayed water towards the panel. The panel had a knockout/void at the bottom which should be filled in to avoid pest/moisture intrusion. (frogs were noted inside panel)

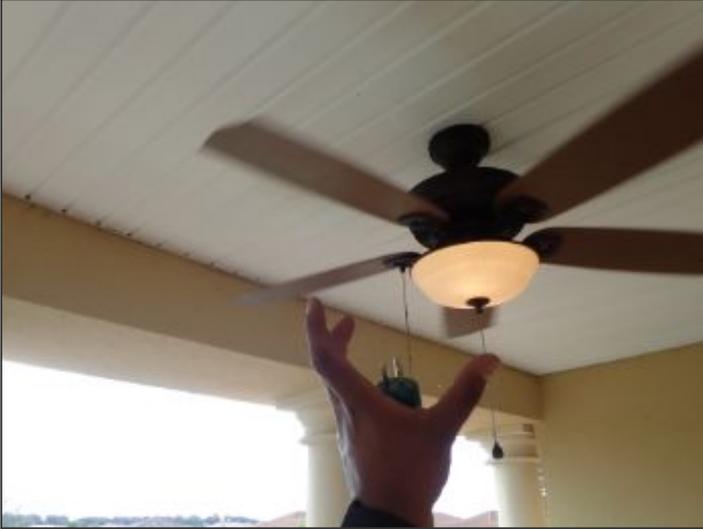
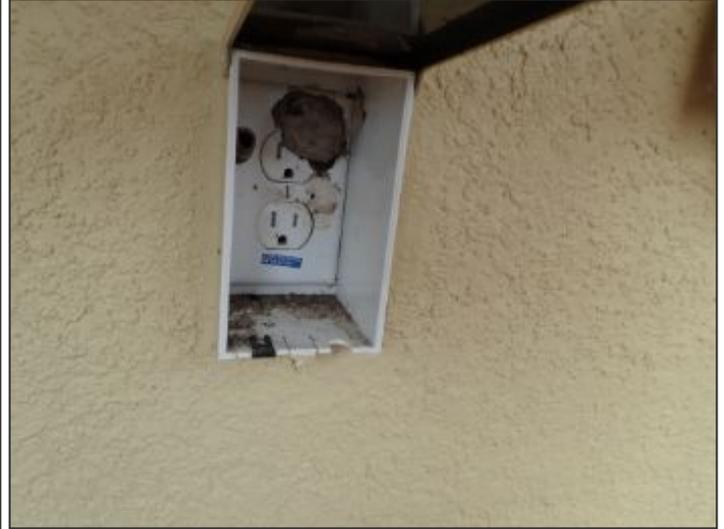
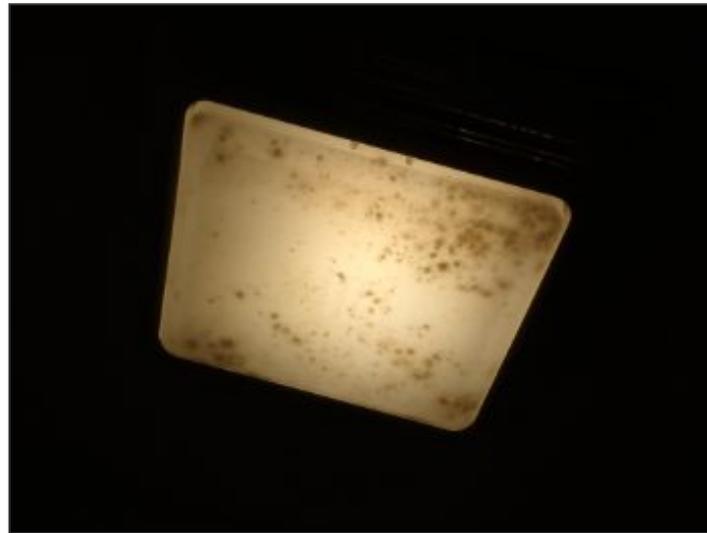
10.1. The ceiling fan at the second floor balcony wobbled when operated, consider servicing this fan. The receptacle at this balcony had muddover (wasps) which should be removed. The ceiling light/fan fixture at the master bathroom (2nd floor) had visible organic growth. The inspector recommends cleaning and servicing. The cause for this growth is unknown.

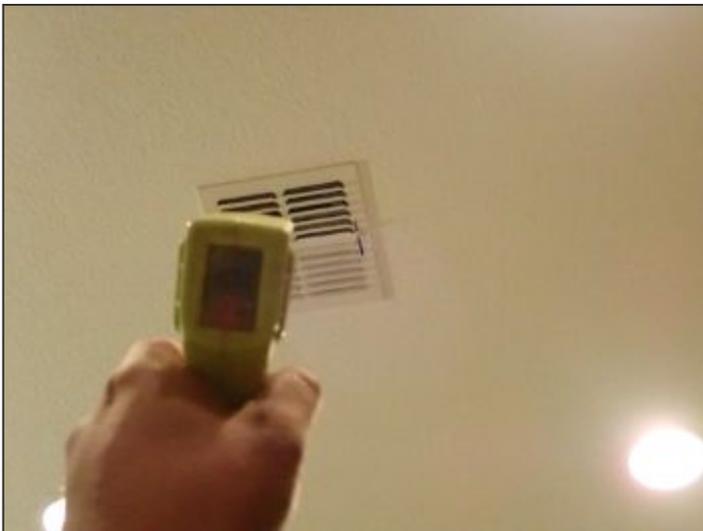
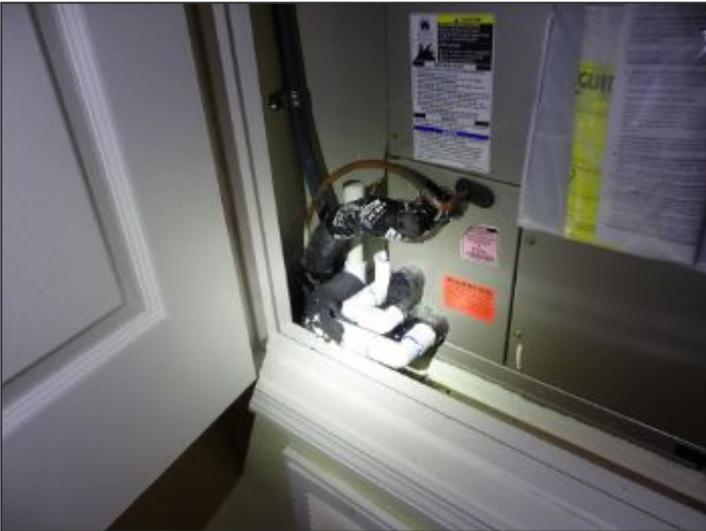
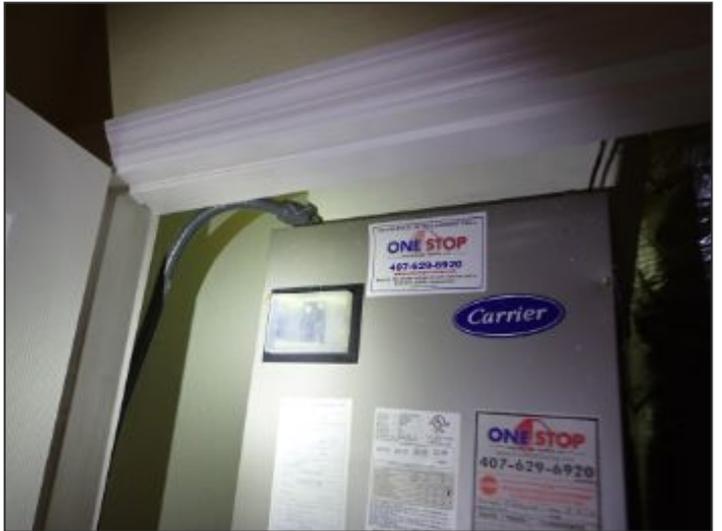
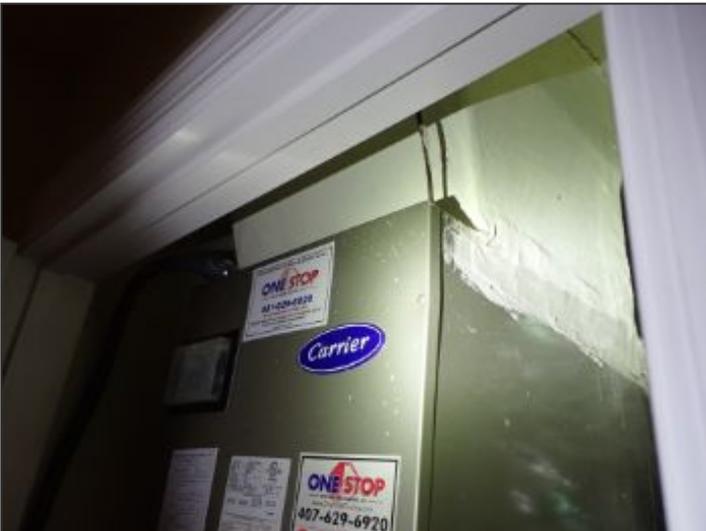
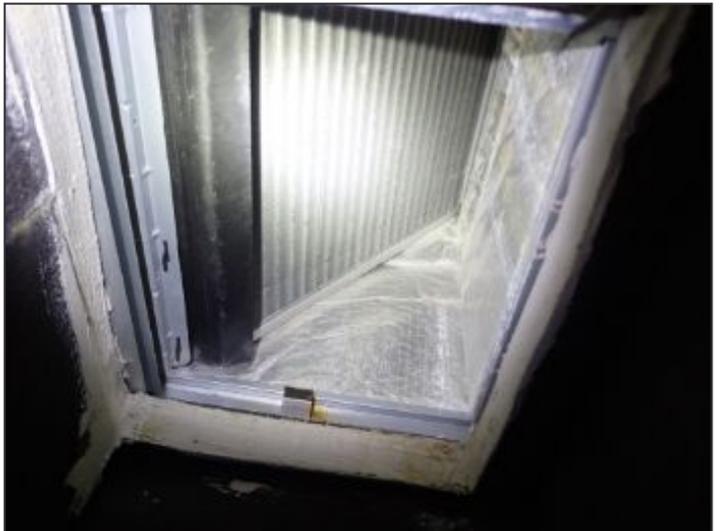
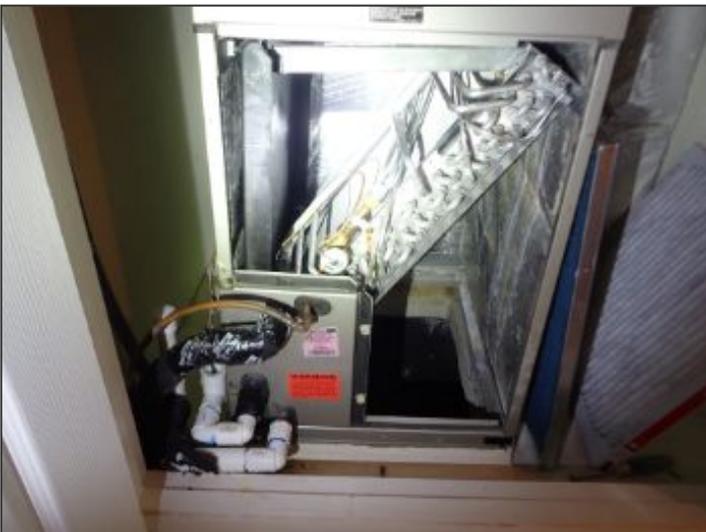
- 1.4. The inspector recommends further evaluation and repairs of the air handlers located at the upstairs closets. The inspector noted unit 2 had leaked condensation previously which caused damage to the second floor baseboard and floor boards. The extent of the damage is unknown and requires further evaluation. Air handler unit 1 was actively leaking condensation at the time of the inspection. The unit had visible corrosion along the coils at the time of the inspection. The unit's fins were dirty and clogged which also appears to be causing issues with proper discharge of condensation, the condensation was falling straight down instead of slant. Moisture damage was noted at both of the air handler's plenum ductwork below the filter. Visible organic growth was noted. The inspector recommends further evaluation by a qualified HVAC Tech. Unit 1's condition may warrant replacement to avoid future issues from arising (based on condition observed), but further evaluation is required by a technician.

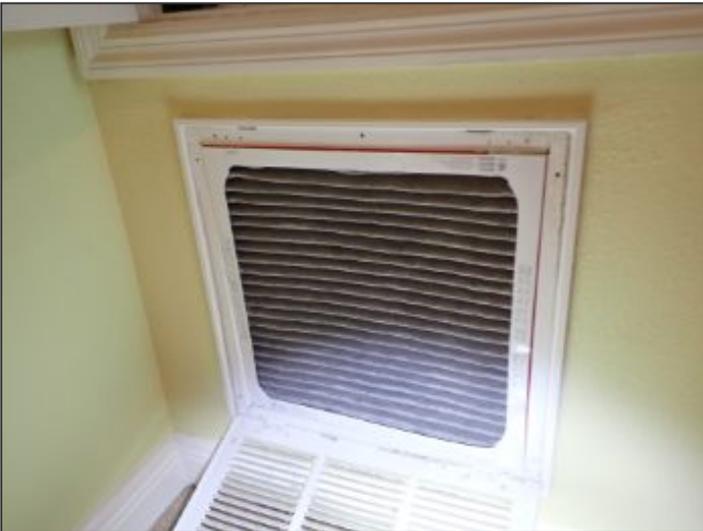
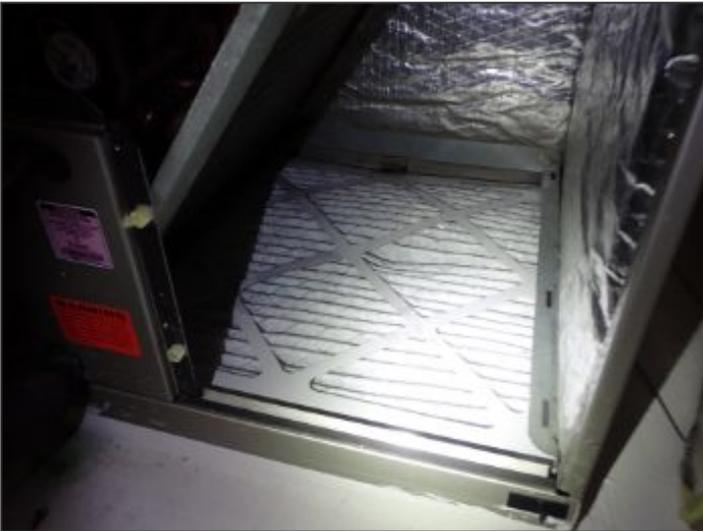
2.3. The filter cover plate at air handler unit 2 was damaged, the latch would not hold closed.

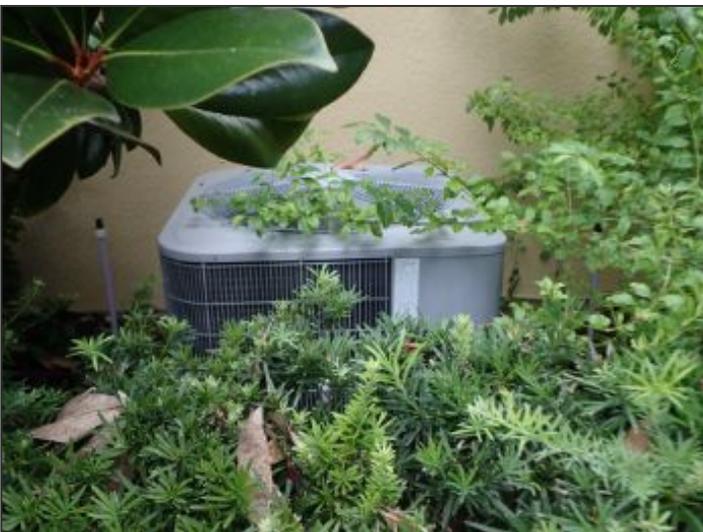
- 4.3. The remaining life expectancy of the unit is approx. 10 years. Average life of an outside **A/C** compressor/condenser is approx. 10-15 years.
- 4.4. Insulation on the air-conditioning suction (large, insulated) line was damaged at unit 1 near the exterior wall, service is required to avoid loss of efficiency.

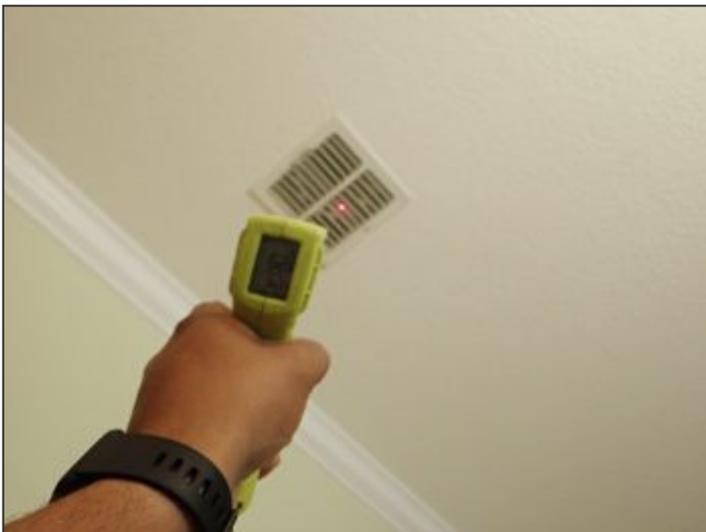
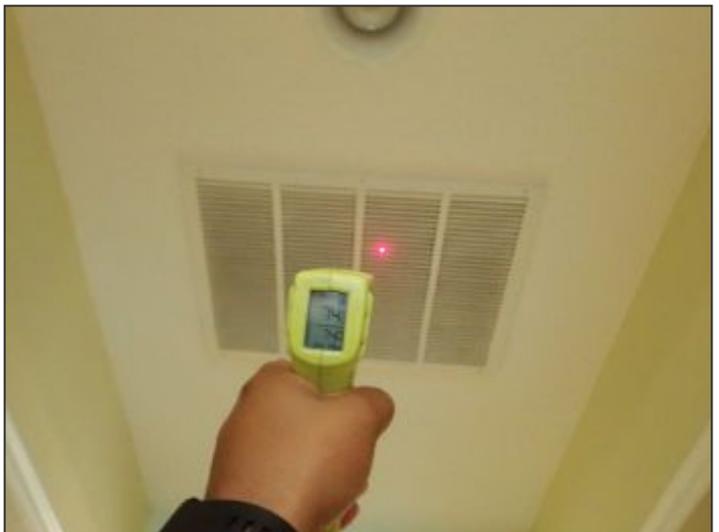
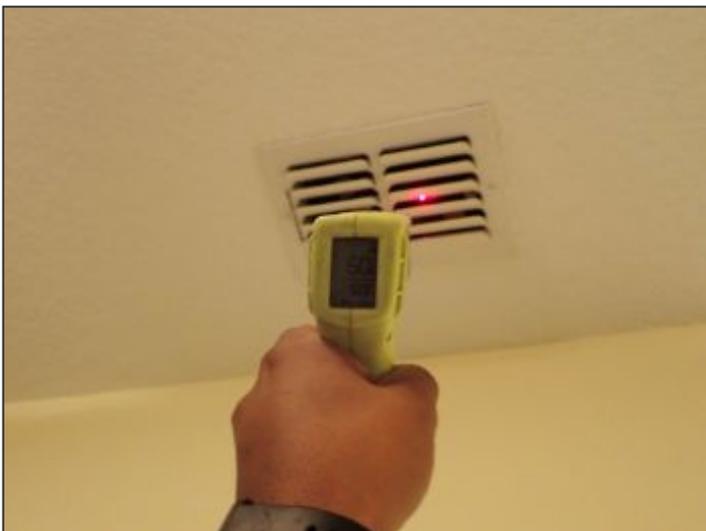
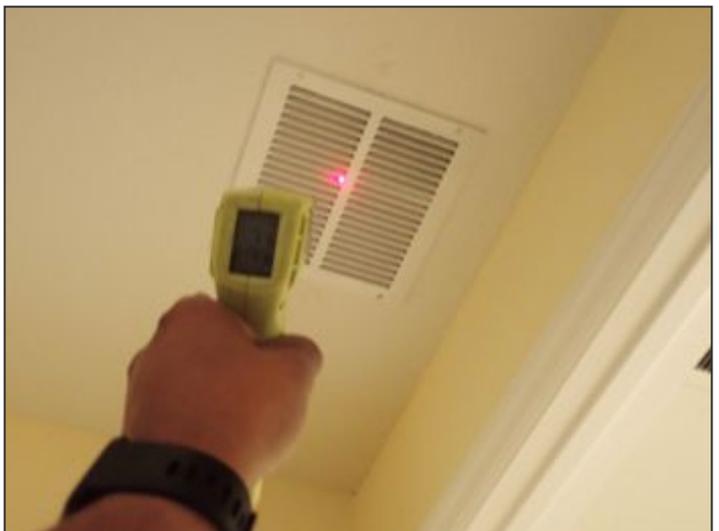
5.1. Air temperature measured at supply and return registers had a difference of less than the minimum of 14 degrees F at unit 1 (first floor). The Inspector recommends service by a qualified HVAC technician.

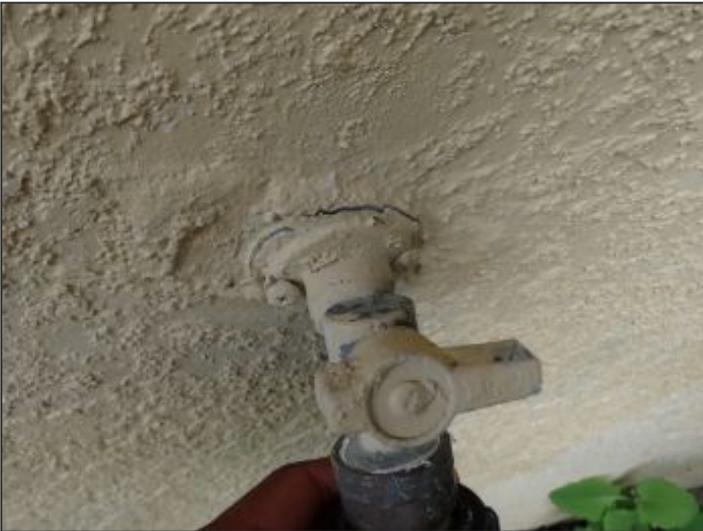
- 5.1. All exterior hose bibs were tested and in good working at the time of the inspection.
- 5.2. Additional piping appeared to run to the rear boat dock.
- 5.3. Hose bibs were loose at the exterior walls, ensure to refasten to avoid damage.

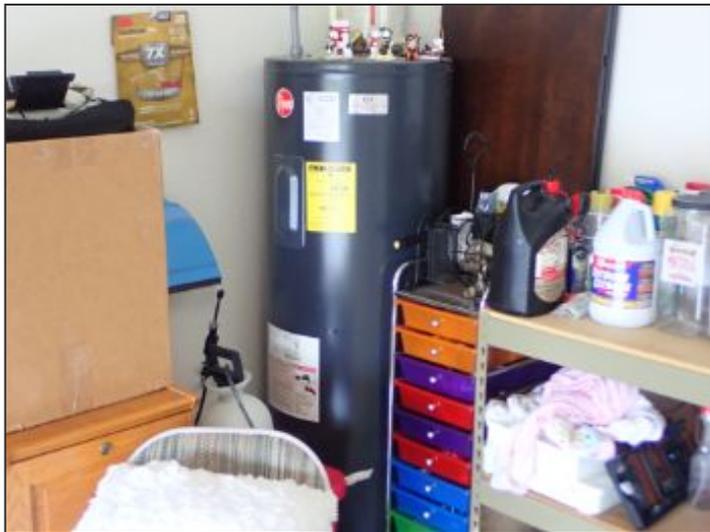
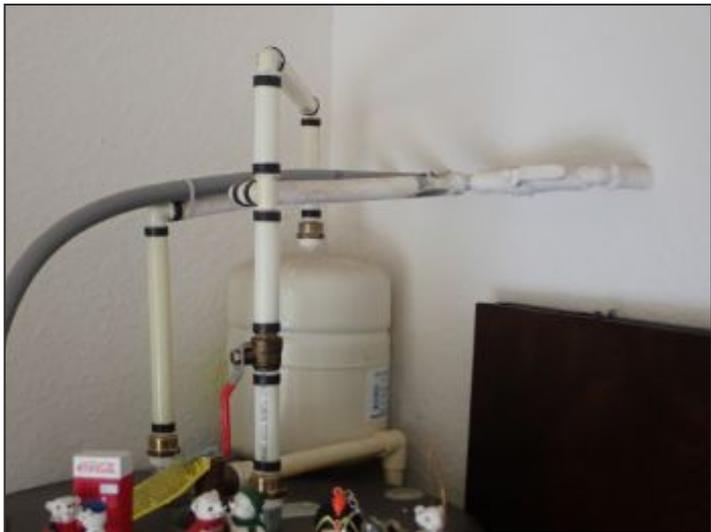
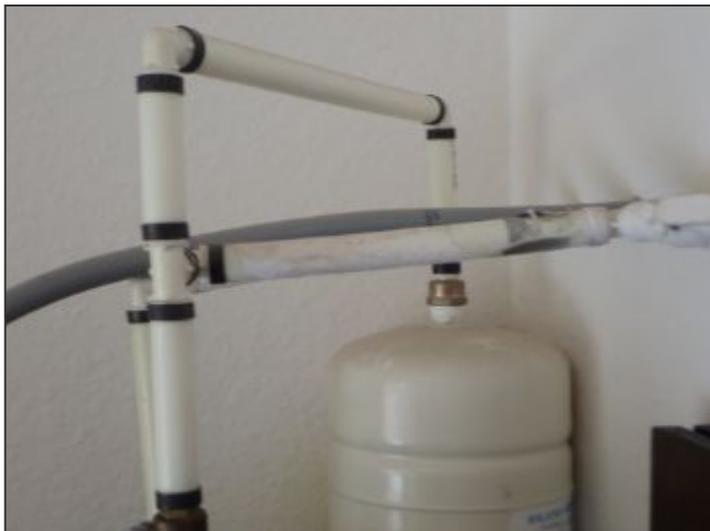
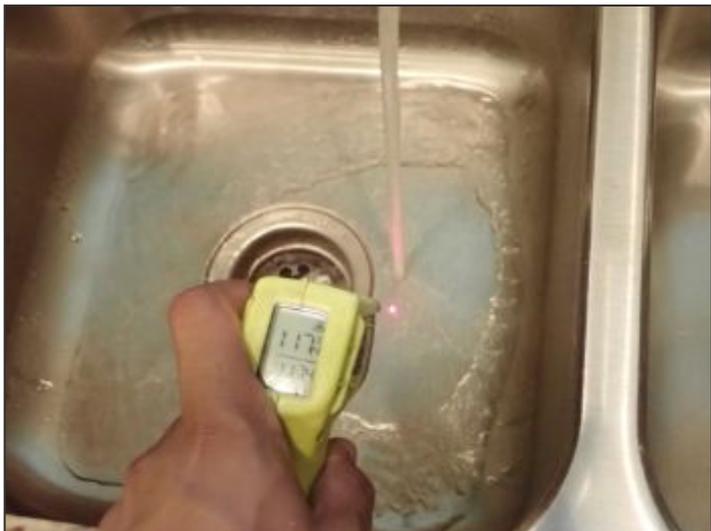
Description: The home was equipped with an electric water heater. This type of water heater uses electric elements to heat water in the tank. These elements can often be replaced when they burn out. Heating elements should be replaced only by qualified plumbing contractors or HVAC technicians. The water heater brand was Rheem.

Location: The water heater was located in the garage.

Capacity: Water heater capacity was 65 gallons.

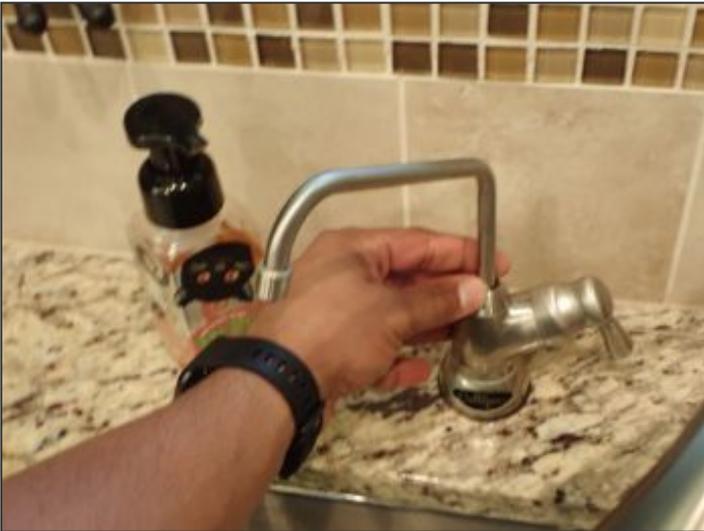
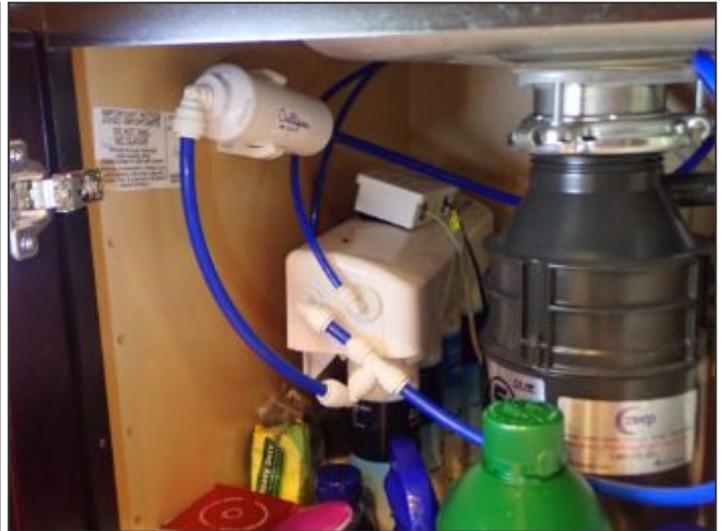
3.1. The kitchen sink faucet was functional and in good condition. The unit was loose and should be fastened.

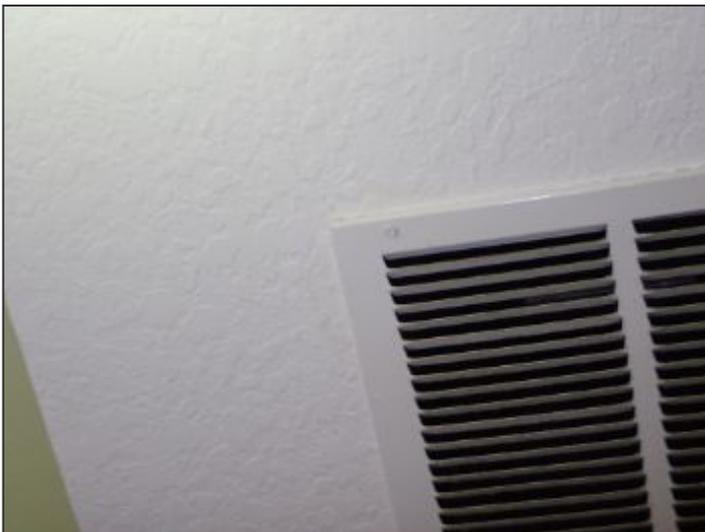
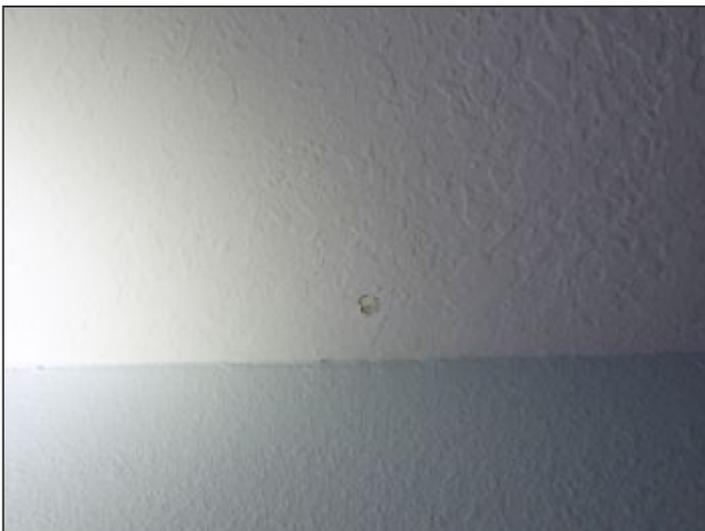
2.2. The inspector noted moisture stains along the ceiling register of unit 1 (first floor hallway), this appears to be an active leak from the air handler coils. Further evaluation and repairs are recommended by a qualified HVAC Tech to avoid further damage. The inspector also noted moisture stains along the crown molding at the front family room near the corner of the garage ceiling (2 car section). The area and adjacent did register with levels of moisture which should be serviced and repaired as mentioned. There was minor cosmetic damage observed at the master bathroom ceiling was a nail pop, fasten and seal.

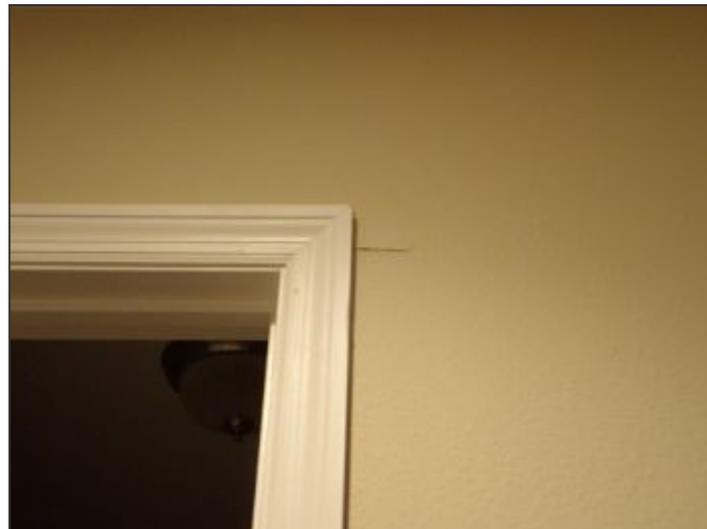
4.1. Inspector noted cracks/damaged wall (cosmetic) at the kitchen pantry door. Consider servicing the area.

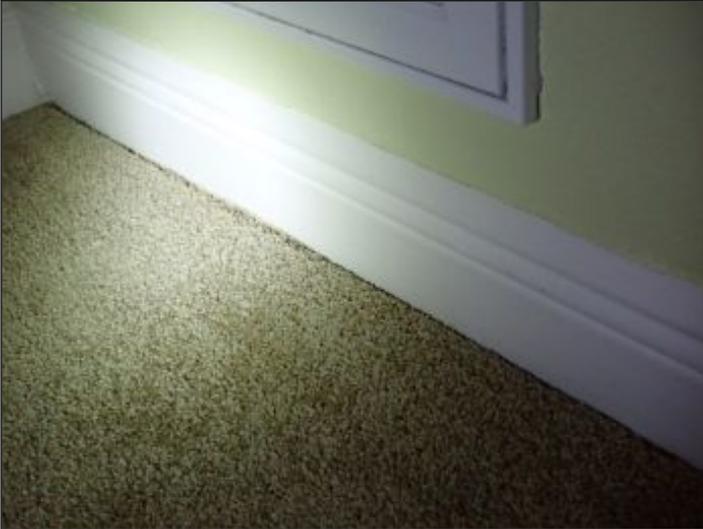
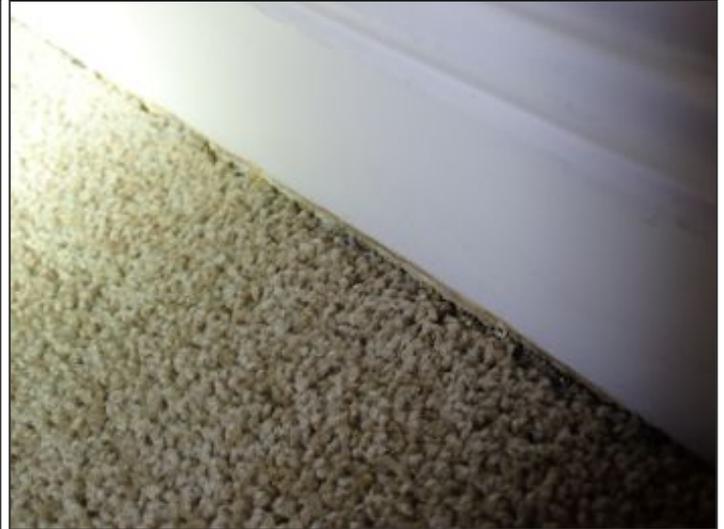
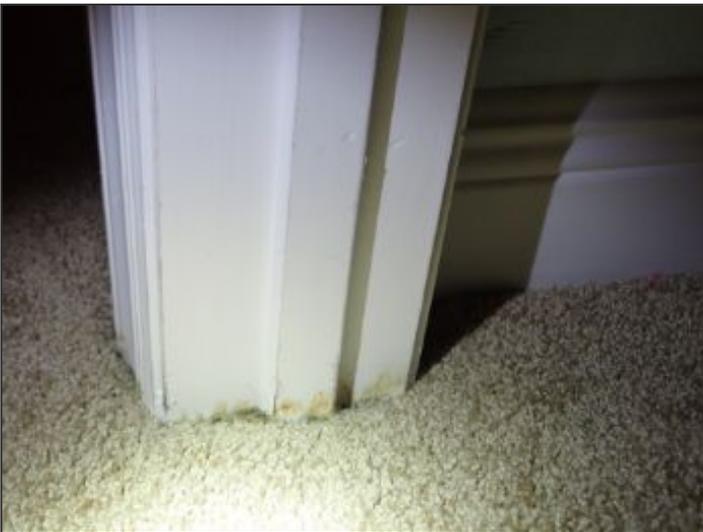
5.1. The inspector observed floor boards/baseboards at the second floor near the air handler at unit 2 had moisture damage. The damage was noted at the baseboards near the air handler and the second floor master bedroom room door trim. The extent of the damaged caused by this leak is unknown. The inspector recommends the seller for disclosures, if none is available, consider intrusive inspection for review.
