Home Inspections by PJM, Inc.

Confidential - Property Inspection Report - Confidential

1234 Sample Rd, Kissimmee, FL 34746
Inspection prepared for: Sample Sample
Date of Inspection: 5/9/2017 Time: 2:00 PM
Age of Home: 5 years Size: 3,650 SqFt
Weather: Scattered Clouds/Warm
The utilities were on at the time of the inspection.

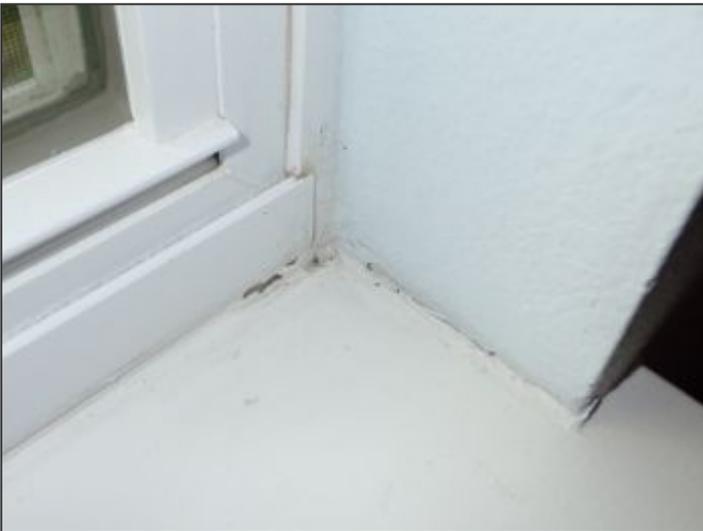
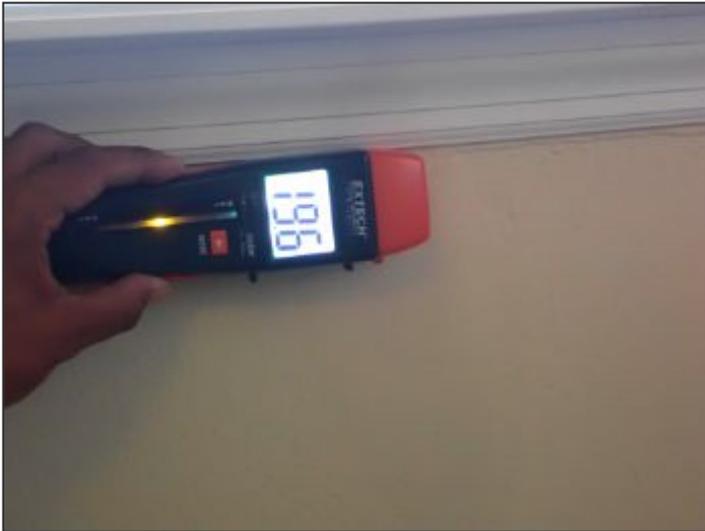
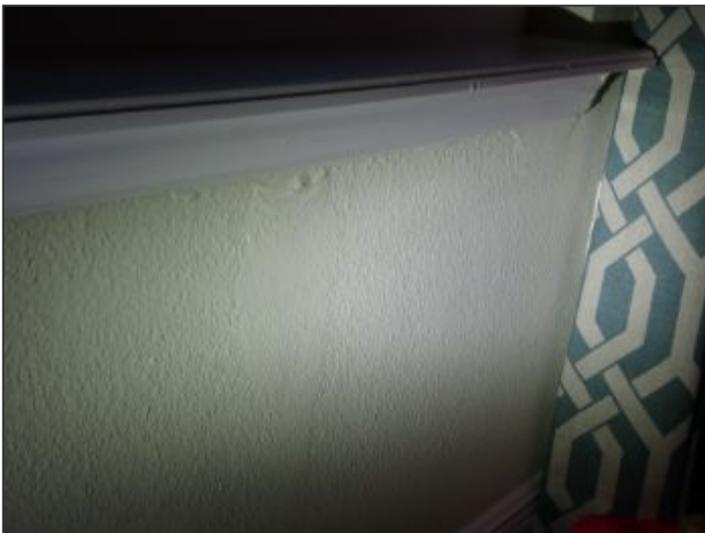
8.1. Ensure to reseal and service all caulking throughout all windows in the home, as mentioned gaps were visible at the interior and exterior. The inspector noted minor levels of moisture was observed below the window sills of windows. The wall paper was noted with moisture stains. Ensure to service as required.

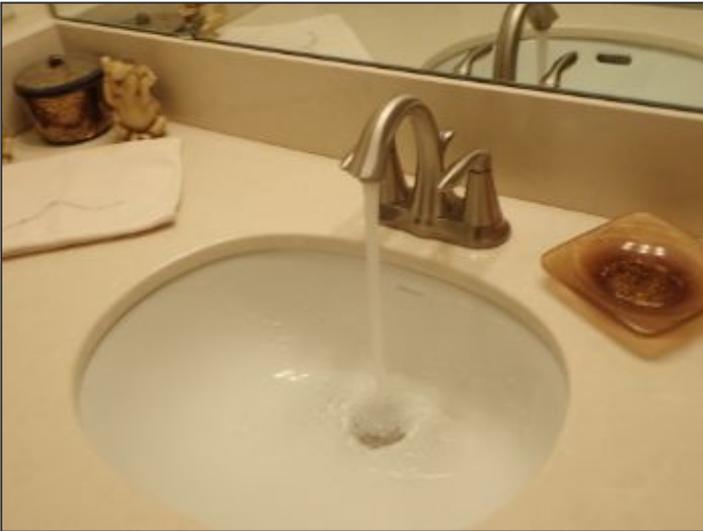
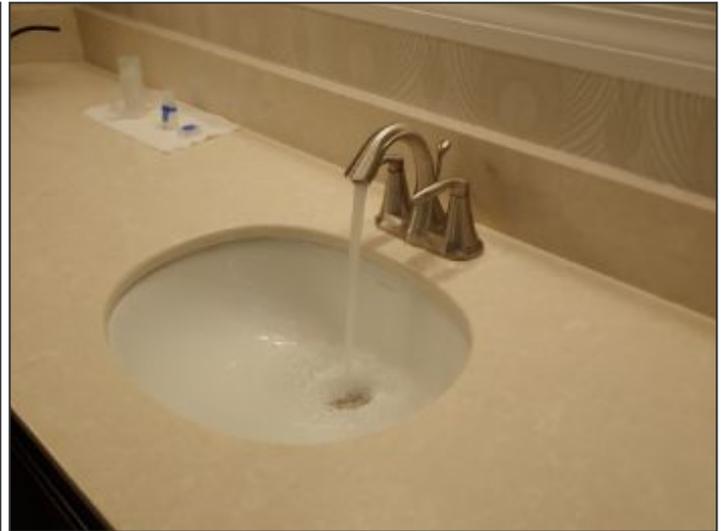
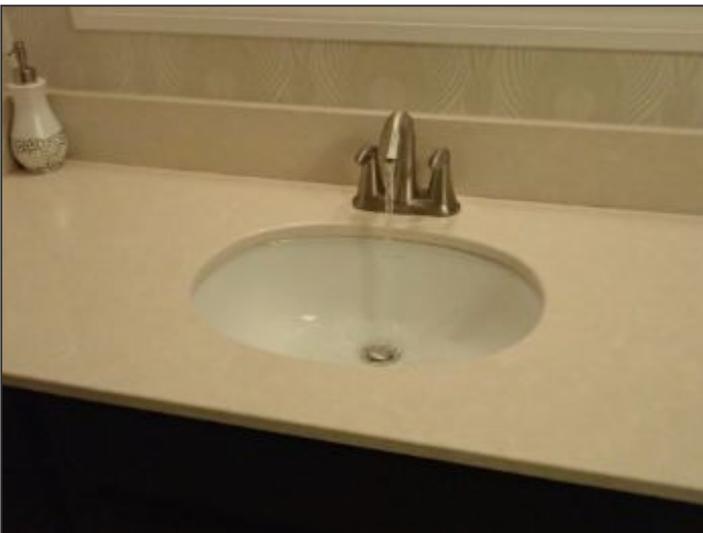
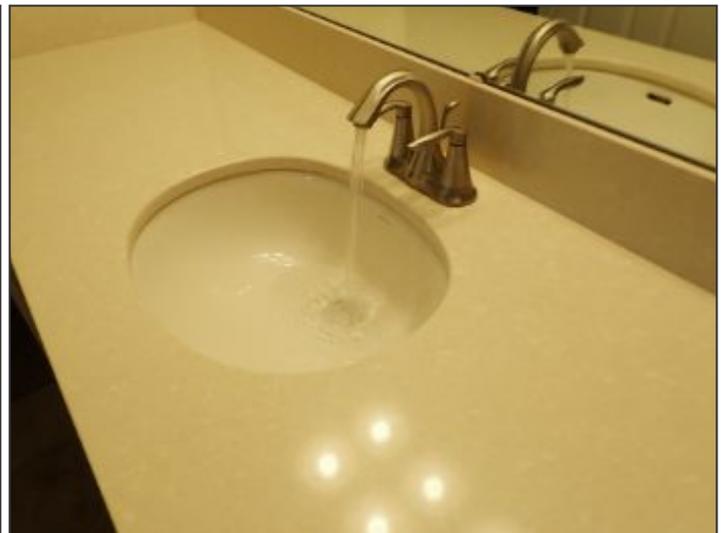
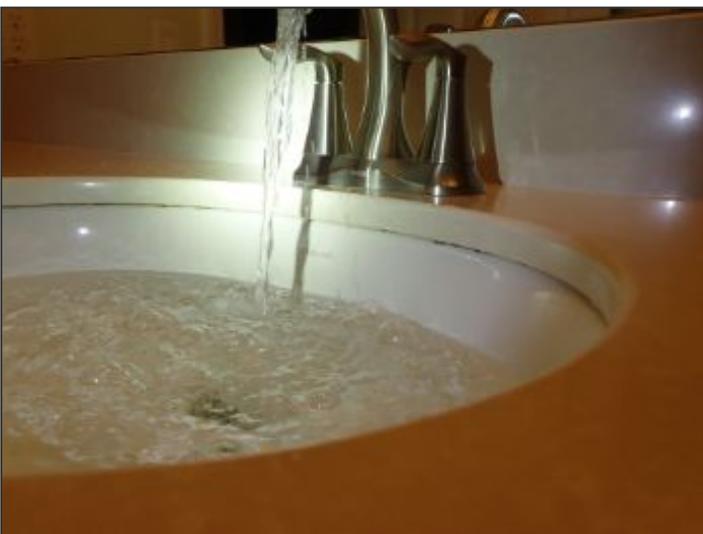
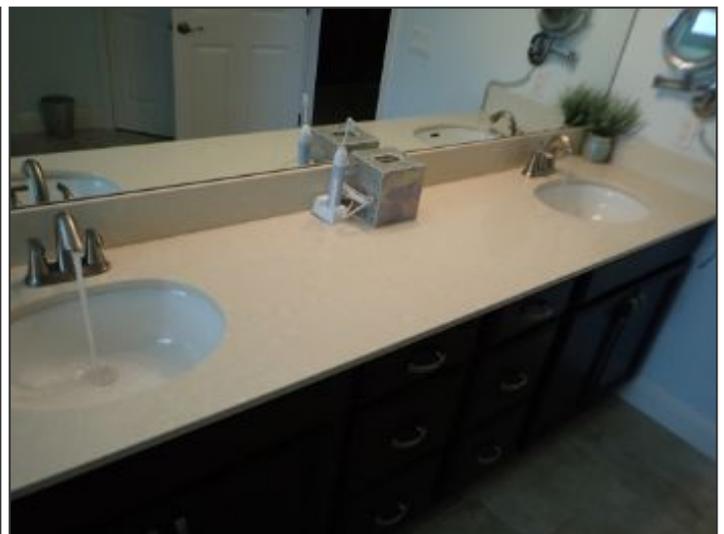
- 3.1. The sinks in all the bathrooms appeared to be in satisfactory condition at the time of the inspection.
- 3.2. Ensure sink as properly caulked and resealed at the countertops.

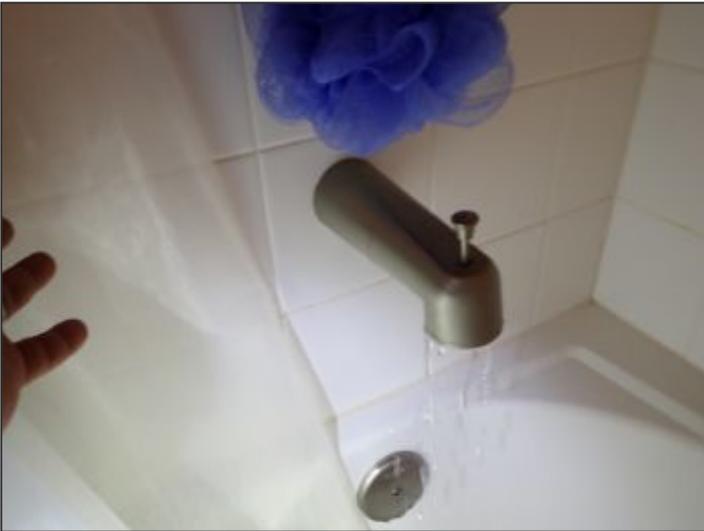
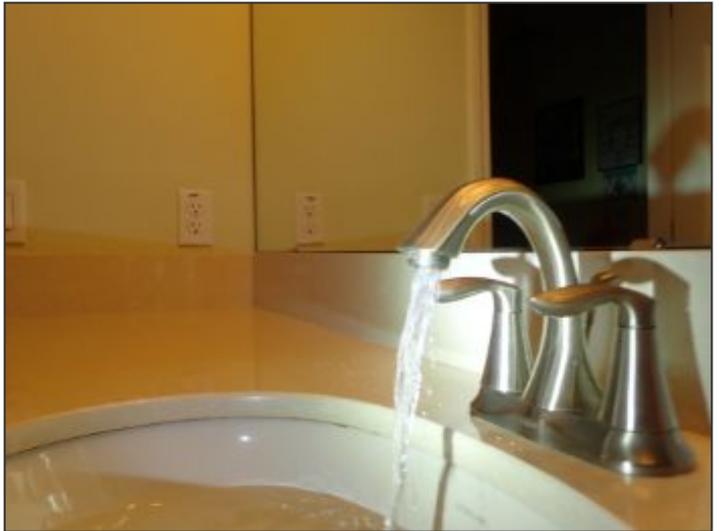
4.1. The shower faucets should be refastened and caulked to ensure moisture intrusion does not occur at the underlying wall structure. The guest bathroom in the second floor washer and faucet should be fastened. The water was spraying irregular.

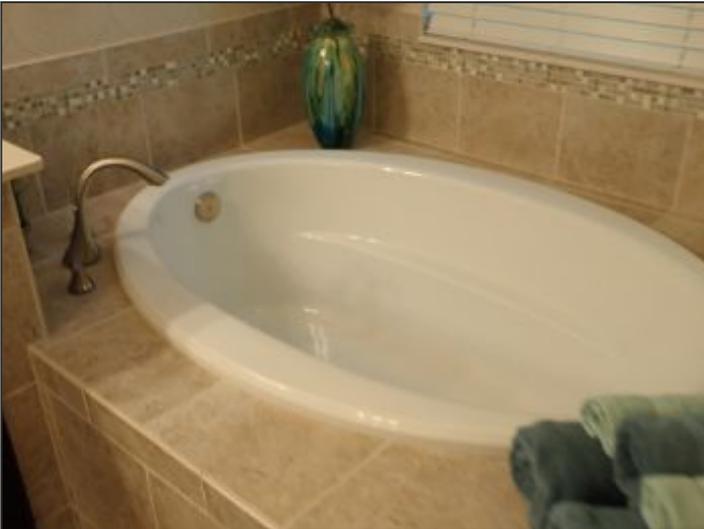
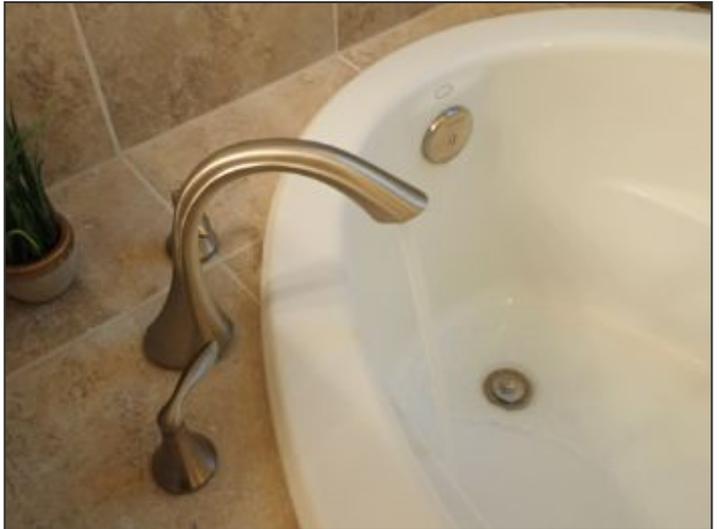
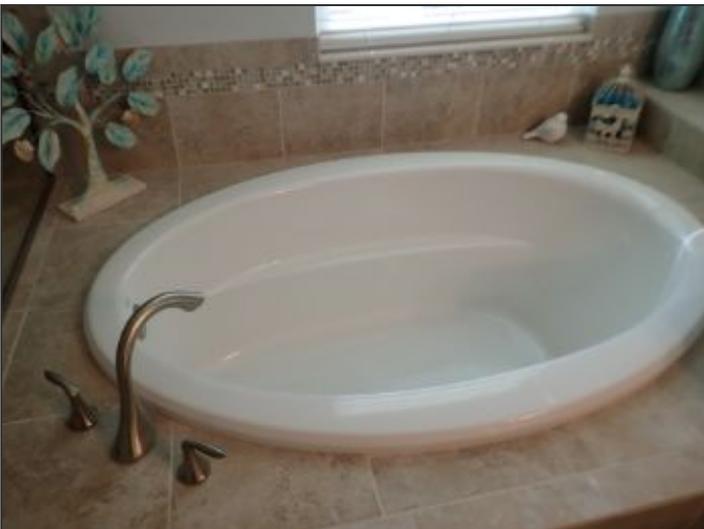
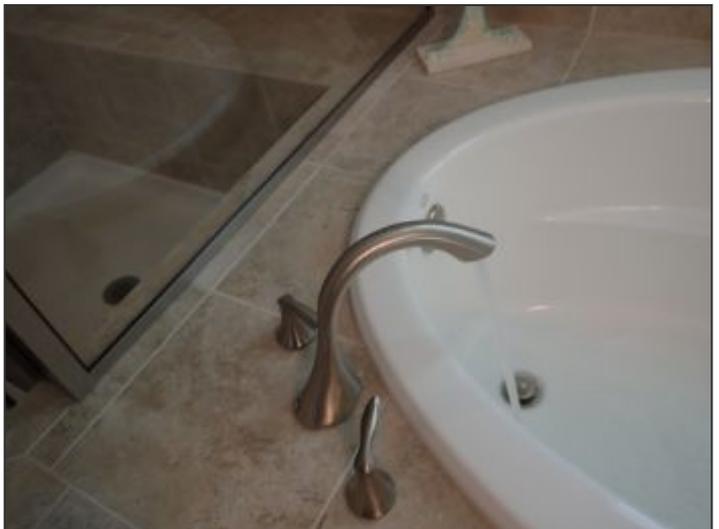
5.1. The bathtubs were in fair condition at the time of inspection.

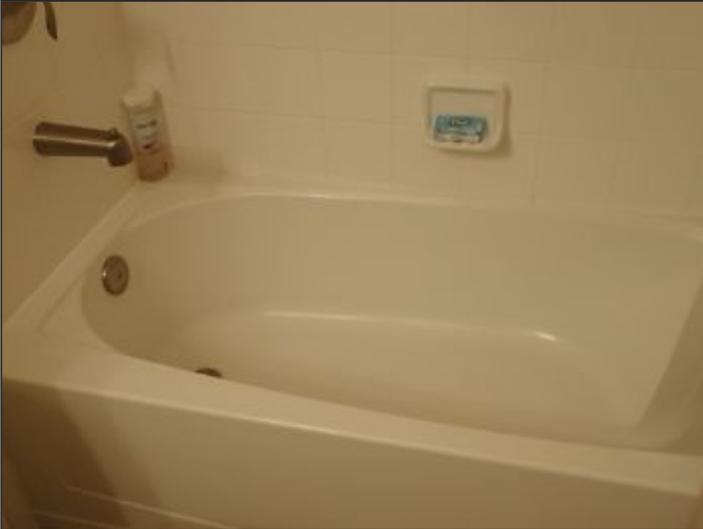
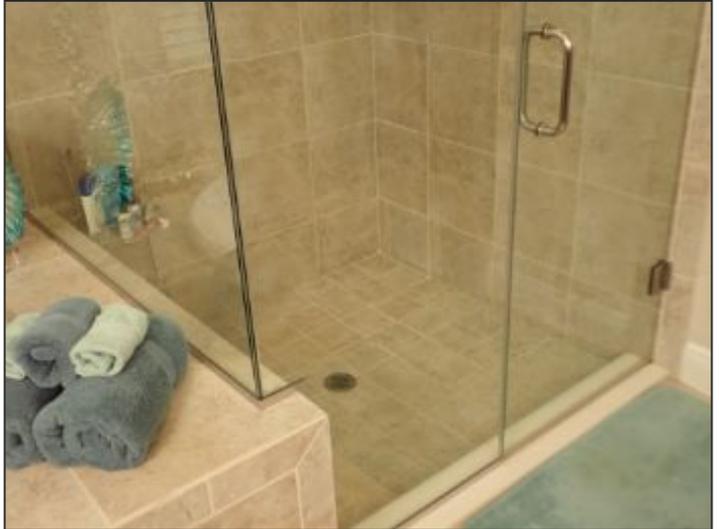
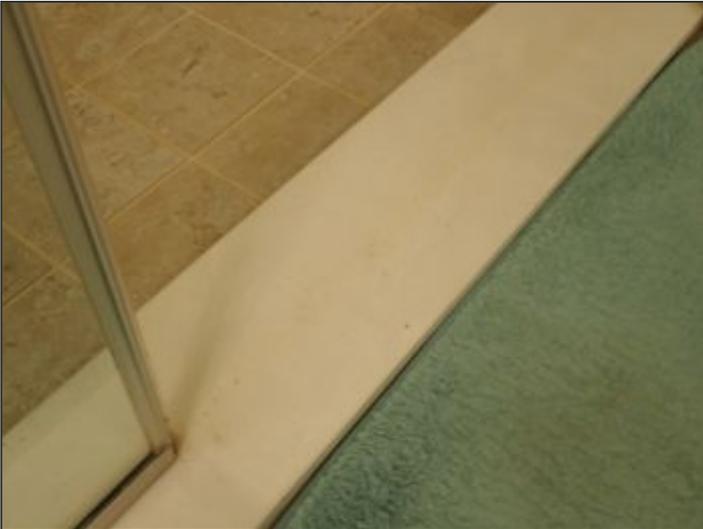
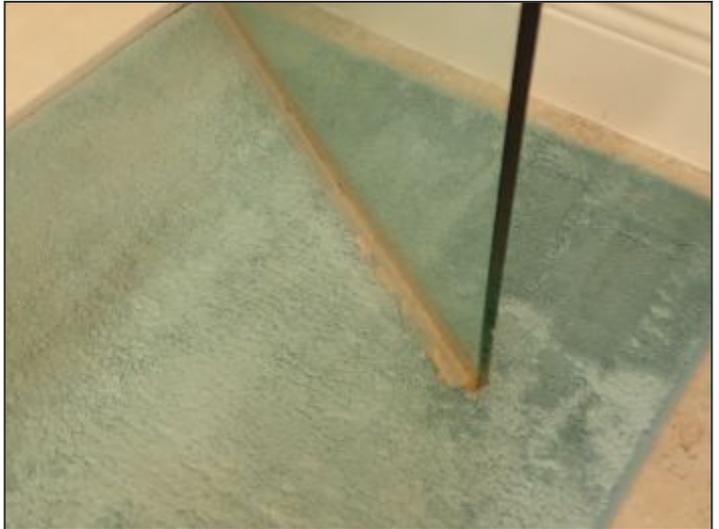
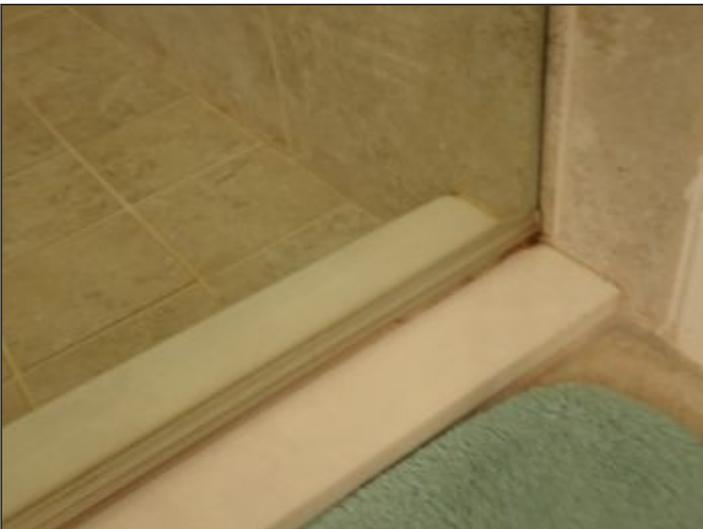
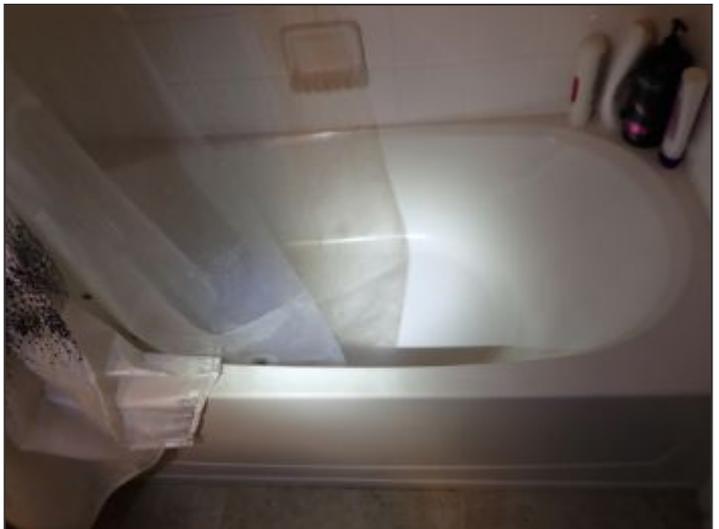
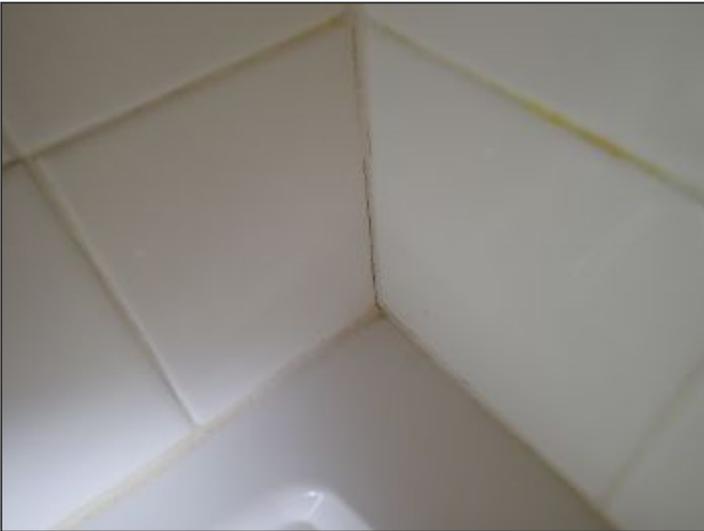
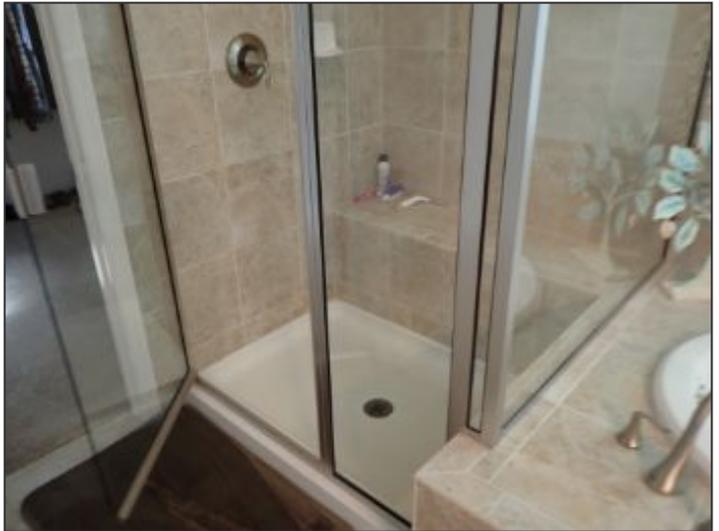
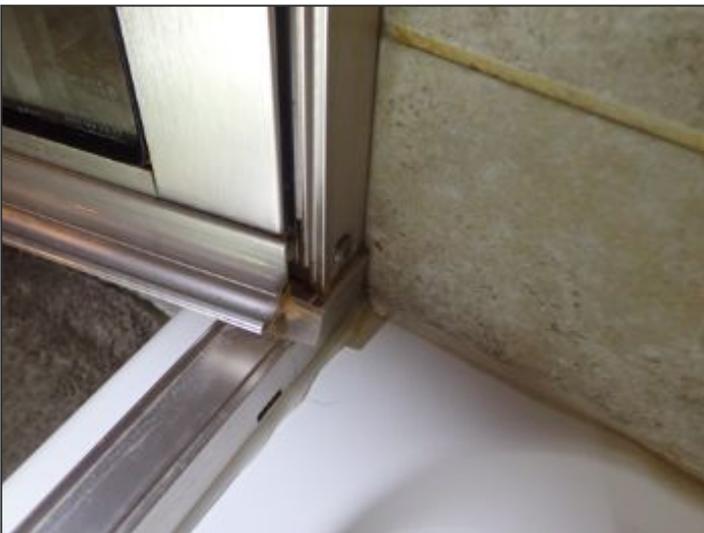
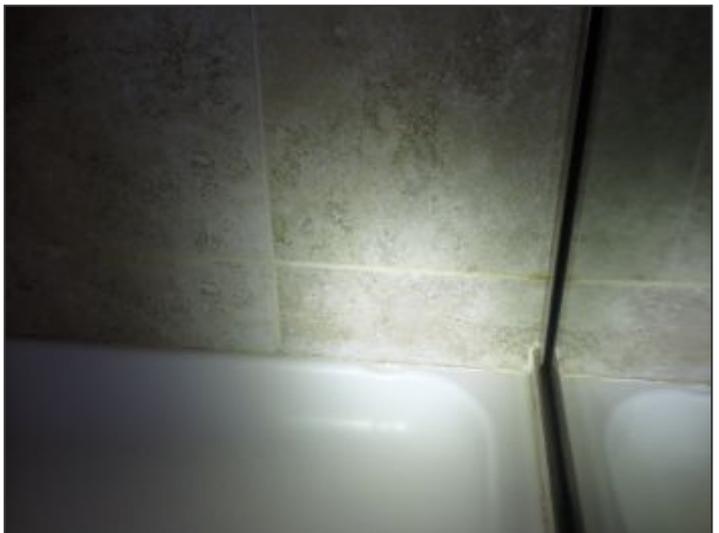
6.1. Both of the master bathroom showers at the first and second floor will require service. The inspector noted grout lines had visible gaps and cracks which will require repairs/service. The weatherstrip at the door should be serviced, if not replaced based on the condition observed to avoid moisture seeping out of the enclosure. Ensure to service all shower enclosures as required maintenance.

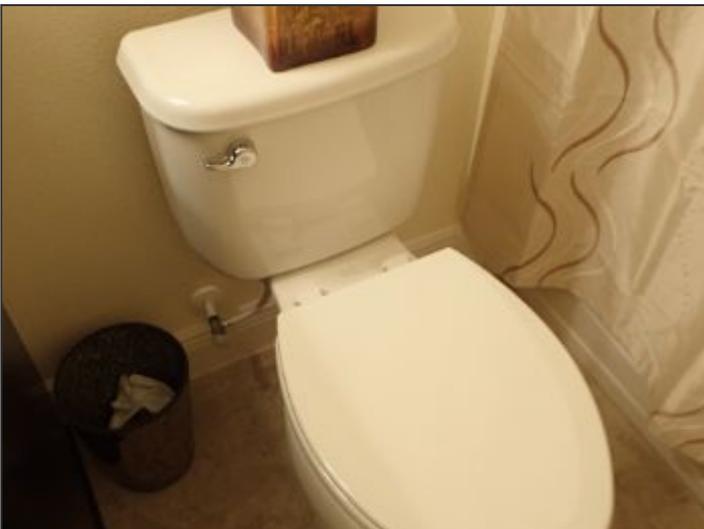
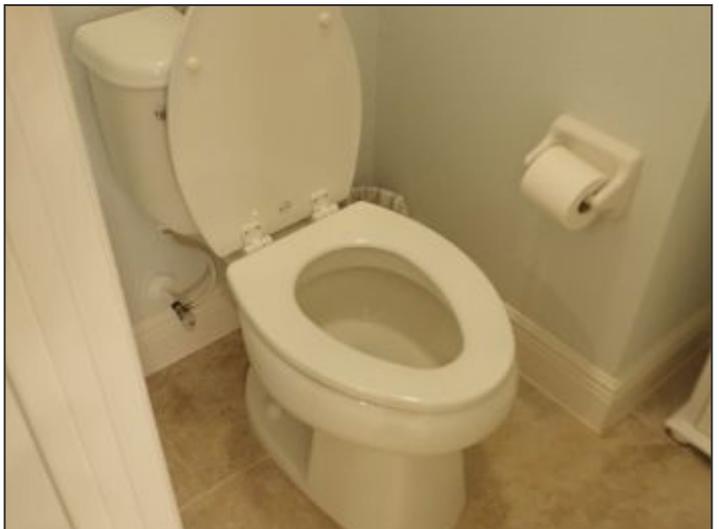
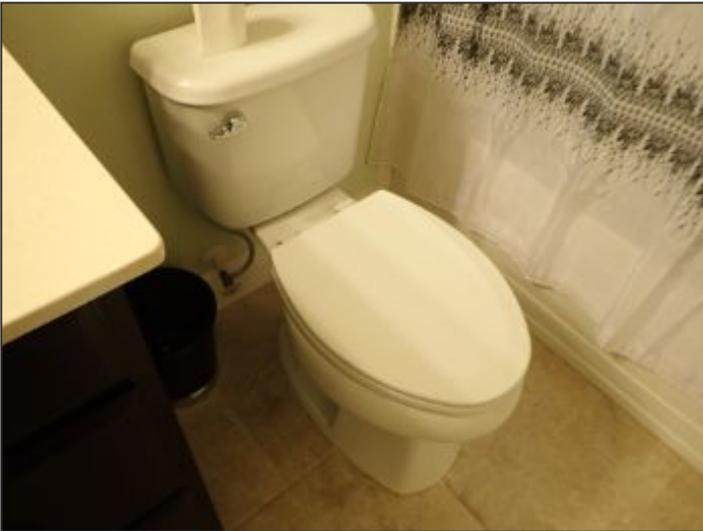
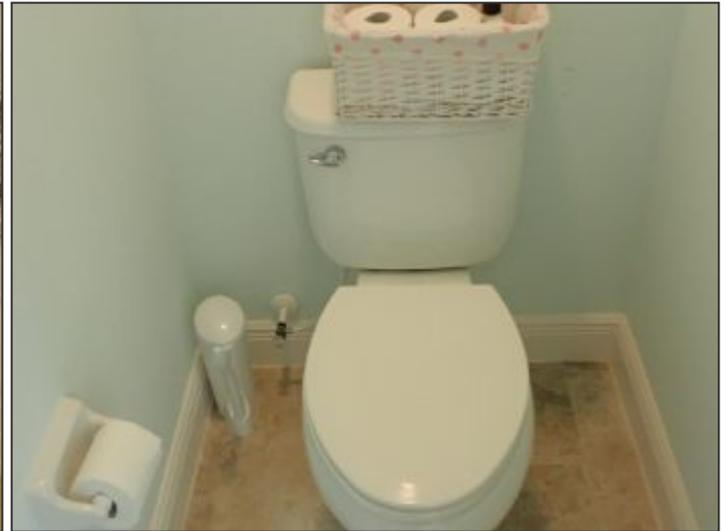
7.1. The toilets were operated and appeared to be in good working condition at the time of the inspection.

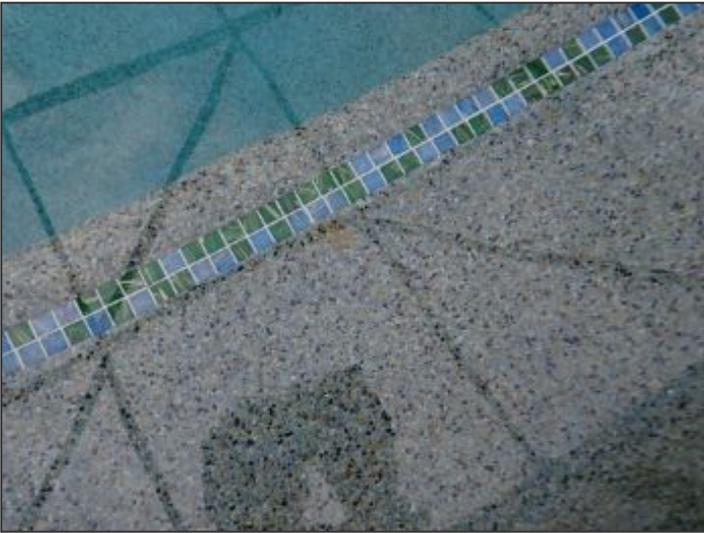
2.1. The pool vessel appeared to be in satisfactory condition at the time of inspection. There were areas of minor discoloration and rusting/corrosion. The inspector does not suspect any major issues, appears to be normal wear for age. Ensure to service pool as required to avoid premature wear and replacement of the vessel.

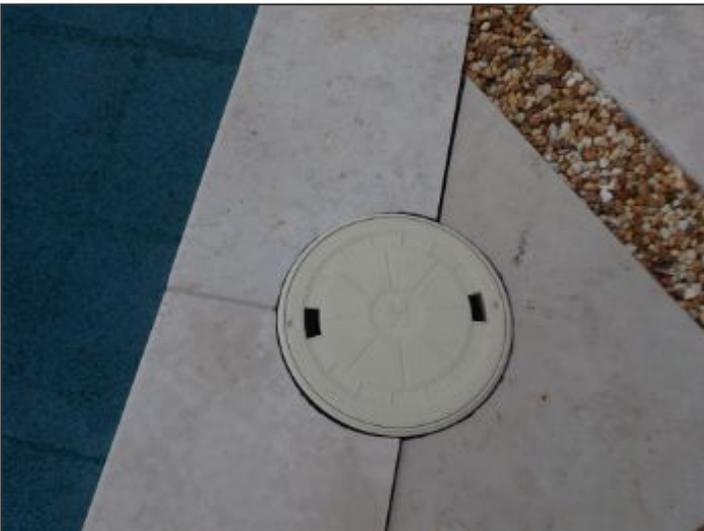
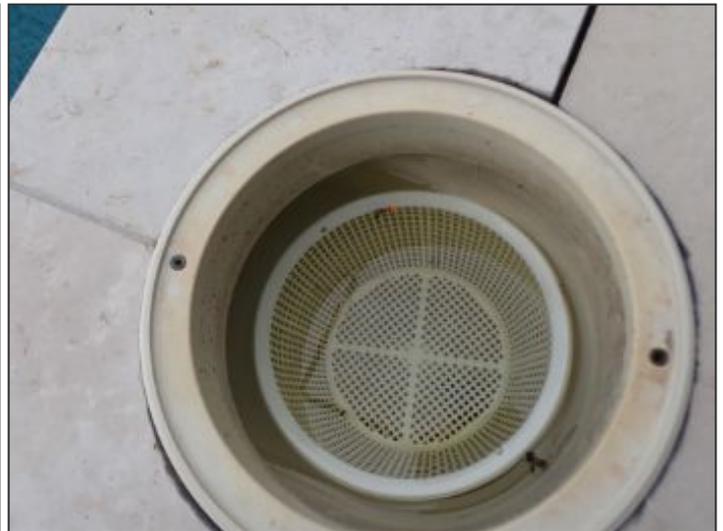
5.1. The skimmer box and its cover are functional.

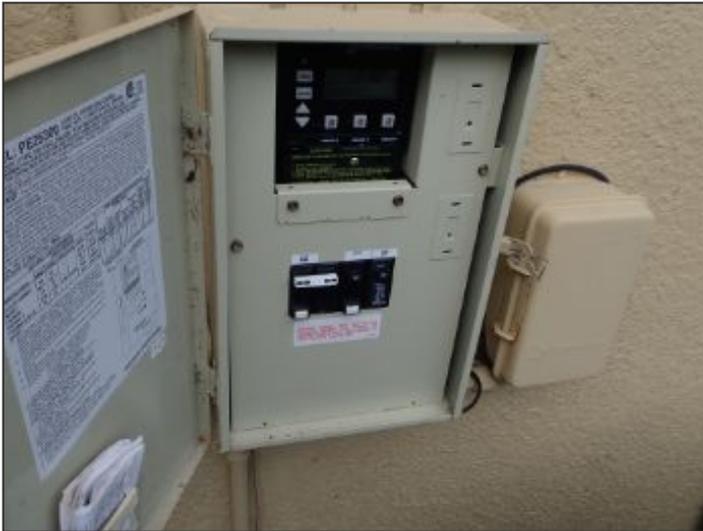
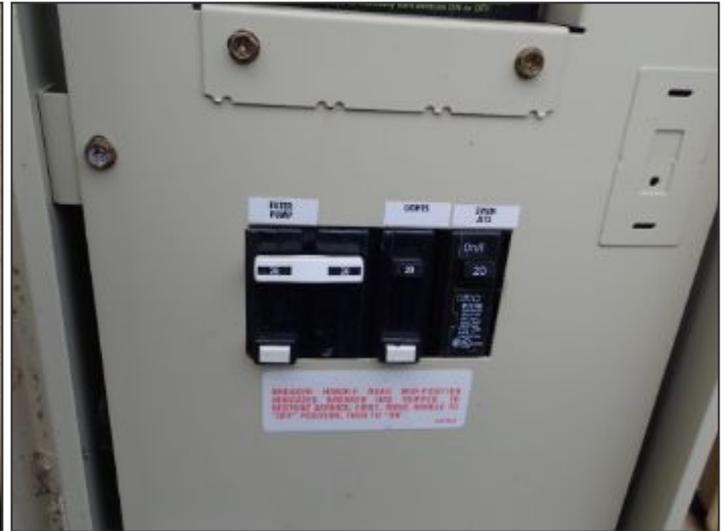
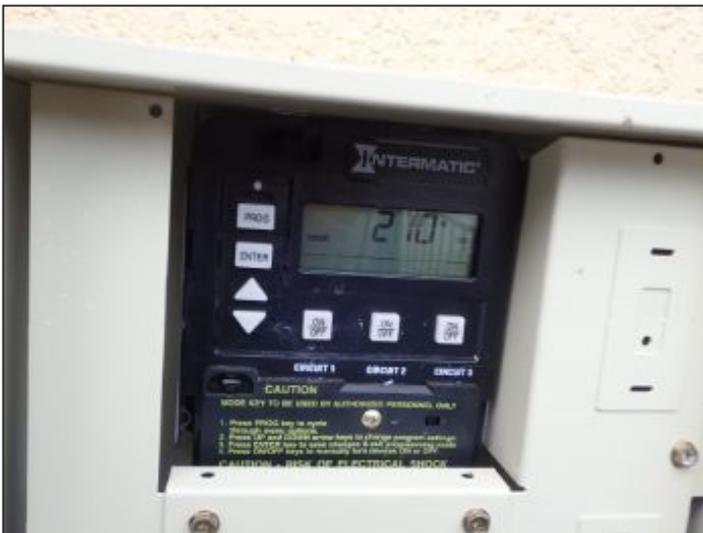
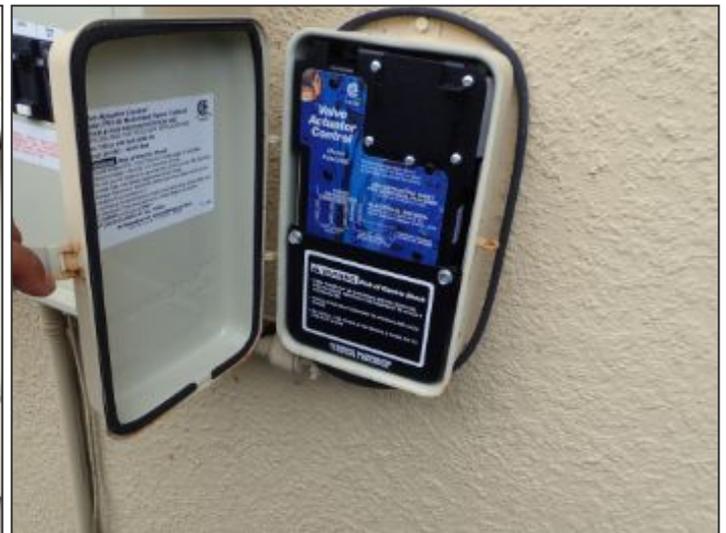
6.1. The control system was operated and appeared to be in good working condition.

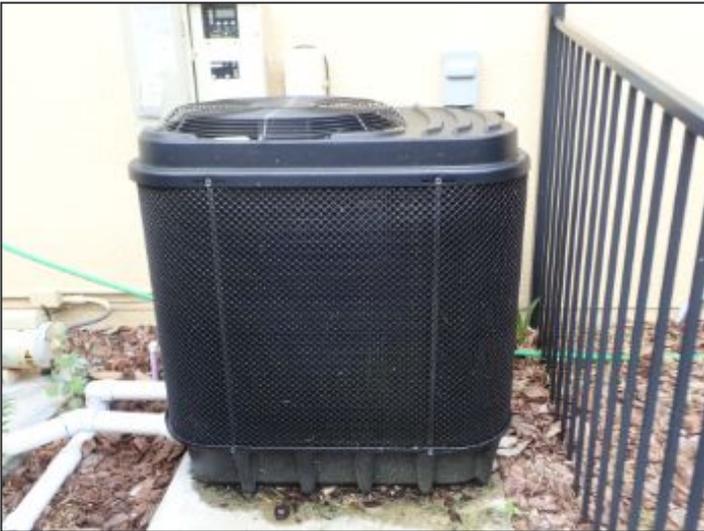
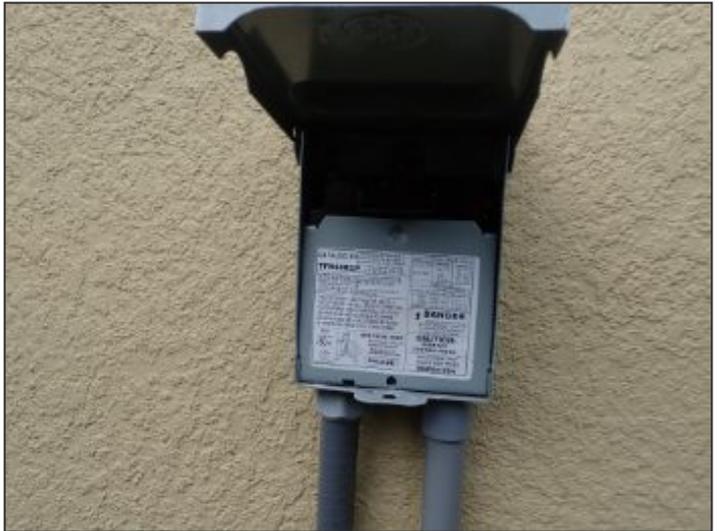
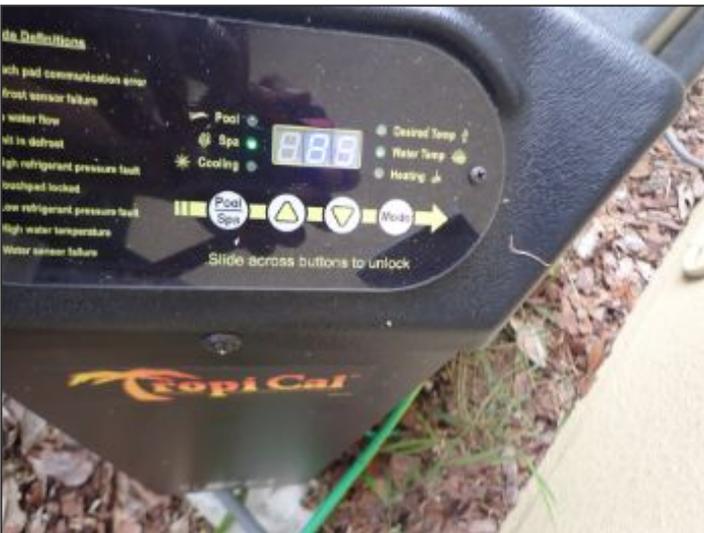
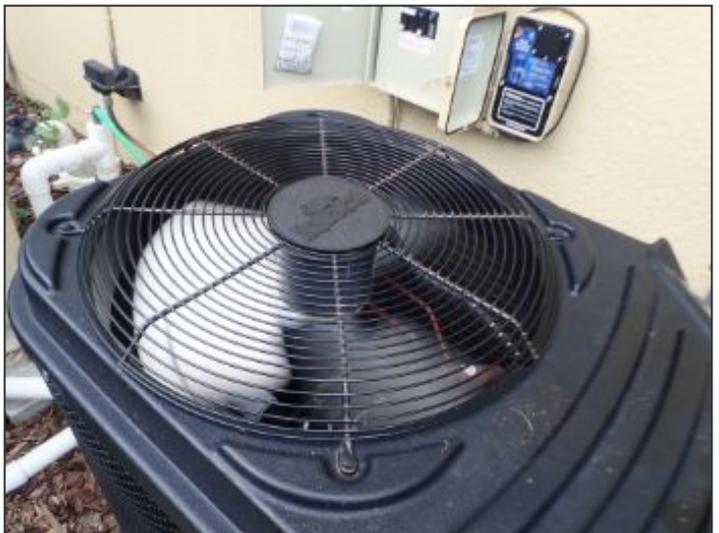
9.1. The pool heating system was operated and responded to the controls at the time of the inspection.

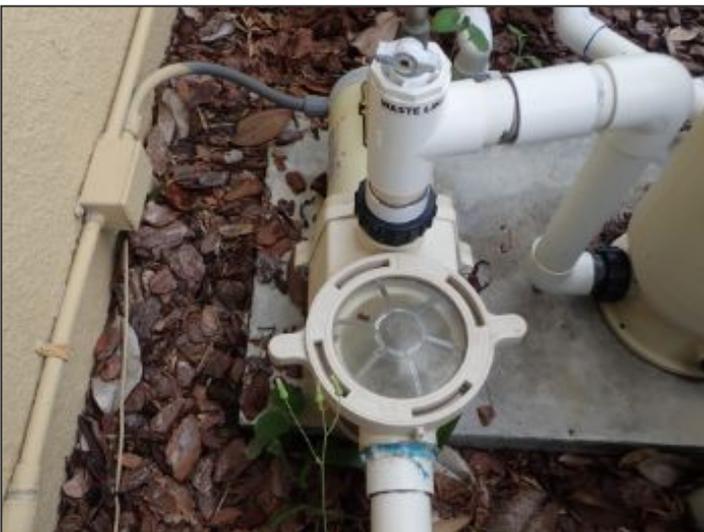
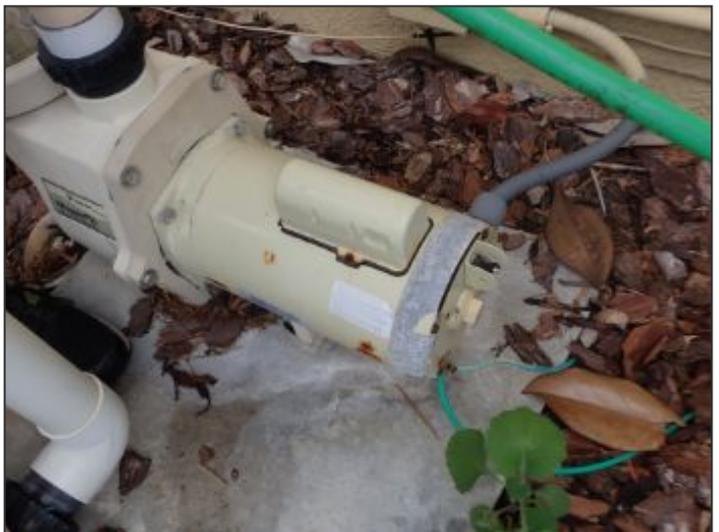
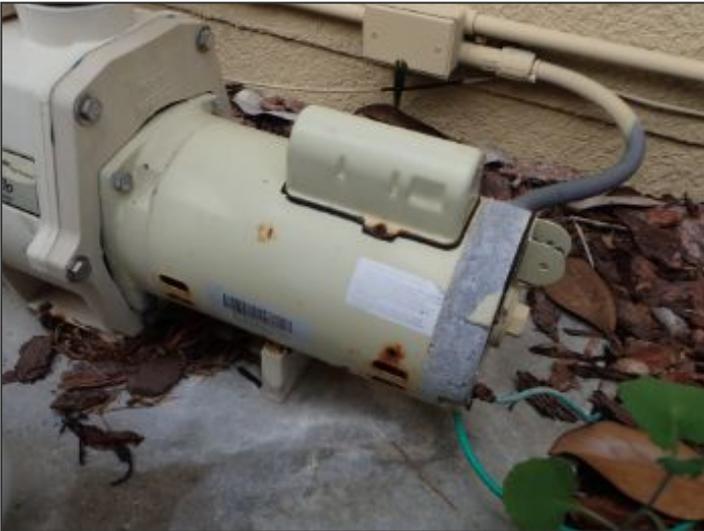
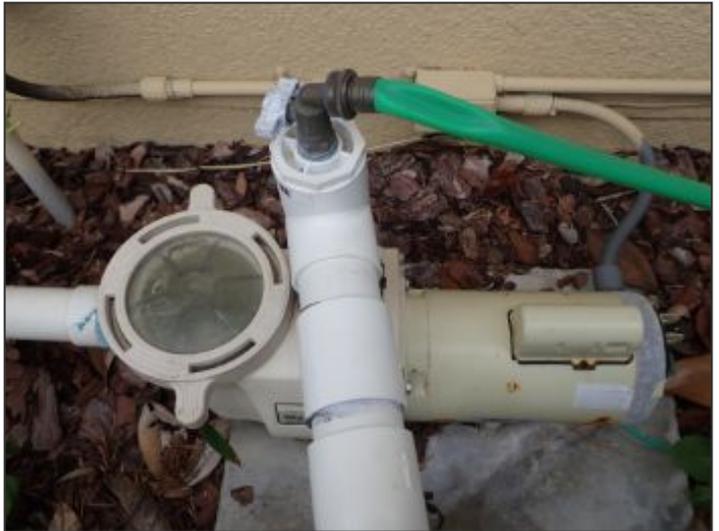
10.1. The pool pump appeared to be in good working condition at the time of the inspection. The inspector noted sealant along the pump and pipes, ensure to maintain to avoid leaks from arising. The inspector noted corrosion along the pump, this unit appears older, possible replacement may be required in the future.

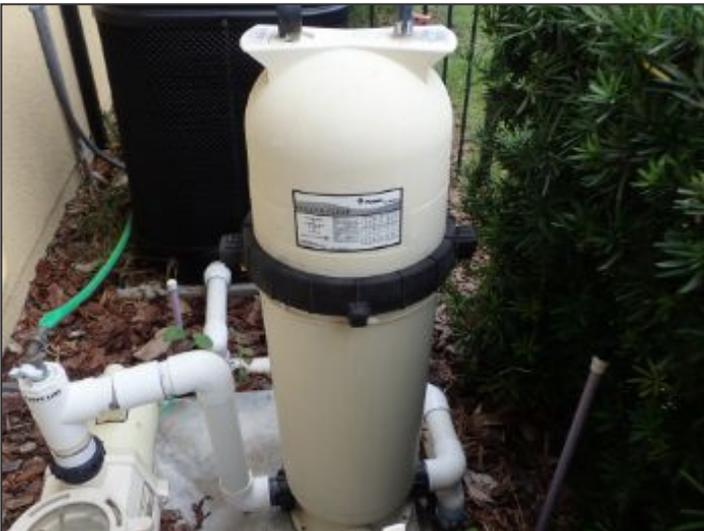
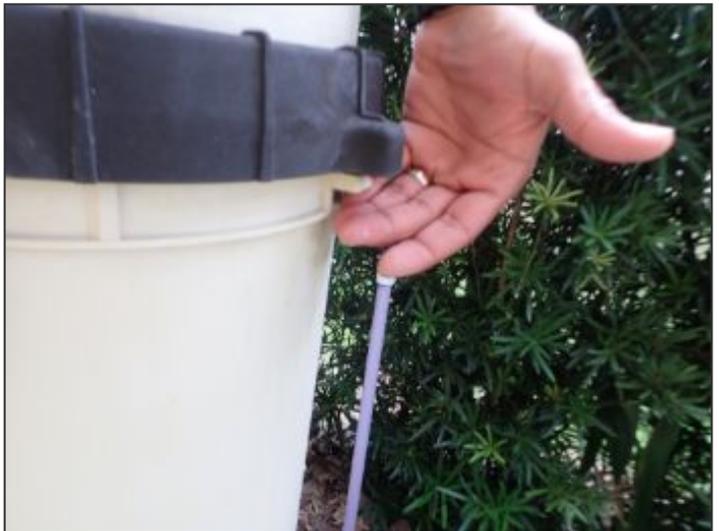
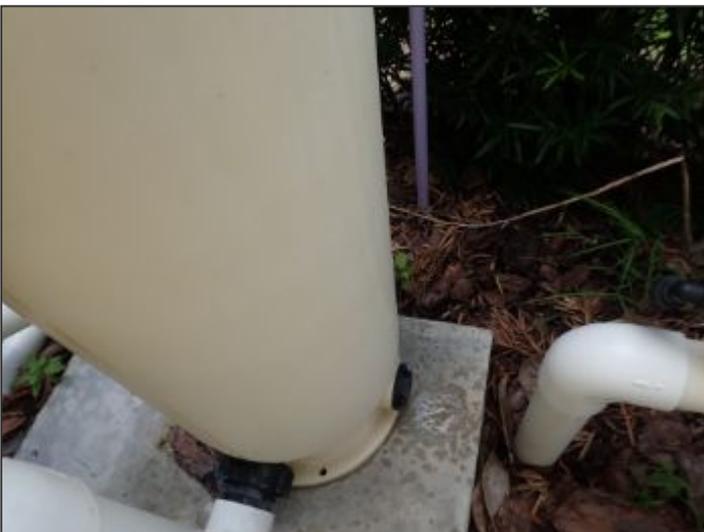
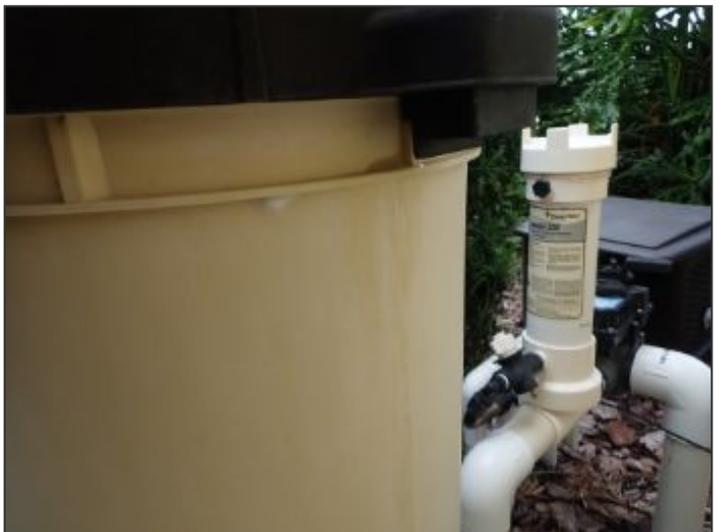
11.2. The pool equipment filter was leaking at the time of the inspection from multiple locations, further evaluation and service is required to avoid further damage from arising.

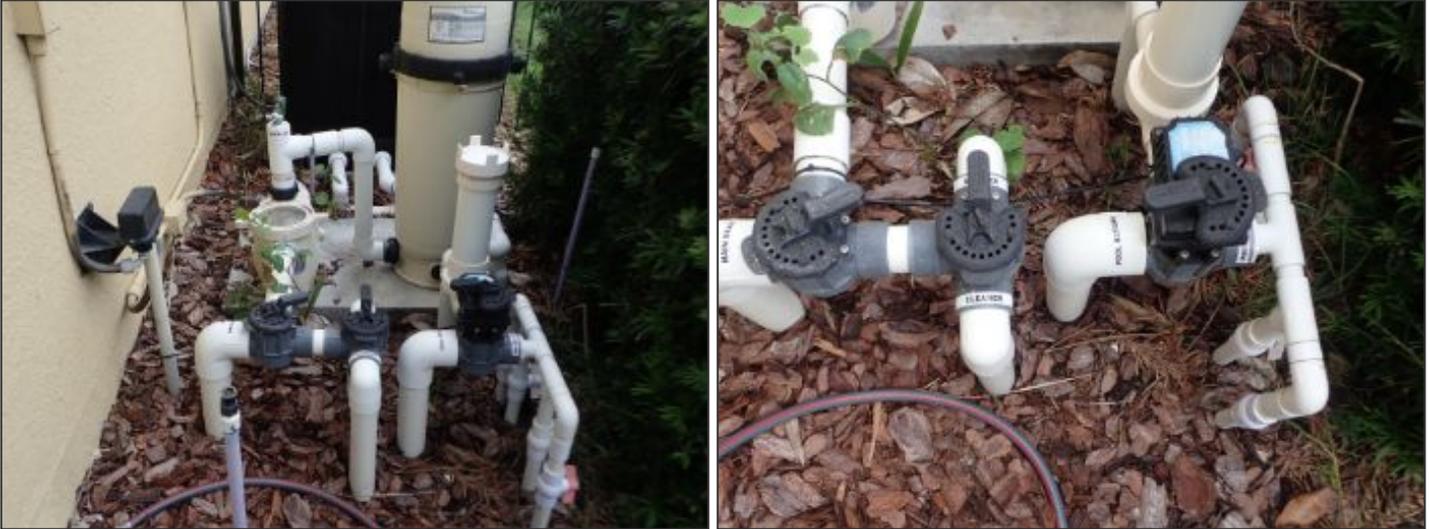
Materials: White plastic PVC pipes were exposed to direct sunlight. This type material is deteriorated by the ultra-violet (UV) radiation in sunlight, and this condition will result in premature failure of pipes compared to similar pipes protected from UV. The Inspector recommends that steps (such as painting the pipes) be taken to protect the affected PVC pipes.

13.1. Plumbing pipes were in satisfactory condition.
