***Home Inspections By
Paul J. Magrone Inc.
321-228-3848 cell
407-816-8209 office***

Inspection Conditions/ Invoice

Year Built: 2003
Building Type/ Stories: Two Story Single Family Home
Front Exposure: East
Building Construction Level #1: Concrete Block Masonry
Building Construction level #2: Wood Frame
Exterior Wall Covering: Stucco & Stone Veneer
Building Foundation Type: Slab
Living Area Square Feet: 5747
Power & Water Utility Services: Public
Sewage Disposal: Private Septic System

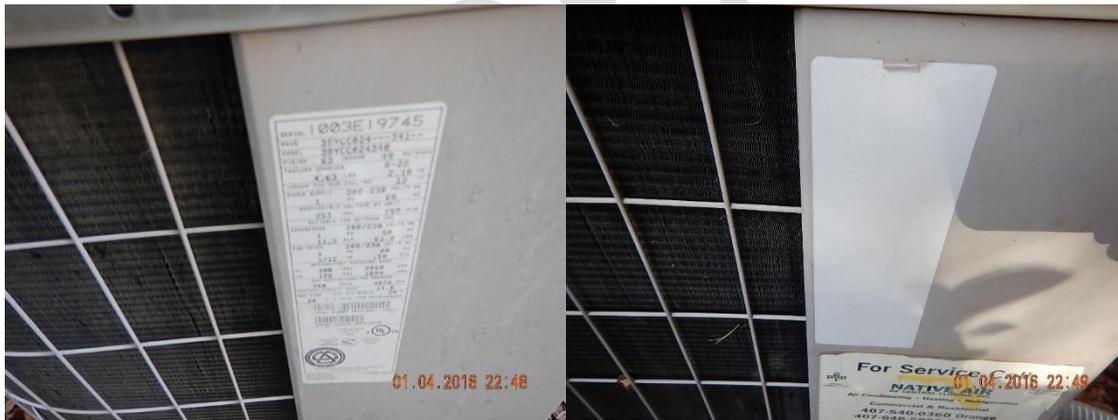
Three of the Condenser Units are installed at the south side of the building

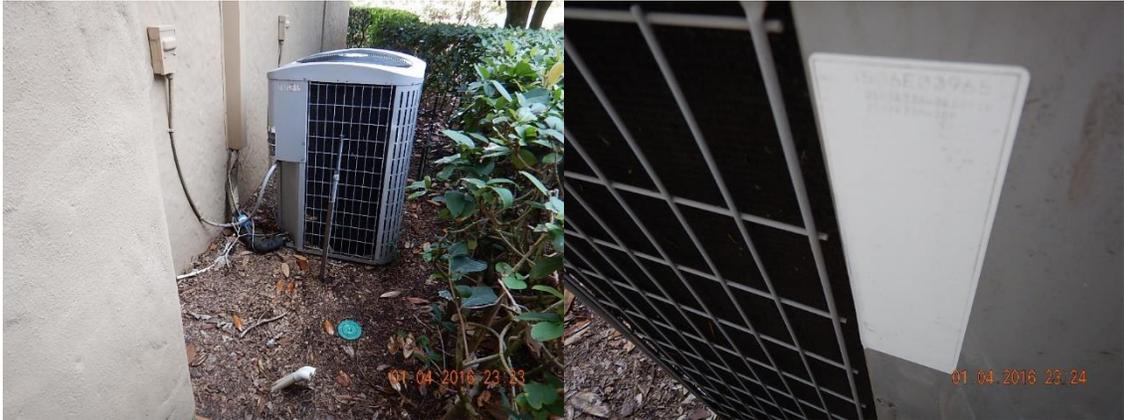
Two of the Condenser Units are installed at the north side of the building

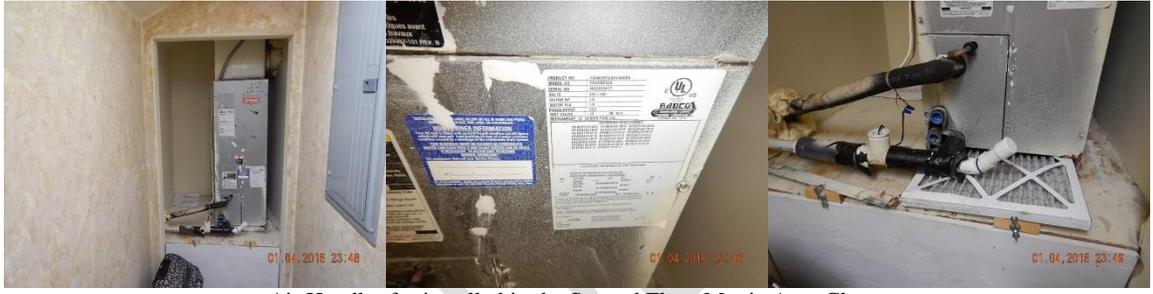
Two of the Condenser Units are installed at the north side of the building/ These are for the Master Bedroom and the First Floor Main Living Area Systems

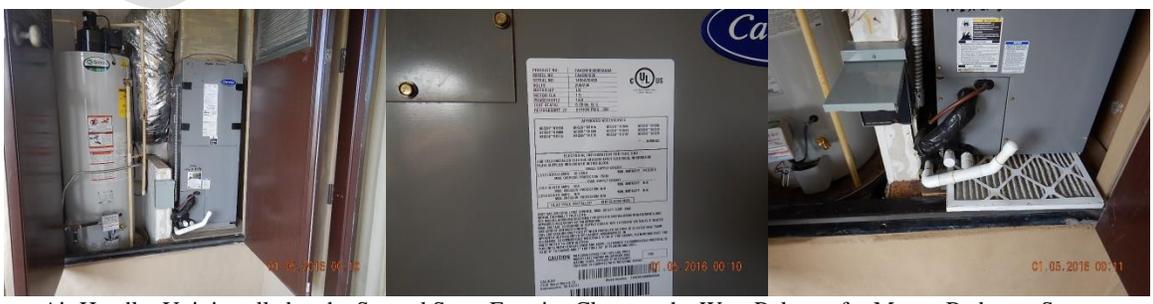
The Coils for the system require further evaluation and service at this time

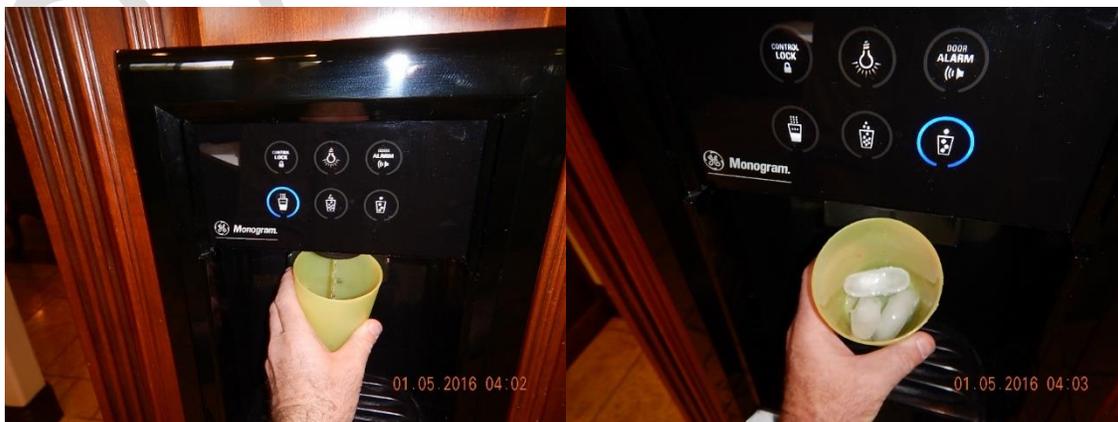
- The Ice Dispenser for the Kitchen Refrigerator is not fully functional/ The Ice gets stuck and jams up when using the Dispenser

Kitchen- The Ice Dispenser for the Kitchen Refrigerator is not fully functional/ The Ice gets stuck and jams up when using the Dispenser

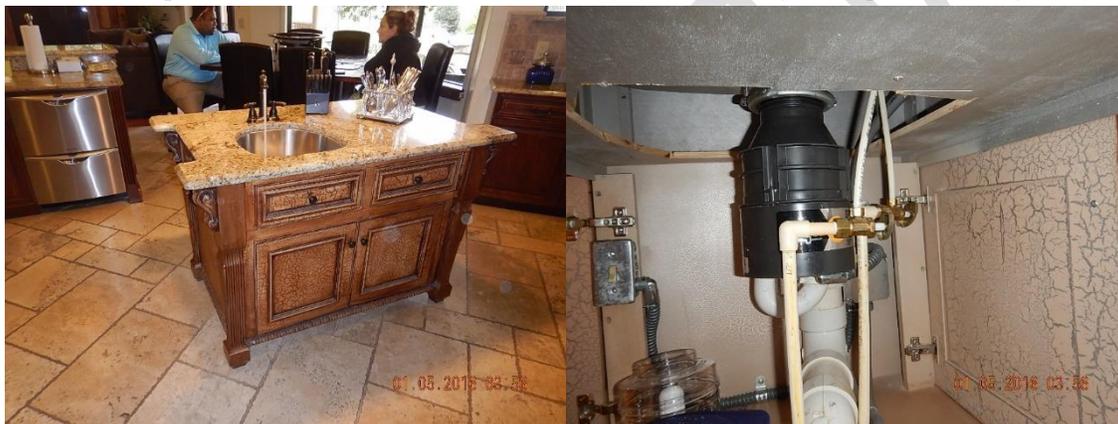
Kitchen Sink- Previous leak stains were noted at the left side Kitchen Sink but no active leaks were present at the time of the Home Inspection/ This location should be monitored over time for reemergence of previous leaking condition

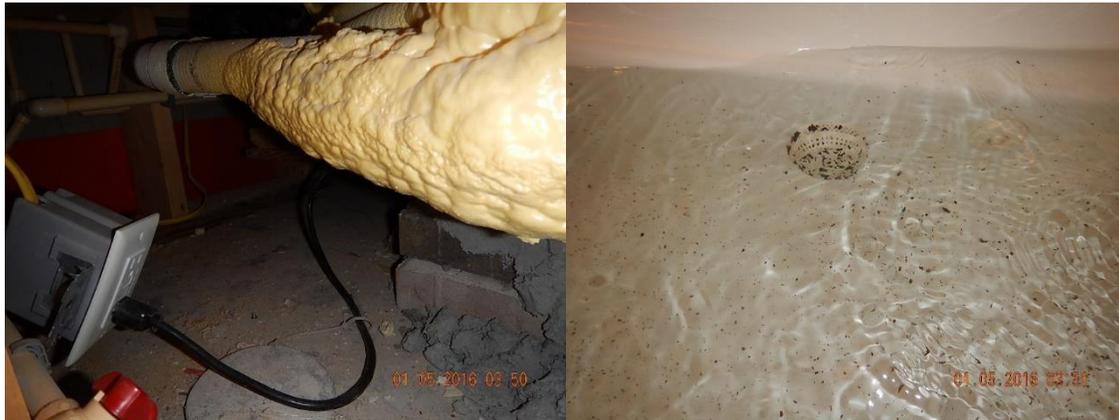
The Jacuzzi Tub in the Master Bathroom was filled and operated during the Home Inspection/ The Tub is functional but requires further evaluation at this time/ There is dirt in the Tub Jet System and the Air Blower function appears compromised at this time/ The Service Access Panel is installed the left side of the Tub/ GFCI Protection was verified

- Service slow drain at the sink in the Pool Bathroom
- Service/ Repair leak at the hot water handle at the Master Bathroom Tub Faucet Fixture
- Have the Master Bathroom Jacuzzi Tub serviced because there is dirt present in the system and when I operated the Tub the dirt came out of the Jets when the Tub was running

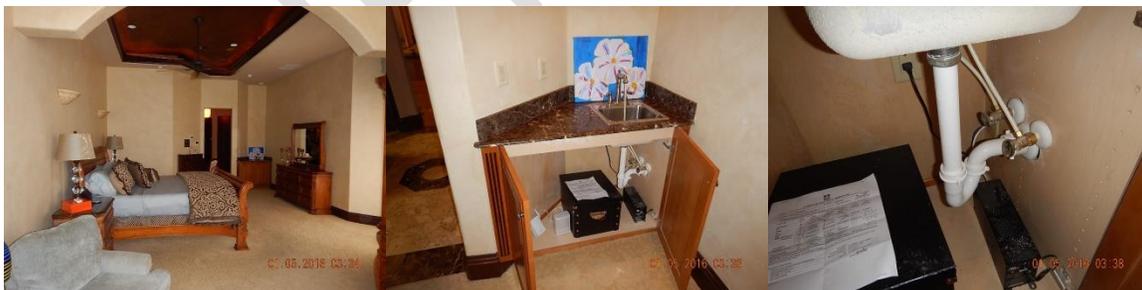
Master Bedroom Wet Bar Sink Areas

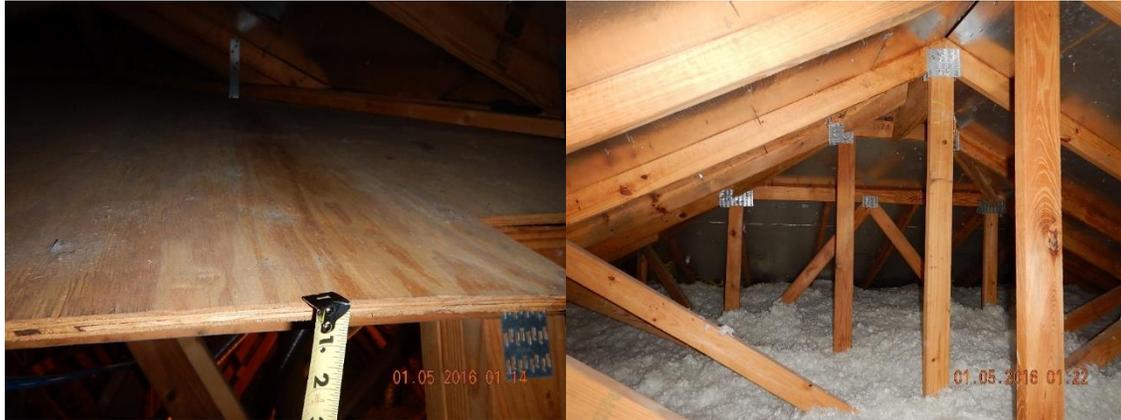
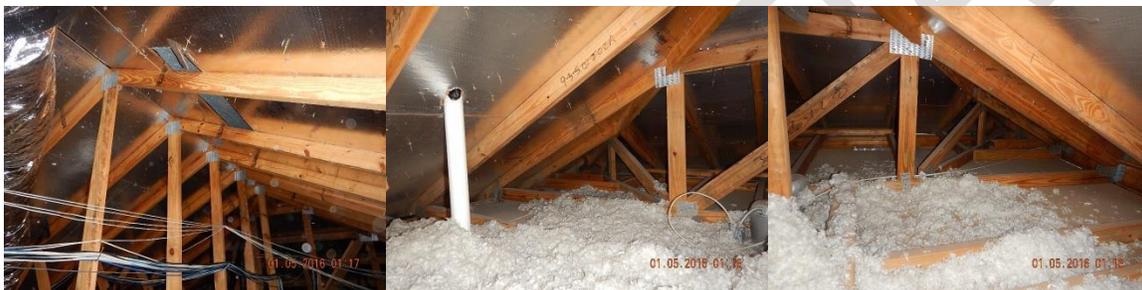
Type of sheathing: 15/32" Plywood/ **Condition:** Good condition at visible & accessible materials- Radiant Heat Barrier inhibited viewing access to the majority of the Roof Deck Materials

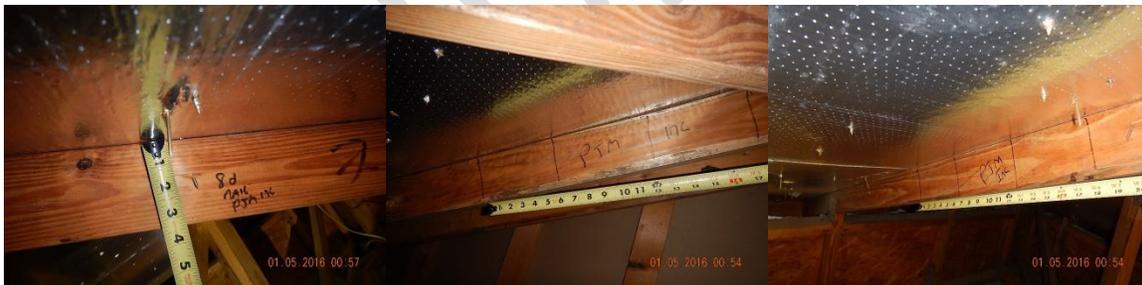
Roof Decking Attachment Nail Size & Spacing: 8d nails spaced a maximum of 6" apart in the field/ I used a Metal Detector to locate and estimate the nails and calculate the spacing

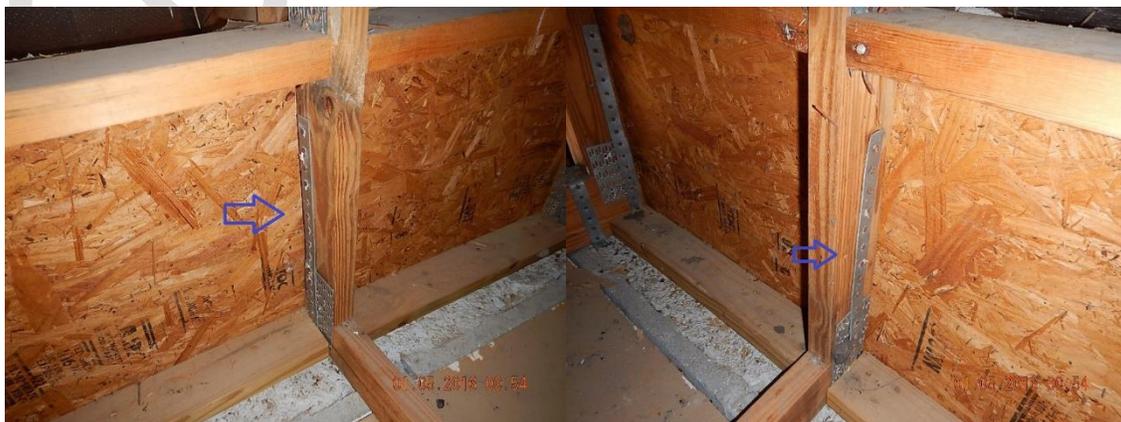
Type of Roof to Wall Connectors: Standard Metal Straps/ Good condition at accessible areas of the Attic

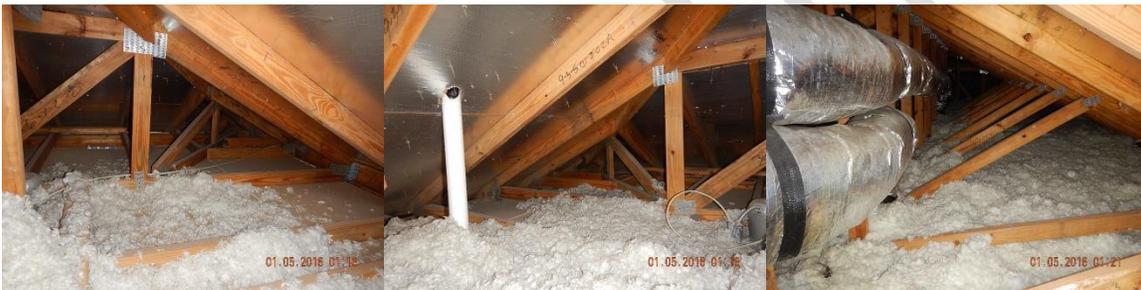
Attic Insulation: R- 30 Loose Fill Fiberglass-Fiberglass Batt-Radiant Heat Barrier/Good condition and evenly installed throughout accessible areas of the Attic

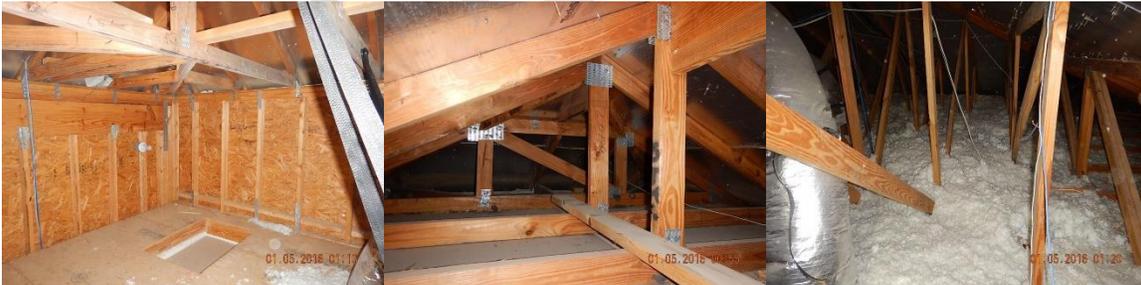
Attic Areas appeared to be in good condition overall

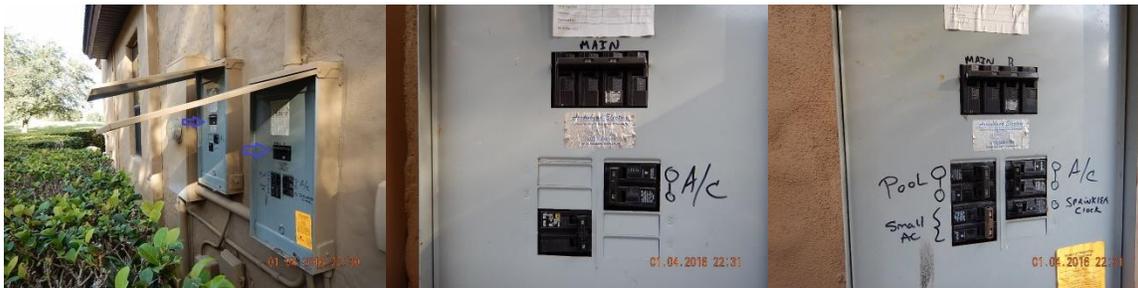
The Main Service Disconnect Panels are installed at the South Exterior Wall/ Both Panels and visible and accessible wiring appeared to be in good condition at the time of the Home Inspection

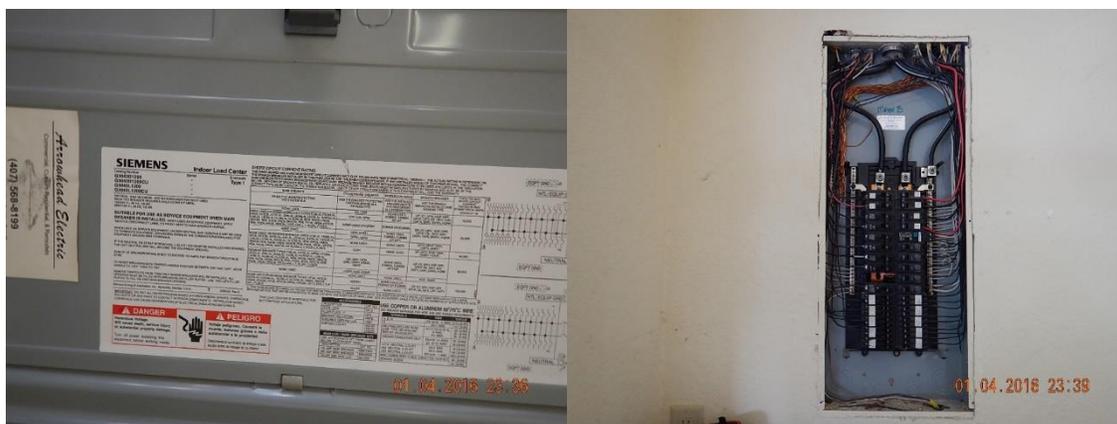
Sub Panel B Location: West Interior Garage Wall- Visible and accessible wiring appeared to be in good condition at the time of the Home Inspection

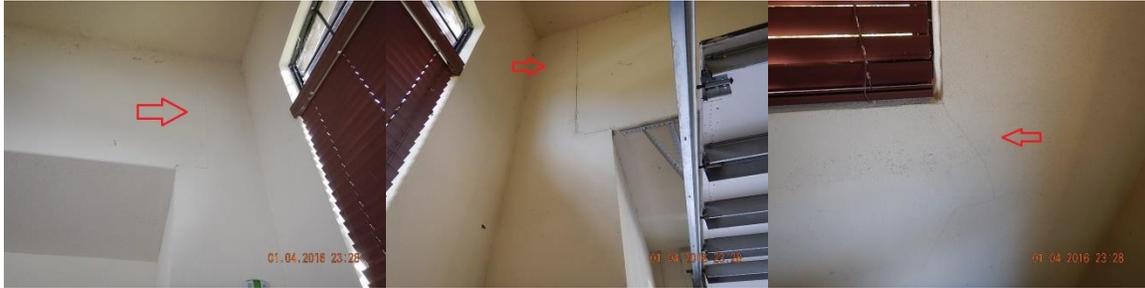
Settlement at the Interior East Side of the Garage

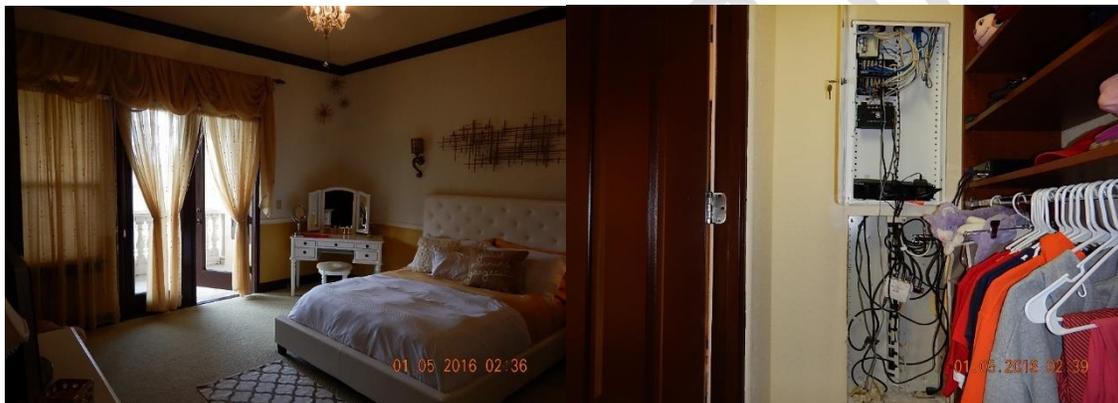
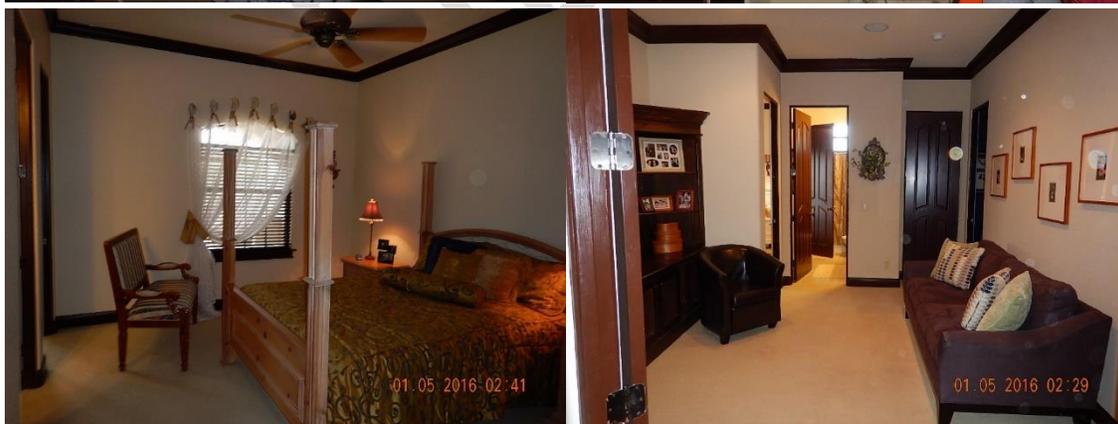
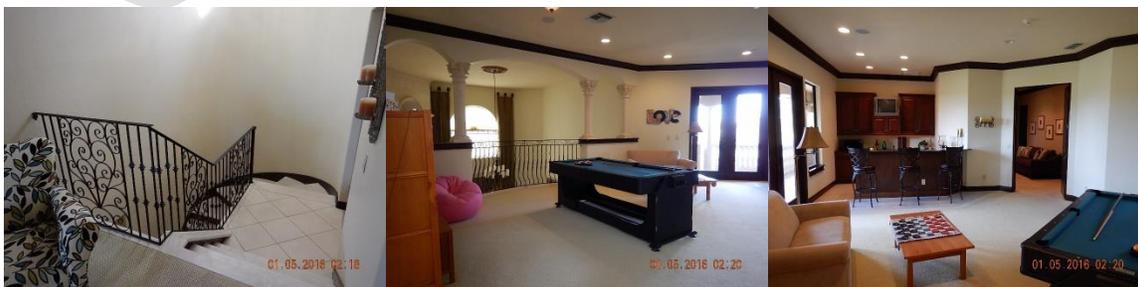
Evidence where previous moisture may have been present in the Bedroom Closet at the East Hall Bedroom and at the bottom left corner of the window in the Second Floor Study were tested with a Moisture Meter and found dry at the time of the Home Inspection indicating the areas have not been recently wet

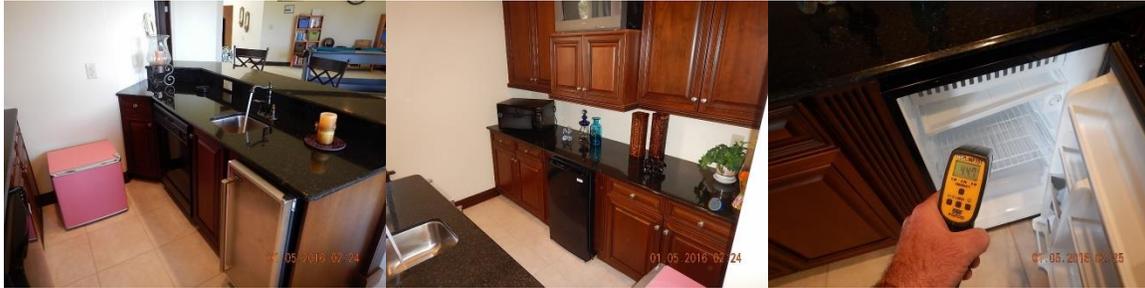
Dishwasher and Refrigerator at the Second Floor Bar Area were checked and operated

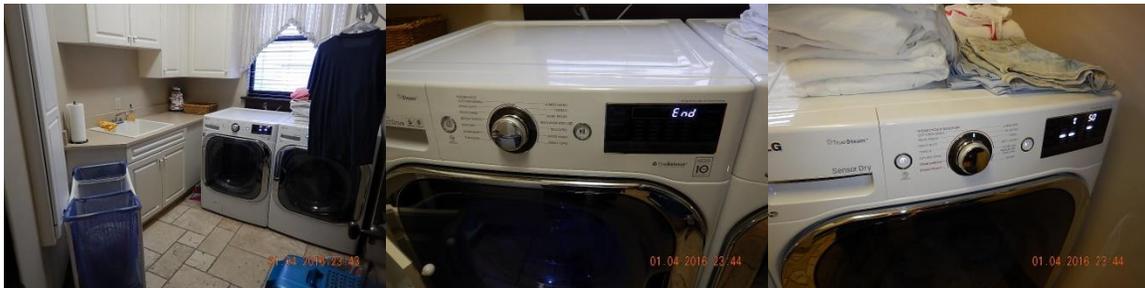
Washer & Dryer were operated

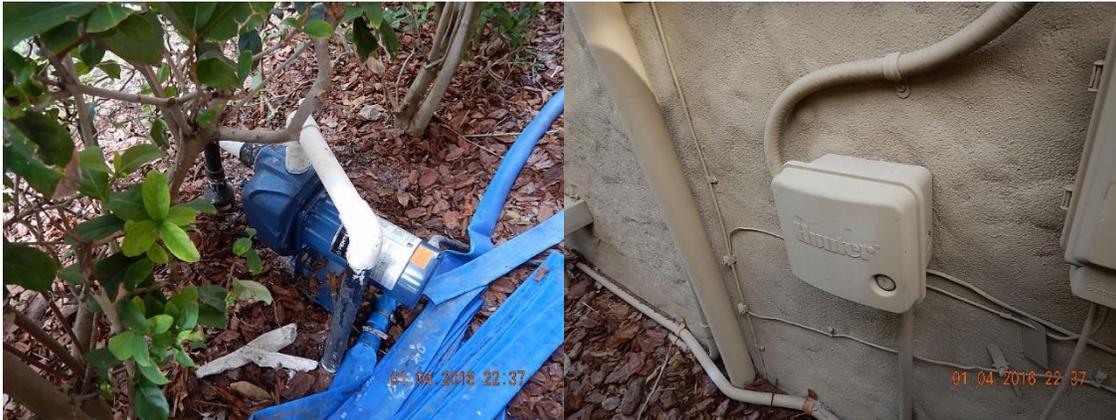
Control Panel Location: South Exterior Side- **Relay & Pump Location:** South Exterior Side

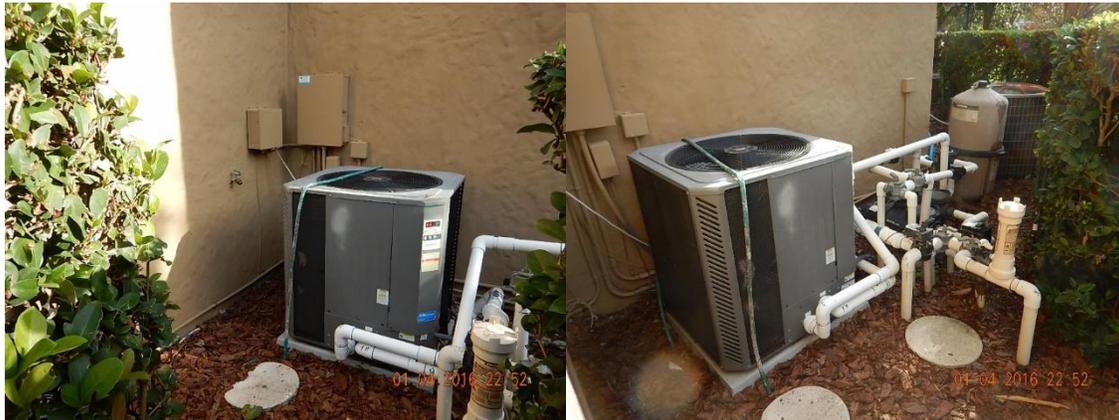
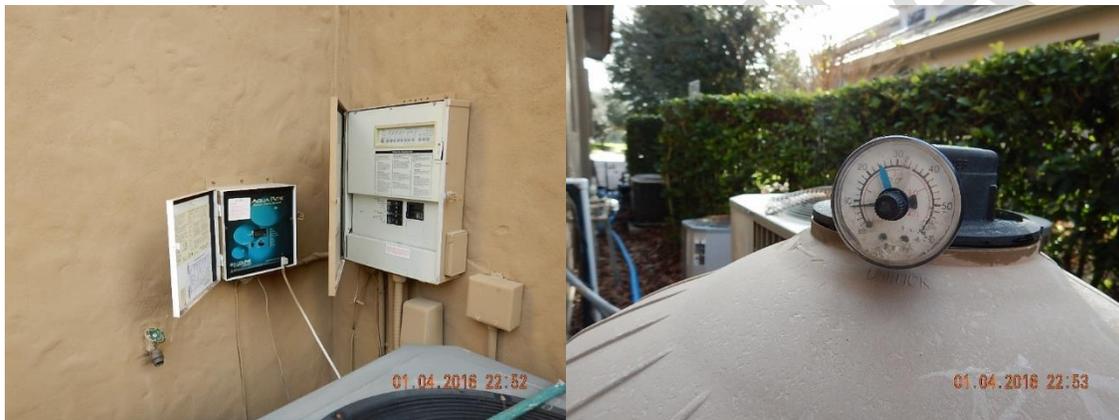
Pool Equipment- Leaking at the Pool Pumps and Filter Pressure Gauge

- Expired Permit located through Orange County Public Records/ We spoke with Mark Keith at Orange County and he stated that the Pool & Spa Permit has expired with no final inspection as the final inspection was cancelled. We recommend further evaluation and follow up to determine how to get the Pool & Spa Permit closed with Orange County.
- Repair two leaks at the Pool Pumps and one at the Pool Filter

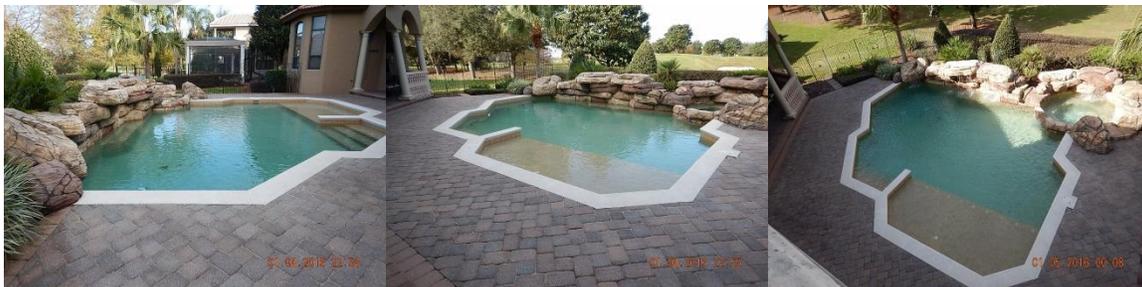
Pool Water & Surface appeared to be in good condition overall/ Well maintained

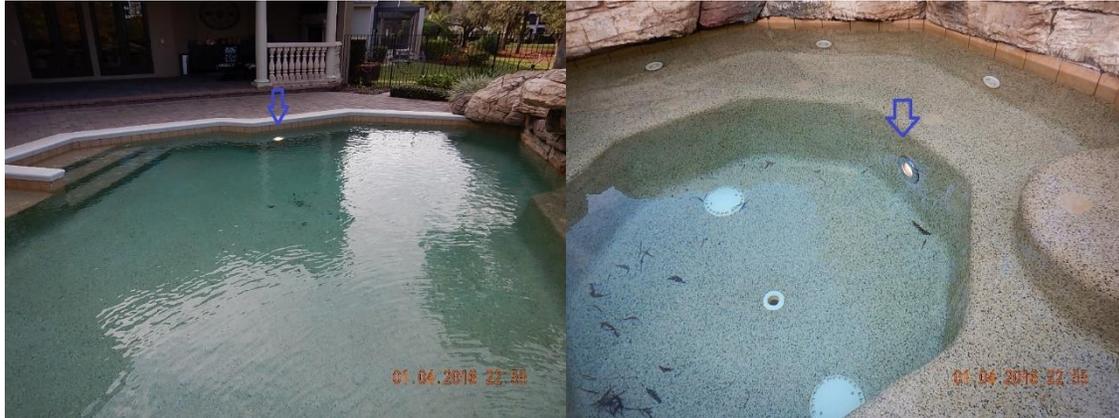
Pool & spa Lighting appeared functional

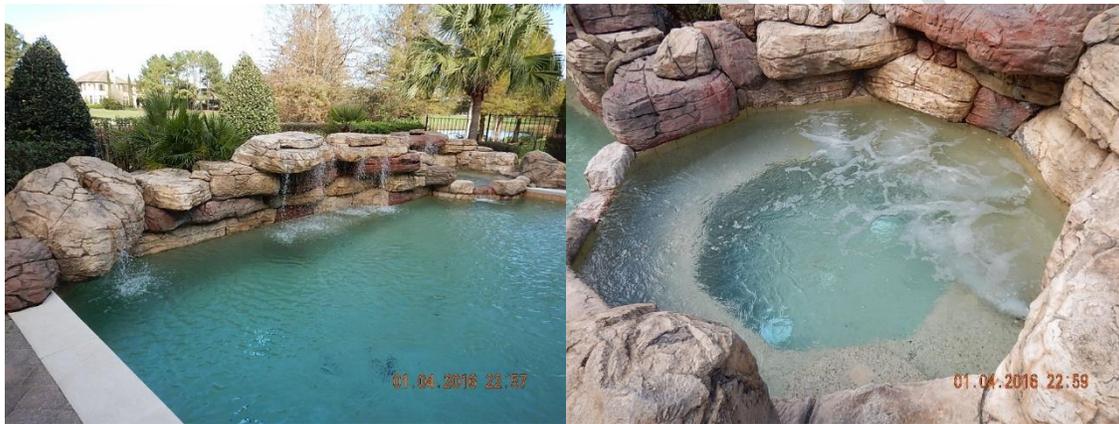
Pool Spa and Water Features appeared functional
